GROUP	MODEL
	Safety Recall Campaign	2021-2023MY K5 (DL3a)
	NUMBER	DATE
	SC263	March 2023
SAFETY RECALL CAMPAIGN		
SUBJECT: SIDE CURTAIN AIRBAG INSPECTION/REINSTALLATION (SC263)

This bulletin provides information to inspect the installed condition of both LH and RH side curtain airbags in all 2021-2023MY K5 (DL3a) vehicles produced from March 27, 2020 through November 16, 2022 and certain 2023MY K5 (DL3a) produced from November 17, 2022 through December 9, 2022. The subject vehicles are equipped with side curtain airbags that may have been installed improperly during vehicle assembly. As a result, the side curtain airbag(s) may not deploy properly in a crash sufficient to warrant such a deployment. An improper deployment of the side curtain airbag(s) increases the risk of injury in a crash. Follow the procedure outlined in this publication to inspect the installed condition of both RH and LH side curtain airbags in the affected vehicles and, if necessary, reinstall properly. Before conducting the procedure, verify that the vehicle is included in the list of affected VINs.

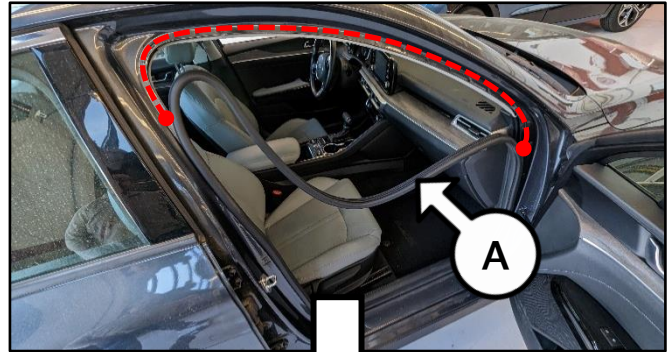
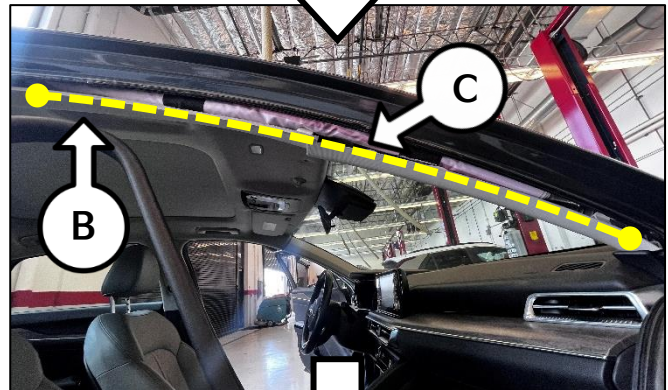
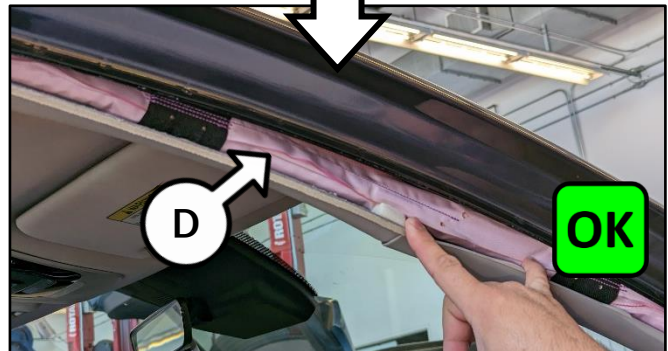
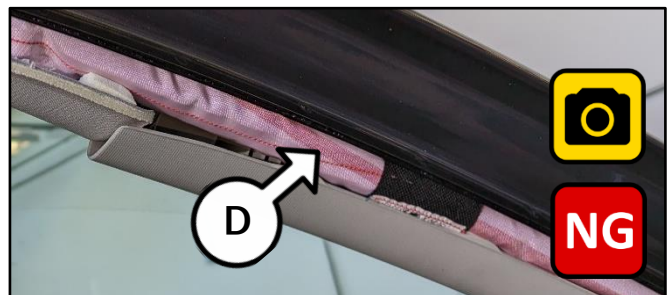
1. Open the passenger (RH) door and partially detach the door weatherstrip (A) as shown.
2. Carefully, pull down on the headliner (B) trim as shown (about 1.0 - 1.5 inches) to view/access the curtain airbag (C).
- 3a. Inspect the curtain airbag (D) along the yellow outlined inspection area (use a flashlight if needed) and confirm one of the following conditions:

- The curtain airbag (D) does not appear to be installed twisted and the **red ¼" line marking is not** visible (**OK**), reinstall the door weatherstrip and proceed to step 3b for the driver (LH) side, page 3.

- The curtain airbag (D) does appear to be installed twisted and the **red ¼" line marking is** visible (**NG**). Take a photo using KDS and open a Techline Case. Repeat Steps 1-3 for driver (LH) side, then proceed to step 4.

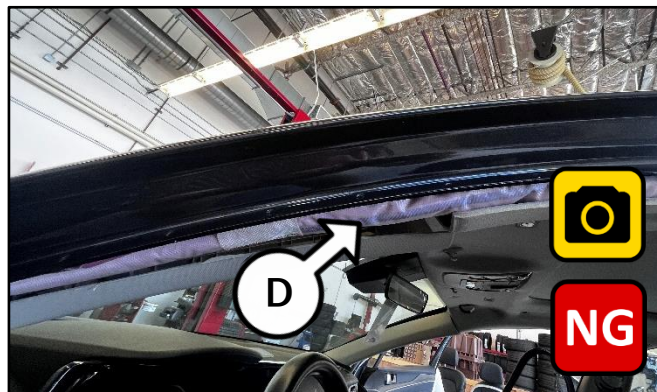
- 3b.
- The curtain airbag (D) does not appear to be installed twisted and the blue ¼" line marking is not visible (OK), then skip to step 5.
 - The curtain airbag (D) does appear to be installed twisted and the blue ¼" line marking is visible (NG). Take a photo using KDS and open a Techline Case and then proceed to step 4.

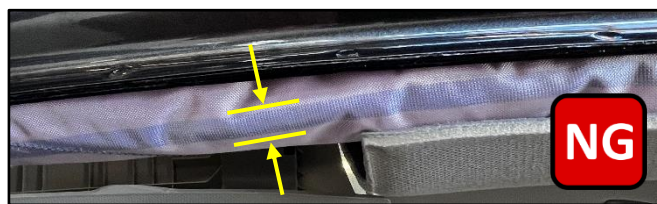
Note: The ¼" line marking is colored **blue** for the (LH) driver side airbag. (The line marking should be facing the inside of the vehicle, not outside).

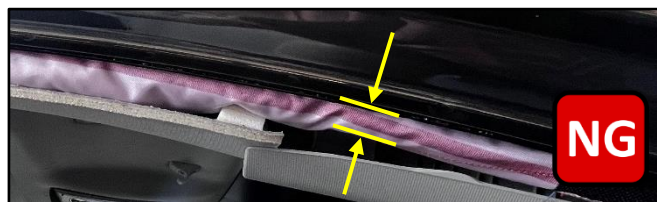
Note: The ¼" line marking is colored **red** for the (RH) passenger side airbag. (The line marking should be facing the inside of the vehicle, not outside).
