SERVICE PROCEDURE

23507R3

SUBJECT: SAFETY RECALL

Grille surround on certain 2020 thru 2024 International® HX® Series trucks built 03/13/2019 thru 02/28/2023

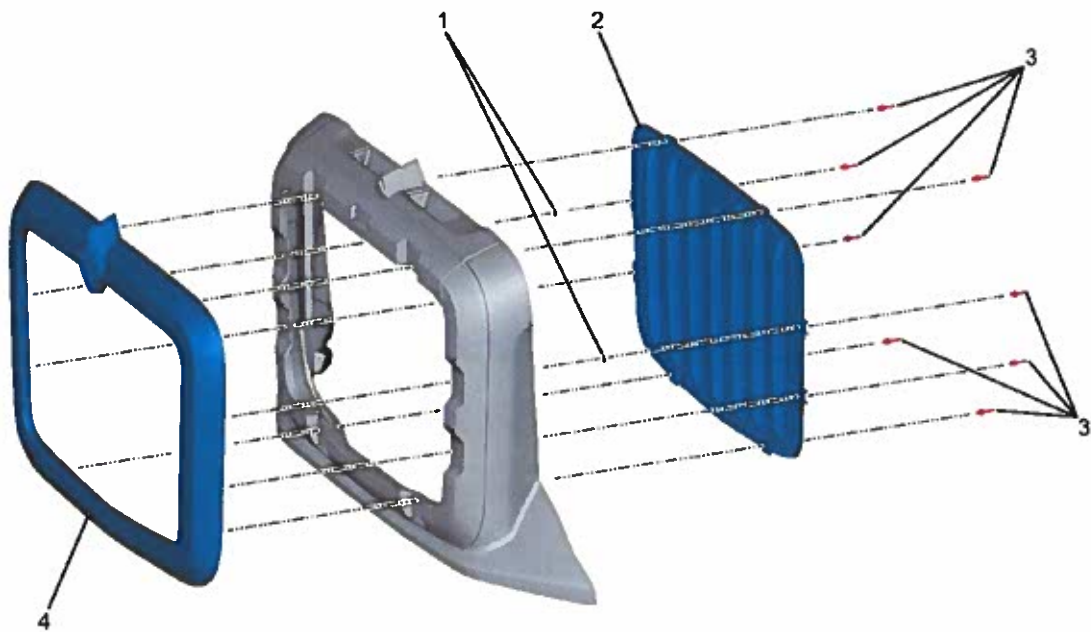
Figure 1. HX615 and HX620 Models Grille Surround Removal

Over time, the grille surround may come loose from the eight mounting brackets that secure it to the hood. This may cause the grille surround to separate from the truck. A grille surround that separates from the truck and falls to the roadway while the vehicle is in operation can increase the risk of a vehicle crash that may result in property damage, personal injury, or death.

1. M8 palnut (2)
 2. Grille assembly
 3. M8 Keps nut (8)
 4. Grille surround
6. Remove eight M8 Keps nuts (Figure 1, Item 3) from the back of grille surround (Figure 1, Item 4). Save M8 Keps nuts for reuse.

7. Remove grille assembly (Figure 1, Item 2) from truck by pushing inward and rotating 90 degrees to remove it through hood opening.
 8. Remove two M8 palnuts (Figure 1, Item 1) from stud by rotating them counterclockwise. Save M8 palnuts for reuse.

9. Remove and discard grille surround (Figure 1, Item 4).
 10. With hood in open position, position new grille surround (Figure 1, Item 4) into place on hood and install two M8 palnuts (Figure 1, Item 1).

11. Install grille assembly (Figure 1, Item 2) inserting it through hood front opening, rotate grille 90 degrees, and position into place.
 12. Install eight M8 Keps nuts. Tighten nuts to 5.3 – 6.6 lb-ft (7.2 – 9.0 N·m).

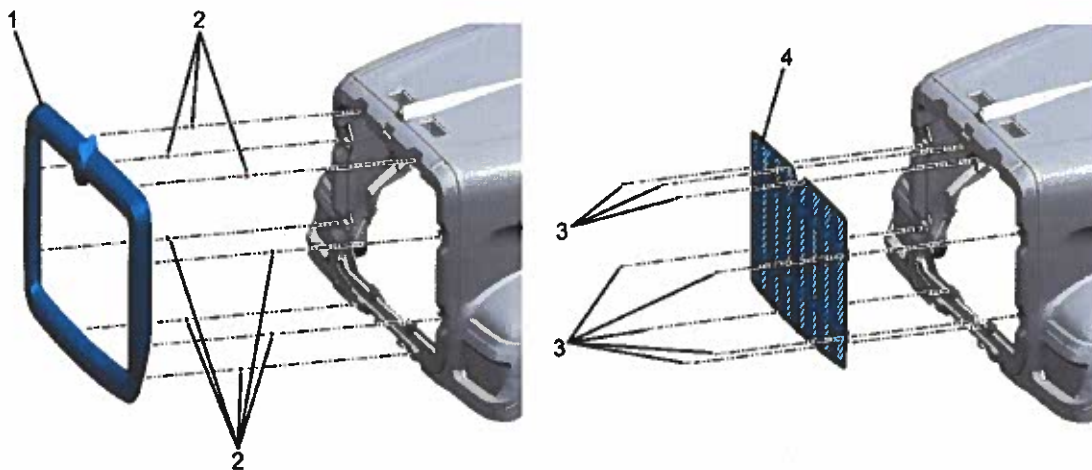
Figure 2. HX520 Model Grille Surround Removal

15. Before assigning a technician to this recall, check the grille surround to verify it requires the interim repair. Using hand force, pull the grille surround away from the hood to see if one or more brackets have de-bonded from the grille surround.
 - a. If one or more areas of the grille surround moves, assign a technician and have them proceed to Step 16.
 - b. If the grille surround does not move, then no repair is required at this time. Proceed to Step 28.

16. With hood closed, remove eight M8 Torx® bolts (Figure 2, Item 3) from center of grille assembly (Figure 2, Item 4). Save Torx® bolts for reuse.

17. Remove grille assembly (Figure 2, Item 4) and safely set aside.
18. Remove eight M8 prevailing torque nuts (Figure 2, Item 2) from back of grille surround (Figure 2, Item 1). Save nuts for reuse.
19. Remove grille surround (Figure 2, Item 1) from hood and place face down on a clean, protected workbench.

20. Determine condition of support bracket mounting.
21. For each support bracket that is loose on one pad but not fully detached, perform the following:

- a. Press the loose pad back down to the original location on the back side of the grille surround.
 - b. Using heavy double-sided tape or a clamp, hold support bracket in place on grille surround for drilling and riveting.

22. For each support bracket that is fully detached from the grille surround, perform the following:
 - a. Using pneumatic grinder with rotary sanding wheel, clean rust and / or corrosion from both the grille surround and the mounting surface of the support brackets.

- b. Apply a 2-inch strip of heavy double-sided tape to each pad of the mounting brackets.
 - c. Install the detached mounting brackets into their correct location on the hood.

- i. For HX520 Series trucks, install eight M8 prevailing torque nuts to hold the mounting brackets in place. Install M8 prevailing torque nuts to hold each separated mounting bracket to keep it in place.

- d. Once all brackets are installed and secured, install grille surround onto the hood.
 - e. Apply hand pressure at each location of grille surround. Use the palm of one hand on the grille surround and the fingers of your other hand on the back side of bracket.

- f. Once pressure has been applied to each location, remove nuts installed in Step 22. c. i, and remove grille surround.
- 23. Drill 28 #11 diameter holes from back side.
 - a. Refer to Figure 2 for HX520 Series trucks.
- 24. Once all holes have been drilled, turn grille surround over, deburr each hole taking care not to increase the diameter, and install rivets from front side in all 28 locations.
- 25. Once all rivets have been installed, inspect each rivet for correct installation.
- 26. With hood in closed position, install grille surround (Figure 2, Item 1) and position on hood and install eight prevailing torque nuts (Figure 2, Item 2).
- 27. Position grille assembly (Figure 2, Item 4) into place and install eight M8 Torx[®] bolts (Figure 2, Item 3).
- 28. Remove wheel chocks.
