SUBJECT: SAFETY RECALL

Intellipark Tractor Park Valve Module (PVM) on certain 2023 International® HV™, HX®, LoneStar®, LT®, and RH™ Series trucks built 05/18/2022 thru 08/08/2023 with feature code 04GBN – (Parking Brake Bendix Intellipark) for Tractor or Truck with Trailer Applications

VEHICLE RECALL 23508

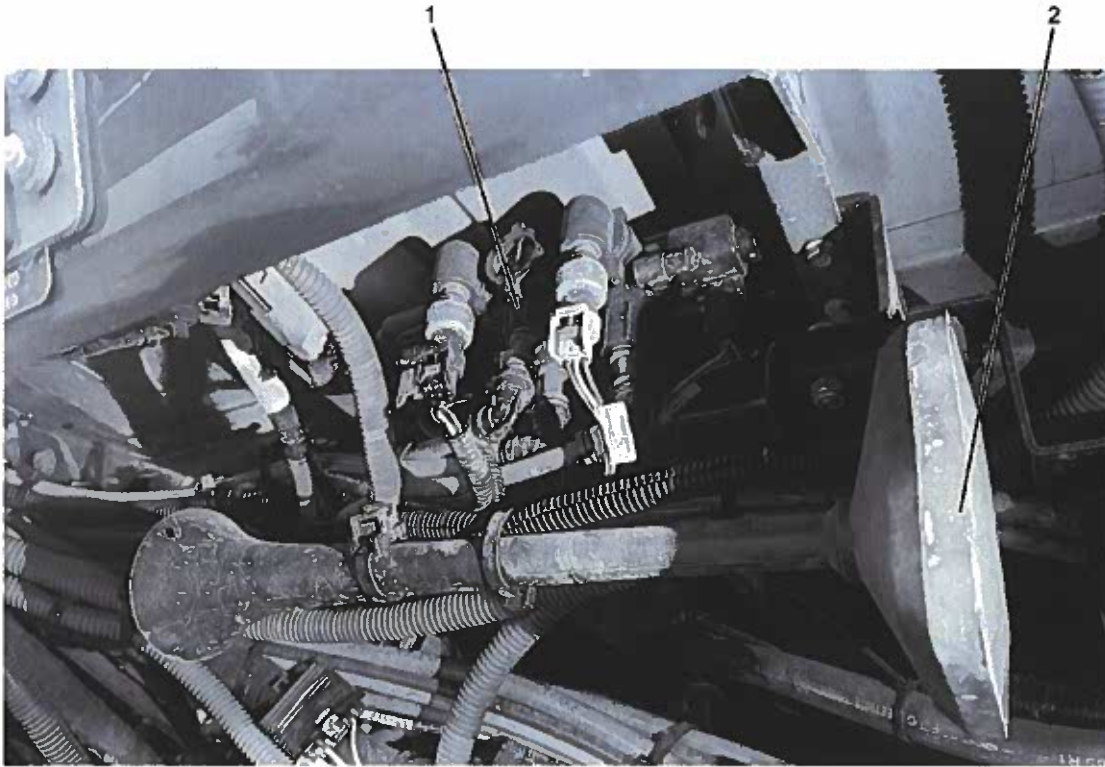
Figure 1. LT Park Valve Module Location

NOTE: The LT and HX Series park valve module is located on the cab floor under the driver-side door. The HV Series park valve module is located under the center of the cab.

7. If necessary, reposition air horn (Figure 1, Item 2).
8. Access park valve module (Figure 1, Item 1).
