Mercedes-Benz

Campaign No. 2023040011, April 2023

Inspect Mounting of Rear Door Trim Bar

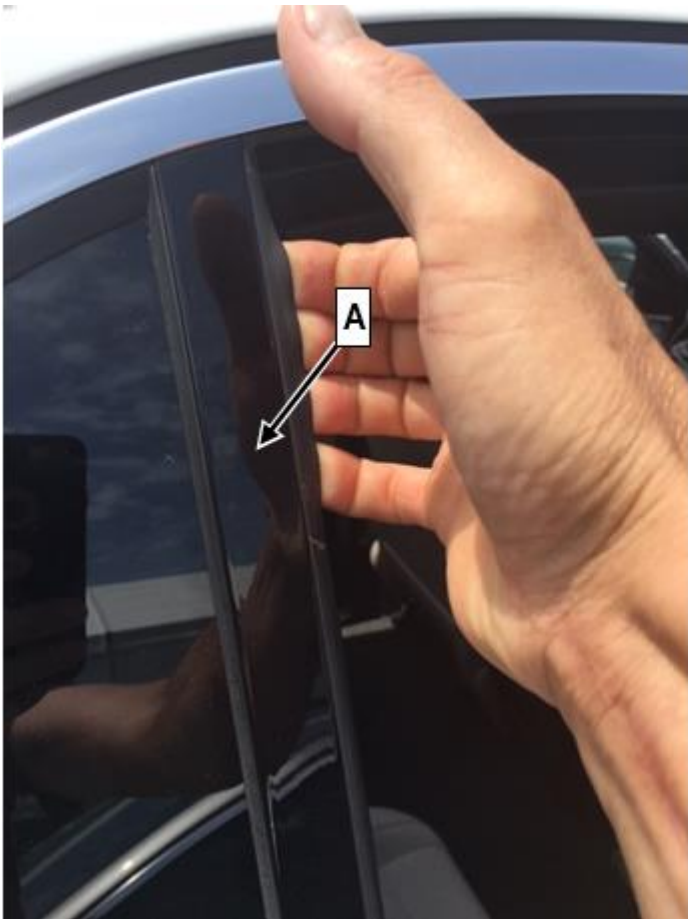
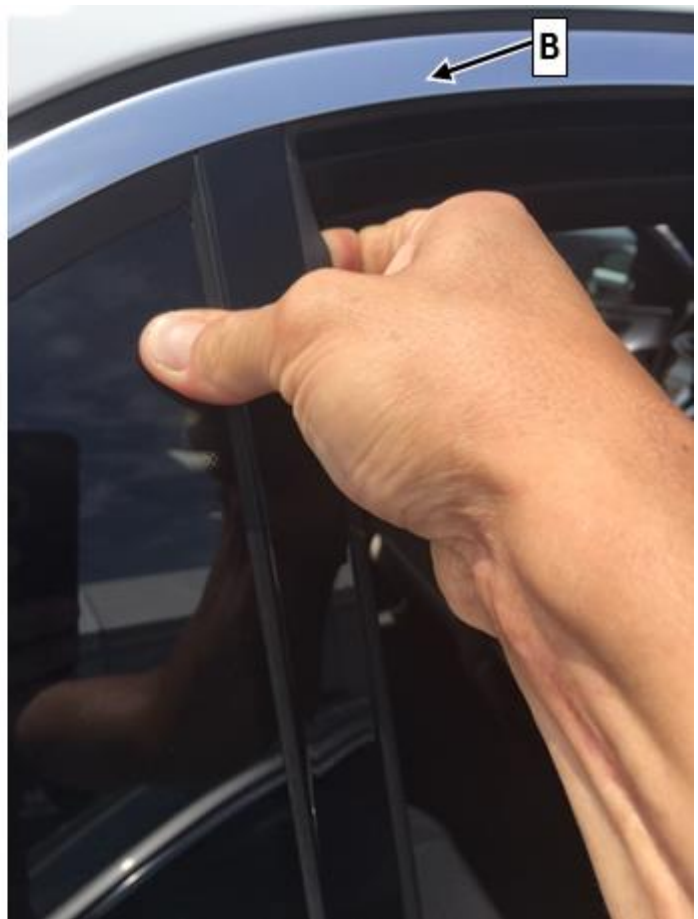
1. Lower side window on the right and left rear doors.
2. Check whether right and left window dividers (A, Figure 1) are seated tightly.
 - i** To do so, grasp the window divider in the upper area with your hand (Figure 1) and support it with your thumb on the fixed window (see Figure 2). Then pull the window divider outward carefully (**approx. 100 N / 22.5lbs of force**) to check whether it is seated tightly.
 - i** The window divider must **not** work loose.Ensure that the window divider is **not** jammed under the trim bar on the window frame (B, Figure 2). This could cause a test error with regard to the holding ability of the trim element on the window divider. A gap of 1 mm from the window divider (A) to the window frame (B) is normal.

- a. Window divider (A) works loose: Carry out **inspect/test procedure B**.
- b. Window divider (A) does **not** work loose: **End measure**.

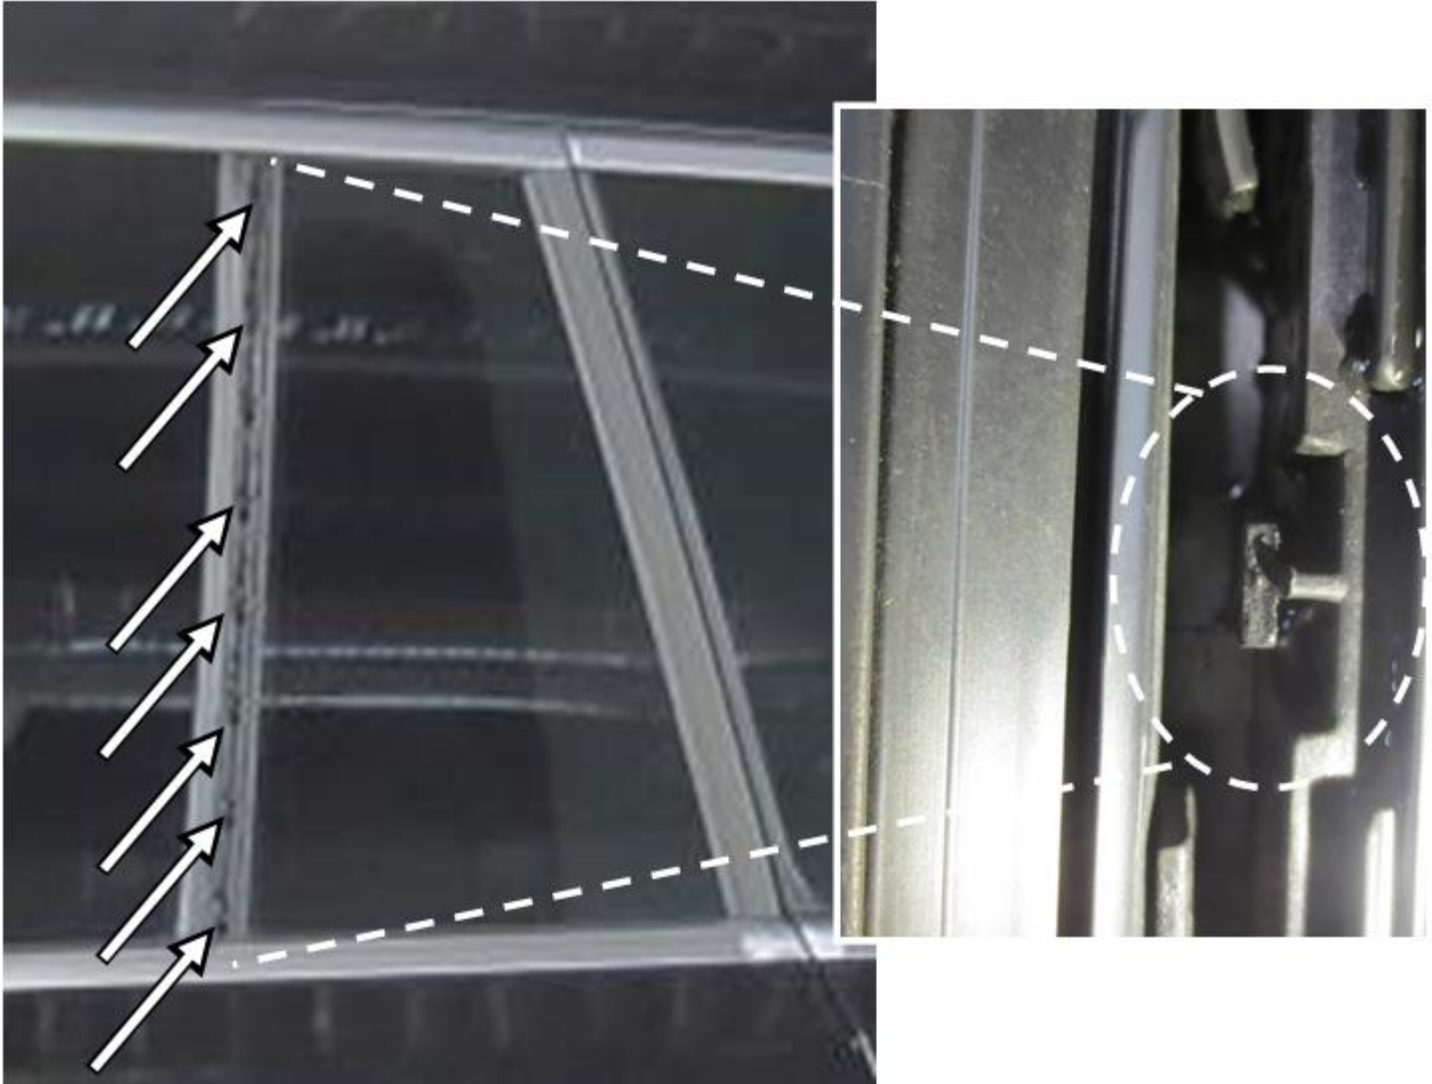
Figure 3

1. Remove window divider completely and check **holder for window divider** on frame of triangular window.

i If no damage is visible, reinstall window divider and check again whether it is tightly seated

a. Holder for window divider broken: Carry out **work procedure**.

b. Holder for window divider **not** broken: **End measure**.

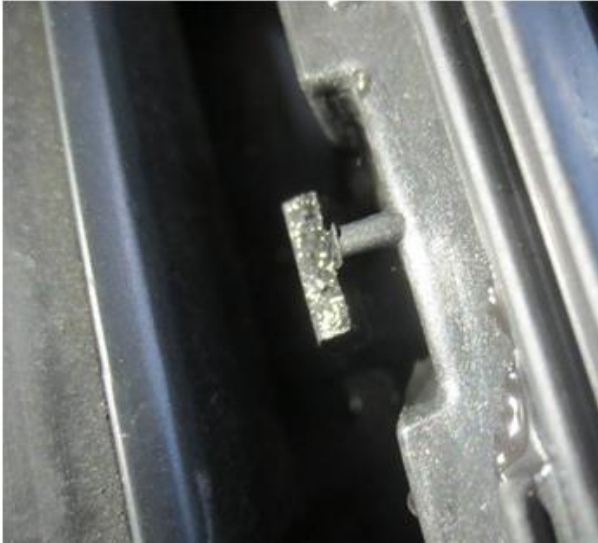
Figure 4

i One or multiple holders for the window divider on the frame of the triangular window are broken (Figure 4).

1. Replace corresponding triangular window of rear door with loose window divider.
