Safety Recall

Code: 69FB

Subject Passenger Occupant Detection System (PODS)

Subject: Safety Recall 69FB –Passenger Occupant Detection System (PODS)

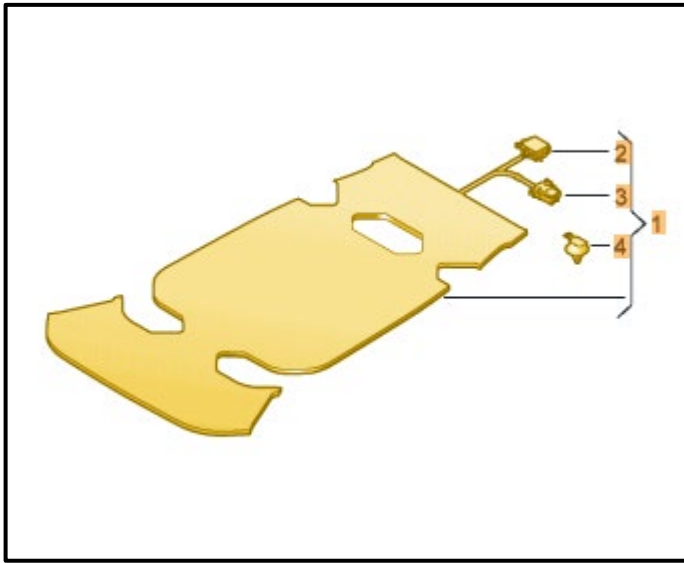
Repair Overview

A wire with a contact fault may cause the Passenger Occupant Detection System (PODS) to detect a malfunction and switch off the passenger airbag, even though the seat may be occupied. In a crash, there would be an increased risk of injury to the occupant seated in the front passenger seat if the passenger frontal airbag is switched off or not working.

- Replace passenger occupancy detection sensor mat and seat harness.

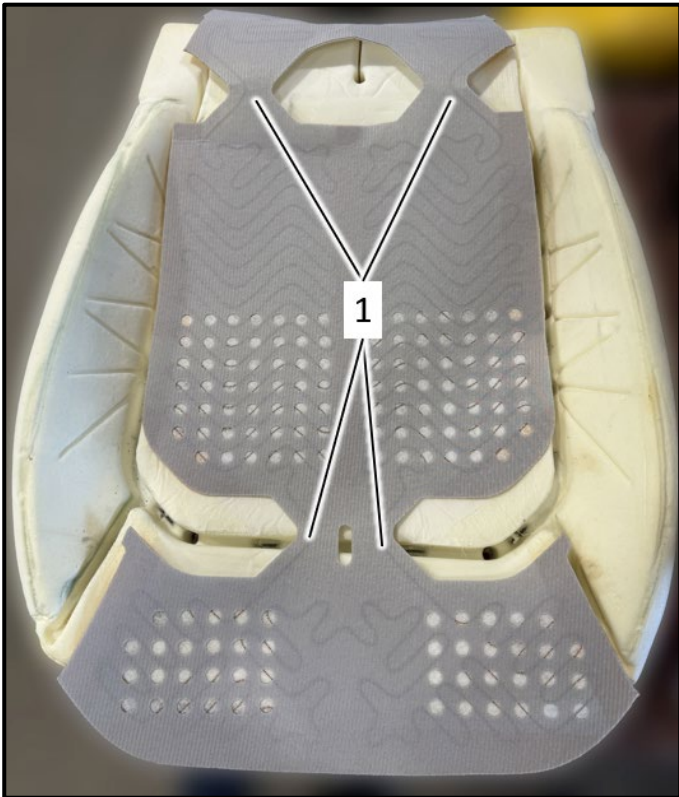
After removal of the occupancy detection mat, there will be adhesive residue left on the seat cushion in the highlighted areas <1>. DO NOT touch the remaining adhesive or allow it to become contaminated. If contaminated, the new sensor mat may not adhere properly.

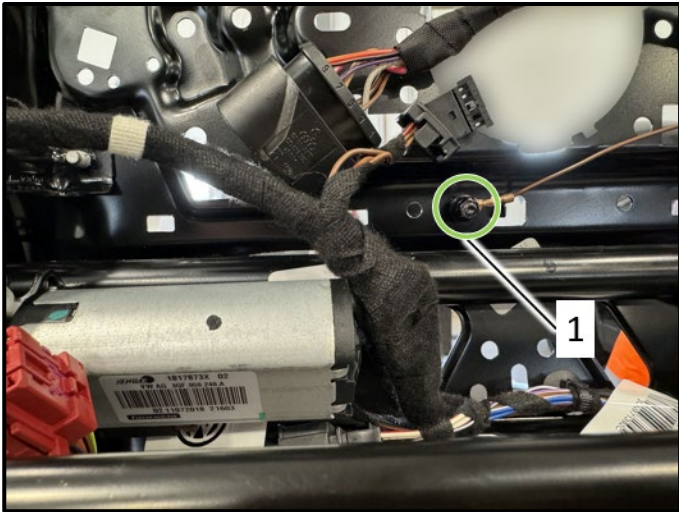
The seat back harness is not replaced during this repair, only the harness pictured <1>.

- With the seat cushion still removed, replace the seat harness <1>.
- Vehicles equipped with power adjustable passenger seats:
 - Remove the PODS module and bracket <2>, taking note of the harness routing.

- Torque the bolted ground connection <1> to 5 Nm.
