GROUP	MODEL
Safety Recall Campaign	2015-2019MY Soul EV (PS EV)
NUMBER	DATE
SC267 (Rev 2, 09/07/2023)	August 2023

SAFETY RECALL CAMPAIGN

HIGH-VOLTAGE BATTERY PACK AND BATTERY MANAGEMENT SYSTEM (SC267)

This bulletin provides information regarding High-Voltage Battery Pack and Battery Management System (BMS) for the subject vehicles below. An electrical short circuit between the anode and cathode of the battery cells can occur within the high-voltage battery pack assembly (BPA) case located underneath the vehicle. If an electrical short circuit occurs, a fire may result while driving, thereby increasing the risk of injury.

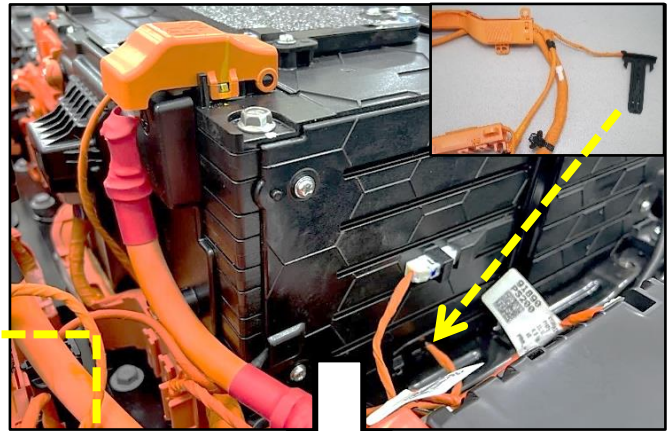
Note: Some vehicles may have a remaining temperature sensor connector hole. If so, disregard, no need to connect to it.

5. During re-assembly, insert the battery temperature sensor into the battery pack lower side area shown.

Connect the outside temperature sensor connector where shown.
