GROUP	MODEL
Safety Recall Campaign	2015-2019MY
	Soul EV (PS EV)
NUMBER	DATE

# SAFETY RECALL CAMPAIGN

# HIGH-VOLTAGE BATTERY PACK & BATTERY MANAGEMENT SYSTEM (SC267)

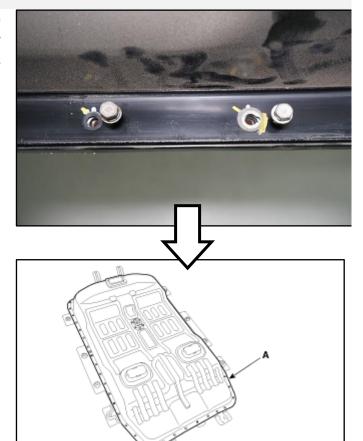
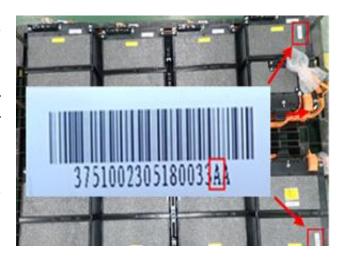
- 2. Verify the 2<sup>nd</sup> to last letter of the Battery Pack Assembly (BPA) shown:
  - A or B: Replace BMS ECU and VTSWH
     (Page 10) and upgrade the BMS ECU
     Software (Page 3).
  - W or X: No further action required. Reinstall all removed parts in the reverse order of removal and confirm normal vehicle operation.

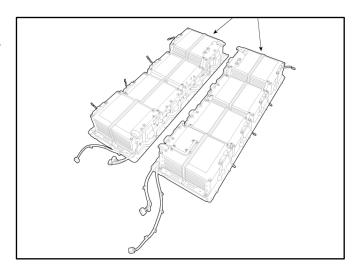
18-19MY ONLY new <u>BPA</u> is equipped with the "new" type harness. There is no need to swap.
