GROUP	MODEL
Safety Recall Campaign	2015-2019MY Soul EV (PS EV)
NUMBER	DATE
SC267 (Rev 1, 08/31/2023)	August 2023

HIGH-VOLTAGE BATTERY PACK AND BATTERY MANAGEMENT SYSTEM (SC267)

This bulletin provides information regarding High-Voltage Battery Pack and Battery Management System (BMS) for the subject vehicles below. An electrical short circuit between the anode and cathode of the battery cells can occur within the high-voltage battery pack assembly (BPA) case located underneath the vehicle. If an electrical short circuit occurs, a fire may result while driving, thereby increasing the risk of injury.

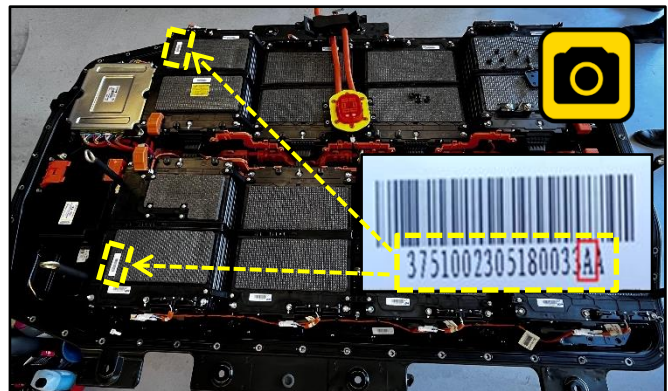
2. Verify the 2nd to last letter of the Battery Pack Assembly (BPA) shown and take a photo of the label using KVID and attach it to the claim:

- **A or B:** Replace BMS ECU and VTSWH (Page 10) and upgrade the BMS ECU Software (Page 3).
- **W or X:** No further action required. Reinstall all removed parts in the reverse order of removal and confirm normal vehicle operation.

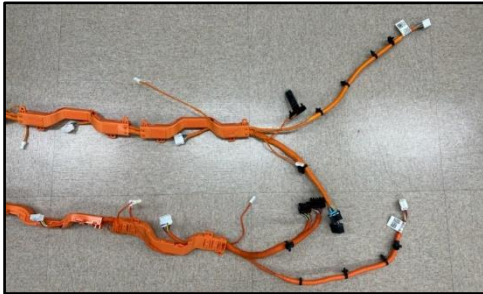
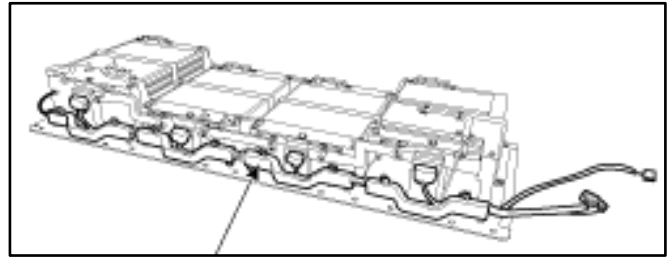
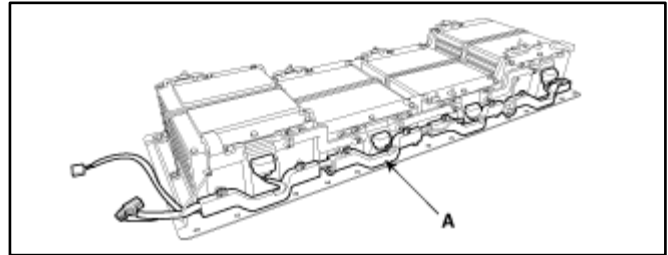
Note: The new harness is different for the removed harness when compared side by side.

- Replace the two voltage temperature sensor wire harnesses (VTSWH) with the new parts.
