GROUP	MODEL
Safety Recall Campaign	2015-2019MY Soul EV (PS EV)
NUMBER	DATE
SC267 (Rev 5, 03/04/2026)	August 2023

SAFETY RECALL CAMPAIGN

HIGH-VOLTAGE BATTERY PACK AND BATTERY MANAGEMENT SYSTEM (SC267)

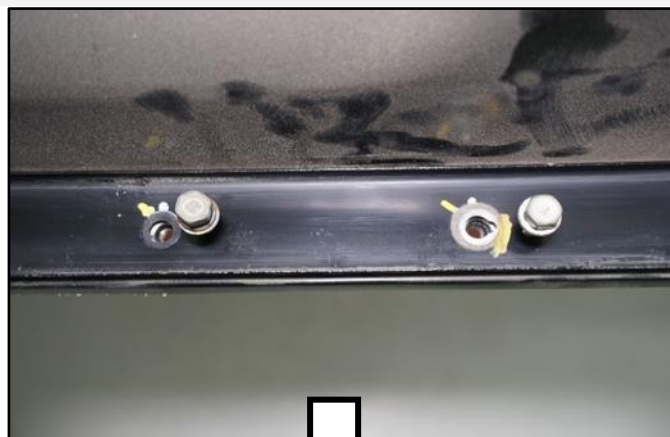
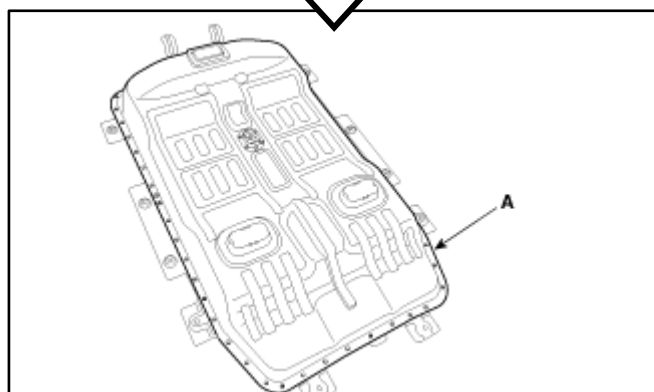
Mark the six (6) 'ground' bolts and their location to prevent mixing with regular bolt prior to reassembly.

1. Remove the BPA upper case (A) by referring to "EV Battery System → High Voltage Battery System → Case → Repair procedures (Removal)" in the applicable Shop Manual on KGIS. Refer to KGIS for bolt/nut torque specs.

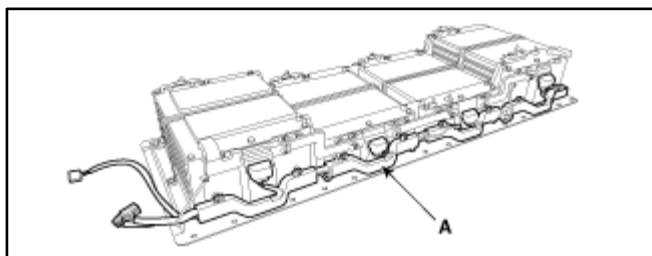
Note: The new harness is different for the removed harness when compared side by side.

- Replace the two voltage temperature sensor wire harnesses (VTSWH) with the new parts.

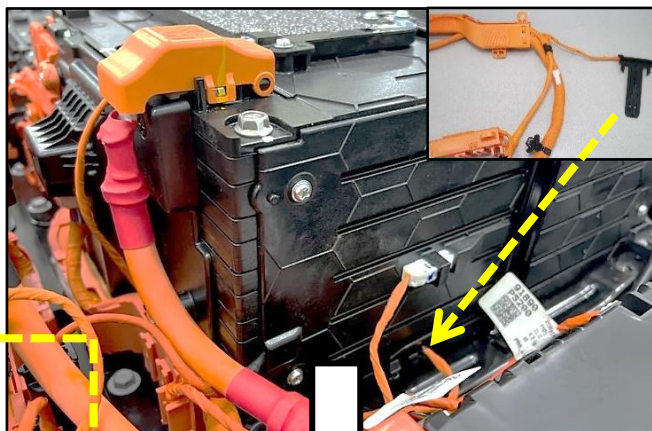
Note: Some vehicles may have a remaining temperature sensor connector hole. If so, disregard, no need to connect to it.

- During re-assembly, insert the battery temperature sensor into the battery pack lower side area shown.

Connect the outside temperature sensor connector where shown.
