GROUP	MODEL
Safety Recall Campaign	2015-2019MY Soul EV (PS EV)
NUMBER	DATE
SC267 (Rev 4, 05/07/2024)	August 2023

HIGH-VOLTAGE BATTERY PACK AND BATTERY MANAGEMENT SYSTEM (SC267)

This bulletin provides information regarding High-Voltage Battery Pack and Battery Management System (BMS) for the subject vehicles below. An electrical short circuit between the anode and cathode of the battery cells can occur within the high-voltage battery pack assembly (BPA) case located underneath the vehicle. If an electrical short circuit occurs, a fire may result while driving, thereby increasing the risk of injury.

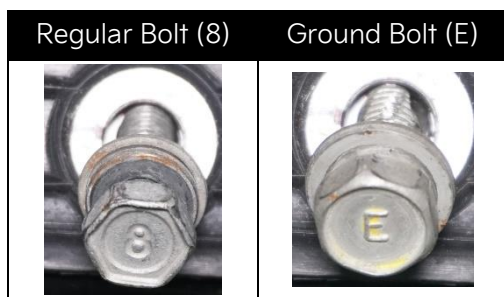
Ground Bolt (E): 6 ea.

Regular Bolt (8): 35 ea.

Mark the six (6) 'ground' bolts and their location to prevent mixing with regular bolt prior to reassembly.

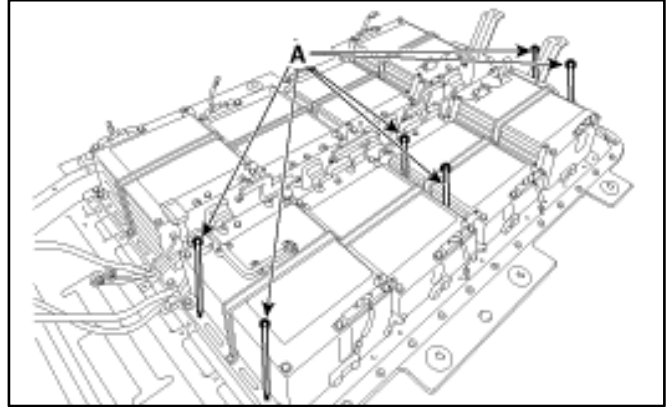
Note: SST OK375 E4300 and crane jack are required.

1. Carefully remove ONLY ONE (1) (left or right) side battery pack assemblies.

Refer to the “EV Battery System → High Voltage Battery System → Battery Pack Assembly → Repair procedures (Removal)” in the applicable Shop Manual on KGIS for detailed instructions.

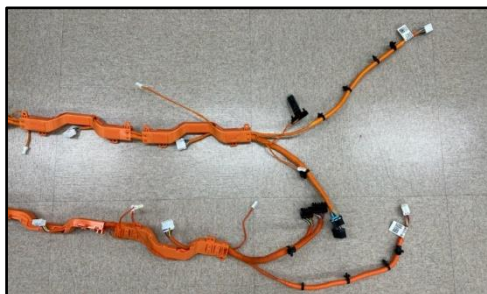
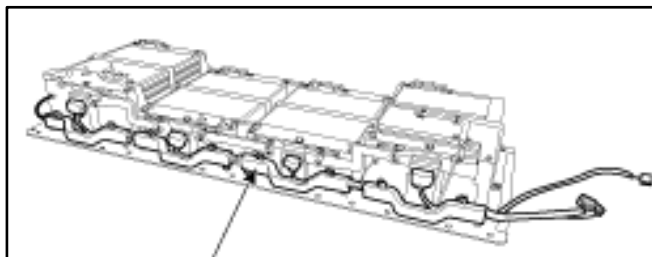
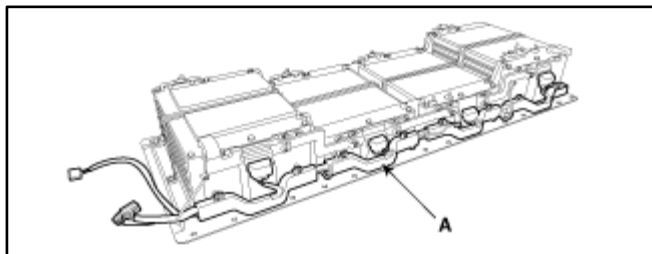
Note: The new harness is different for the removed harness when compared side by side.

- Replace the two voltage temperature sensor wire harnesses (VTSWH) with the new parts.

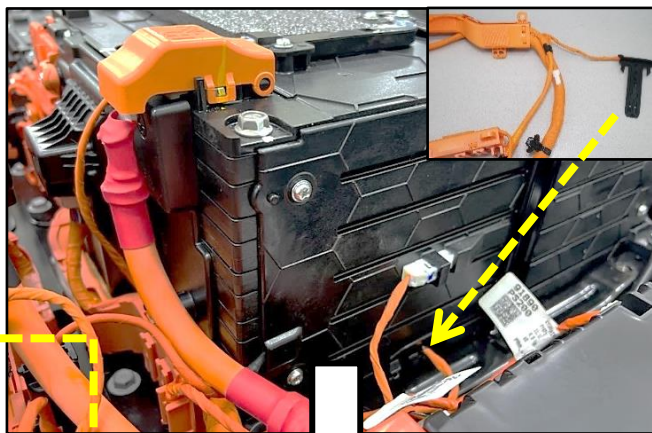
Note: Some vehicles may have a remaining temperature sensor connector hole. If so, disregard, no need to connect to it.

- During re-assembly, insert the battery temperature sensor into the battery pack lower side area shown.

Connect the outside temperature sensor connector where shown.

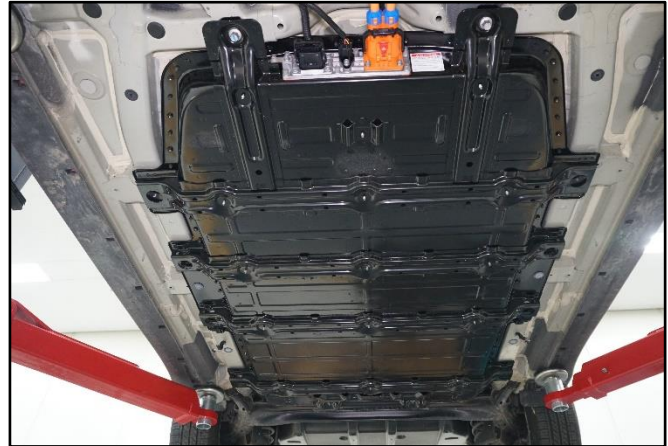
Note: SST OK375 E4300 BPA lifting jig and crane jack (A) are required.

1. Replace the HV BPA by referring to "EV Battery System → High Voltage Battery System → Battery Pack Assembly → Repair procedures (Removal)" in the applicable Shop Manual on KGIS.

Note: Dealer must obtain TL PWA.

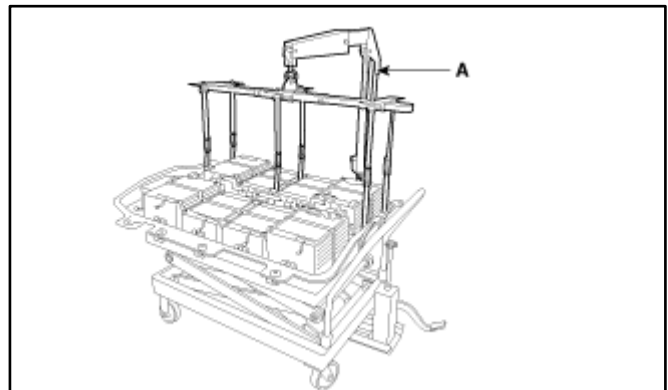
Note: The battery pack assembly (BPA) consists of two (2) (left and right) battery packs.

Place the removed BPA on a clean flat surface. Dealer should follow the process included in TSB ELE044 and obtain TL PWA.
