SAFETY RELATED RECALL

Global Recall Action
Number: N785

Subject: Engine Coolant Pipe and Elbow - Renew	Publication No.: N785
	Model: Range Rover Velar (LY)
	Model Year: 2021 - 2023
	Model: Range Rover Sport (LW)
	Model Year: 2018 - 2022
	Model: Range Rover (LG)
	Model Year: 2018 - 2022
	Model: Defender (LE)
	Model Year: 2021 - 2023
	Date of Issue: 09 May 2023

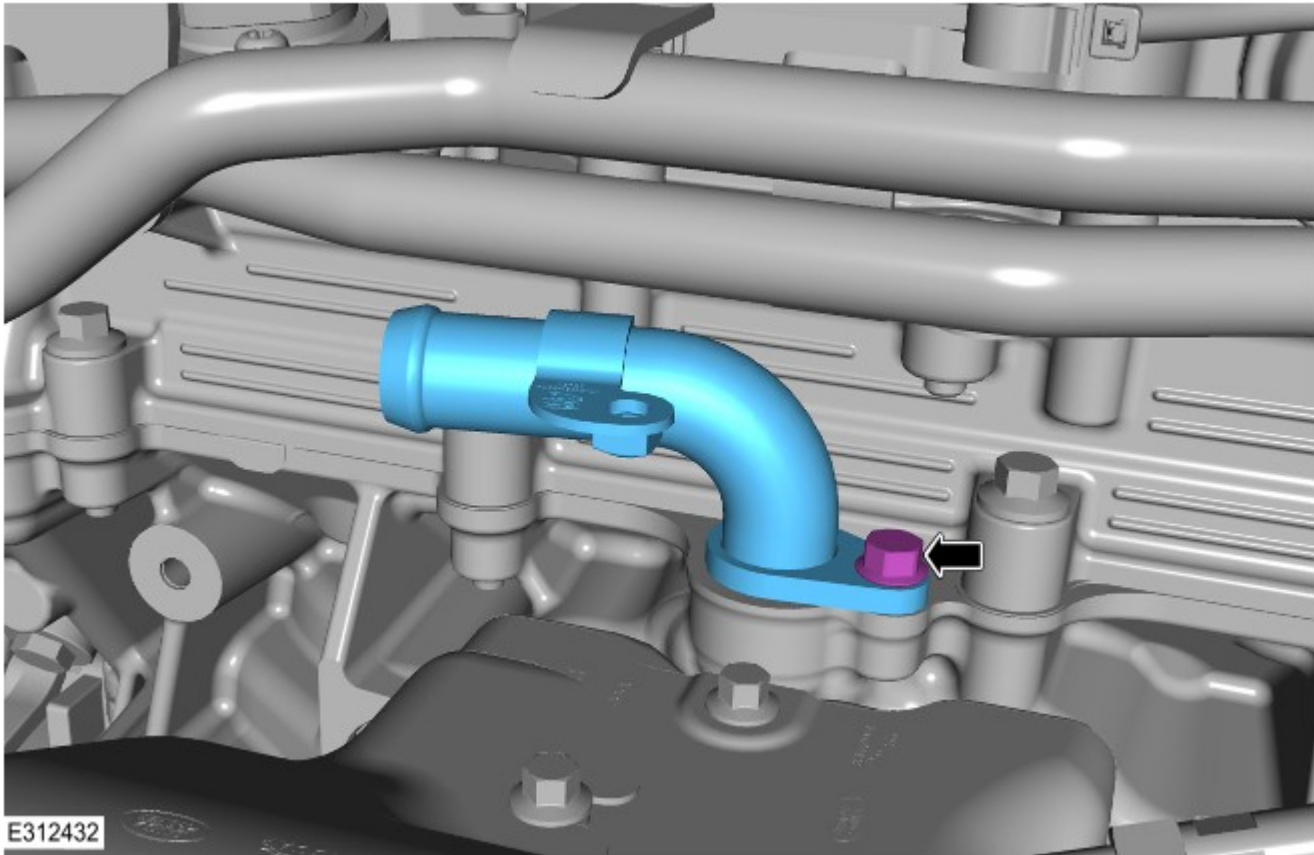
A concern has been identified on Ingenium I4 2.0L Petrol Plug-in Hybrid Electric Vehicle (PHEV) engines where the coolant pump drive belt can become damaged leading to detachment or destruction. Where coolant pump drive is lost, this leads to a loss of coolant flow in the engine. The lack of coolant flow can cause the engine to rapidly overheat, and subsequently ruptures an engine mounted plastic elbow in the cooling circuit.

If the coolant elbow is ruptured this leads to a coolant leak onto the turbocharger heatshield which may lead to a fire in the engine compartment which can propagate to the whole vehicle.

9. Remove and discard the engine coolant elbow.
