RECALL 23V227 / 2023-193 REMEDY INSTRUCTIONS

Make(s): DELLA TERRA & SILVER LAKE Model(s): MANY, SEE BELOW Model Year(s): 2023

CERTAIN – 2023 DELLA TERRA - DET240RLLE & DET255BHLE CERTAIN – 2023 SILVER LAKE - SKT24RLLE & SKT26BHLE

RECALL 23V227 / 2023-193 FOREST RIVER UNDERMOUNT DRAWBAR REMEDY

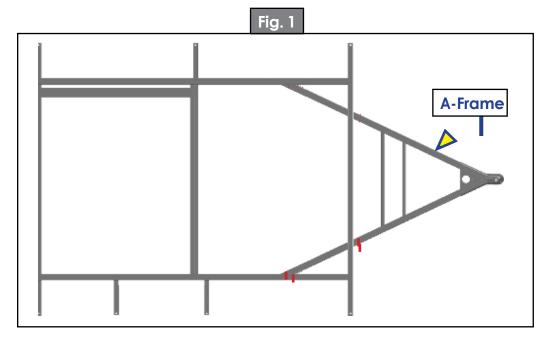
The Drawbar Assembly has an elevated risk of fracture and full failure while traveling. Should the Drawbar Assembly fracture or fail, the trailer has an elevated increase to cause a crash.

- 1. Properly support the frame according to manufacturer's guidelines.
- 2. Cut the A-frame from underneath the main frame rail and the front crossmember (Fig. 1).
