Tesla, Inc. Service Bulletin		<h2 style="margin: 0;">Inspect Front Lower Lateral Links</h2>	
SB-23-31-001 April 14, 2023			
Classification Recall Bulletin		Section/Group 31 - Suspension	Mobile Service Limited
Model Year 2018–2019	Model Model 3	Country/Region All	Version All
<small>The model(s) and model year(s) listed are a general approximation of the affected VIN list. Refer to the VIN/Bulletin Tracker or Customer/Vehicle profile to determine applicability of this bulletin for a particular vehicle.</small>

Condition

On certain Model 3 vehicles, the bolts that secure the front lower lateral links to the subframe may need to be re-torqued to internal specification.

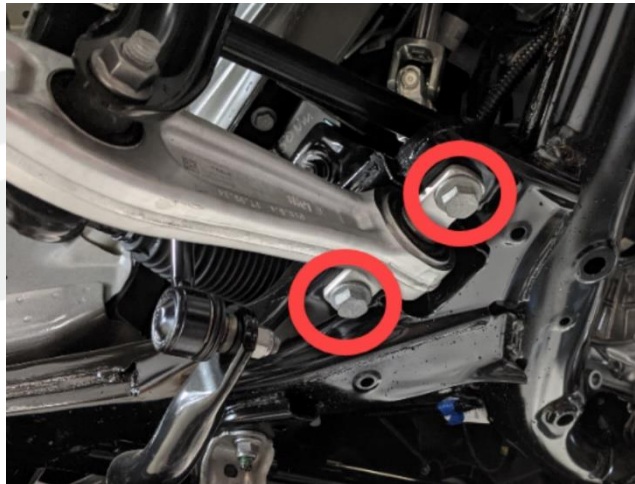
Figure 1 – LH shown; RH similar

1. Remove the front aero shield panel (refer to Service Manual procedure [12030102](#)).
2. Perform a torque check on the bolts that attach the LH and RH front lower lateral links (4 bolts total) to the front subframe (115 Nm) (Figure 1).

⚠ CAUTION: Check that the bolt heads are fully flush with the lateral link flanges and that there are no gaps between the bolt heads, flanges, and subframe. Gaps between these components are a sign of possible cross threading and should be investigated.

- If all 4 bolts are already torqued to specification and no signs of cross threading are observed, the subframe does not need replacement. Take note and skip to step 7.
 - If any of the 4 bolts are missing, damaged, not already torqued to specification, or if signs of cross threading are observed, continue to step 3.
3. Inspect the front lateral link and front subframe to lateral link attachment point (Figure 2), noting damage such as cracks, bent arms/flanges, or damaged bolts.

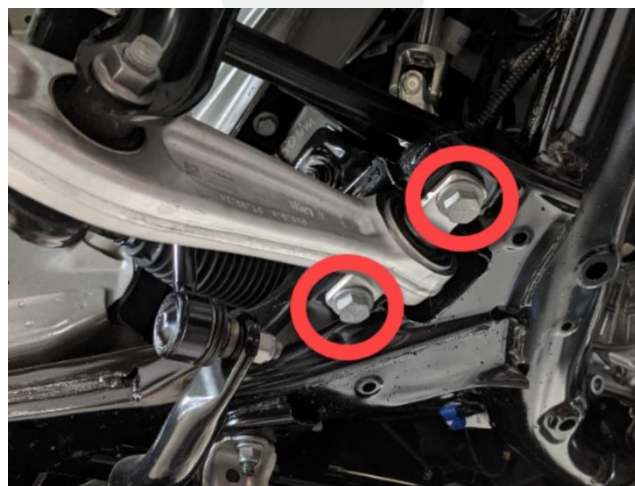
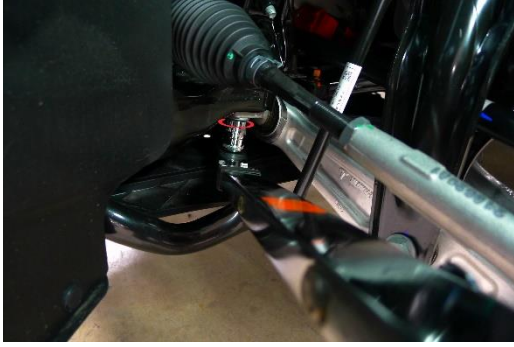
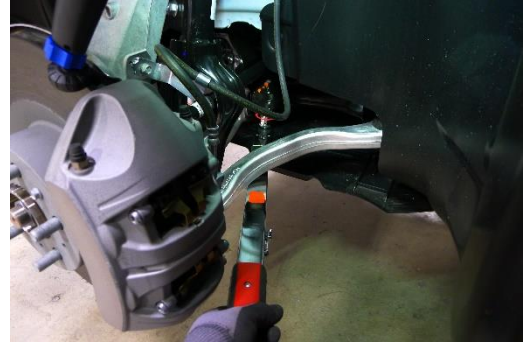
8. Perform a torque check on the bolts that attach the LH and RH front lower lateral links (4 bolts total) to the front subframe (115 Nm) (Figures 5-7).

⚠ CAUTION: Check that the bolt heads are fully flush with the lateral link flanges and that there are no gaps between the bolt heads, flanges, and subframe. Gaps between these components are a sign of possible cross threading and should be investigated.

- If all 4 bolts are already torqued to specification and no signs of cross threading are observed, the subframe does not need replacement. Install all parts that were removed for access and close this bulletin using Correction Code S132331001.
- If any of the 4 bolts are missing, damaged, not already torqued to specification, or if signs of cross threading are observed, install all parts that were removed for access, and tow the vehicle to a Service Center for further inspection. Use Correction Code 31000010 to track work performed, but DO NOT close the bulletin.
