Safety Recall

N222386050 Left Side B-Pillar Wire Harness Fire

Release Date: April 2023

Revision: 01

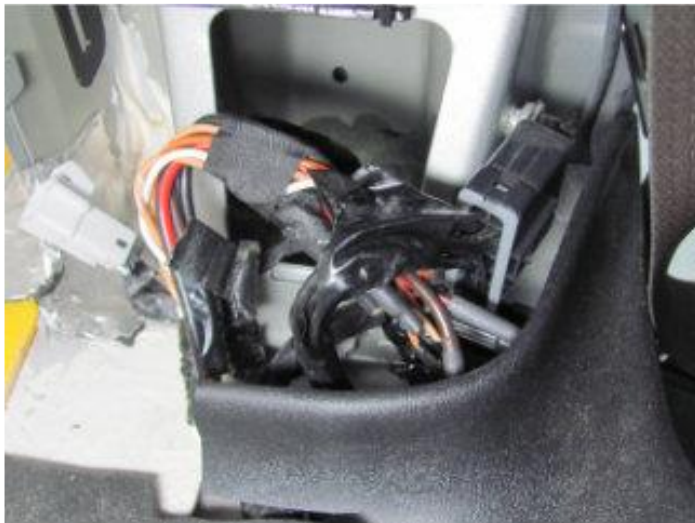
6318094

4. Locate the wire bundle positioned below the driver side seat belt retractor.

3. Remove the left lower pillar garnish molding. Refer to *Lower Pillar Garnish Molding Replacement* in SI.

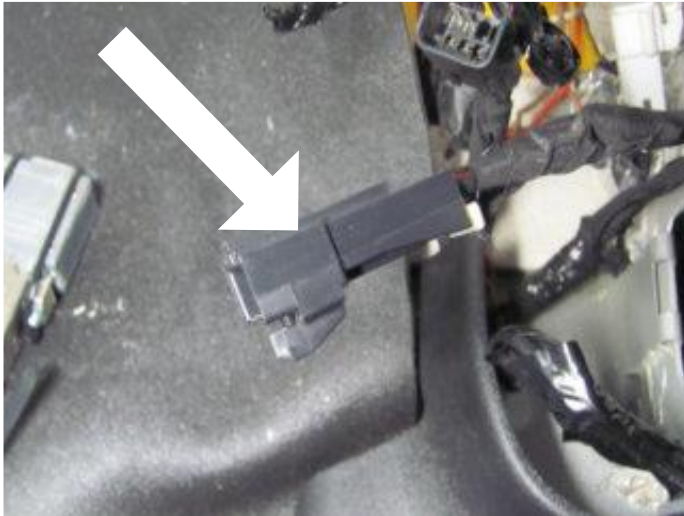
6318095

5. Identify the Rear HVAC Blower two wire circuit, RED/WHITE Tracer and BLACK.

CAUTION: The below steps are for rear HVAC blower circuits that are not being used (terminated leads). If the circuit is in use, proceed to the REAR HVAC BLOWER CIRCUIT CONNECTOR REMOVAL section.
