Safety Recall

N222386050 Left Side B-Pillar Wire Harness Fire

Release Date: April 2023

Revision: 00

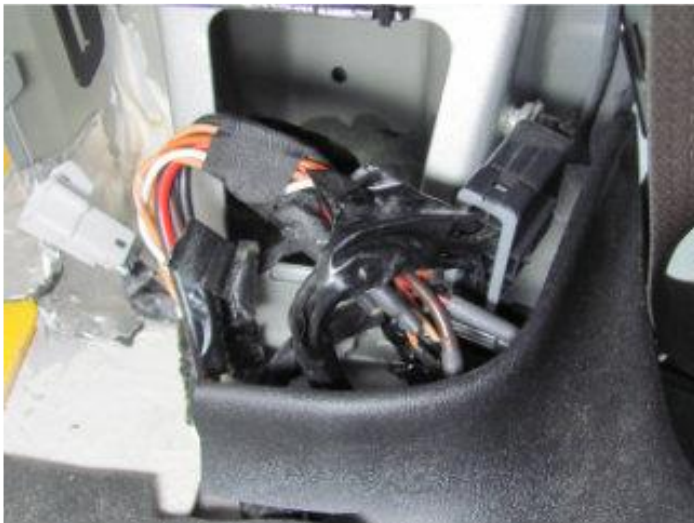
6318094

4. Locate the wire bundle positioned below the driver side seat belt retractor.
