# SAFETY RELATED RECALL

Global Recall Action  
Number: N783

<b>Subject:</b>  <b>Second Row Left Seat Frame Weld</b>	Publication No.: N783
	Model: Range Rover (LK)
	Model Year: 2022 - 2023
	Date of Issue: 05 June 2023

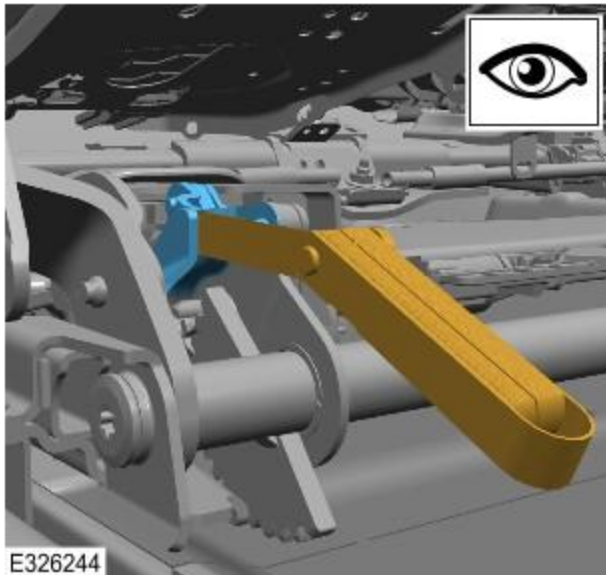
1. The image shows a 0.5 mm feeler gauge being used to check the gap between second row left seat frame latch brackets.

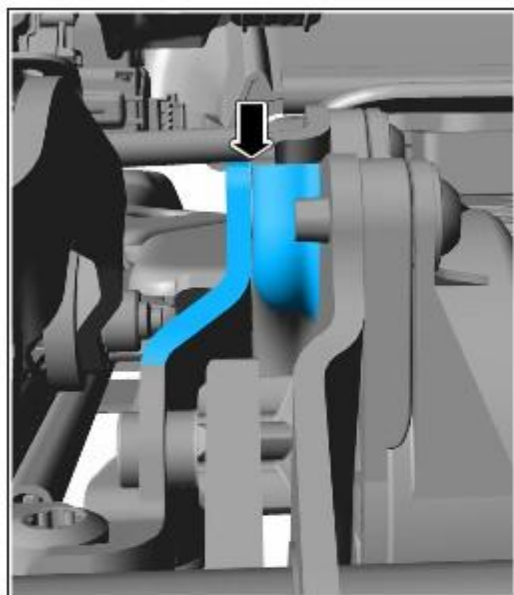
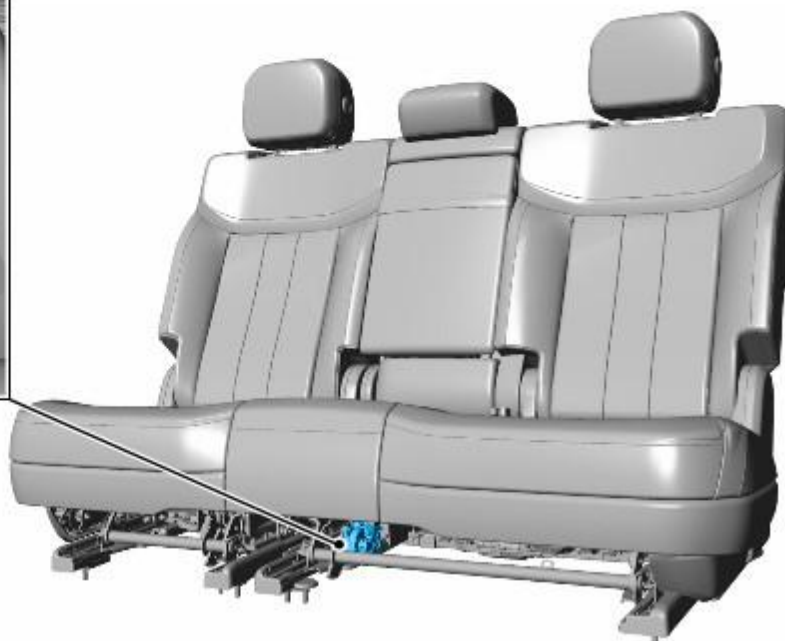
E325073

1. Use a 0.5 mm feeler gauge to inspect the gap between the second row left seat frame latch brackets, shown highlighted in the illustration.

- If the 0.5 mm feeler gauge **does** fit between the brackets, the second row left seat frame has failed the inspection. Continue to the Service Instruction.
- If the 0.5 mm feeler gauge **does not** fit between the brackets, the second row left seat frame has passed the inspection and is not affected. Release the vehicle.

- Only install a new second row seat frame if the original second row seat frame has failed the previous inspection.
- The second row left seat frame is known as the second row left seat base in TOPIx.

1. Renew the second row left seat frame (see TOPIx Workshop Manual section 501-10B: Seating - Second Row Seats - Removal and Installation - Left Seat Base - Vehicles With: 7 Seats).
