SIB 52 09 23

2023-04-14

RECALL 23V-253: 2nd ROW HEAD RESTRAINTS

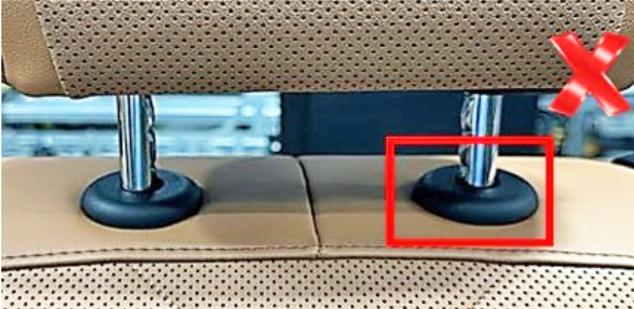
<p>Headrest guide sleeve not OK (without lock).</p>

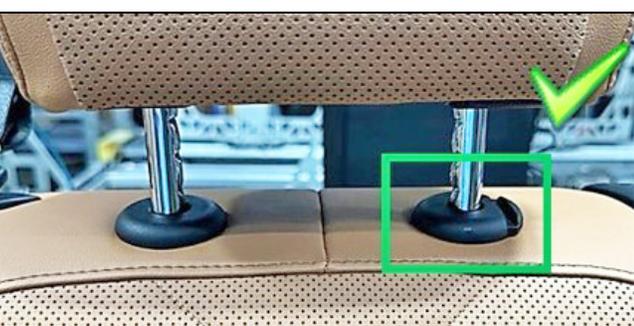
<p>Headrest guide sleeve OK (with lock seen on the right side of the right post).</p>

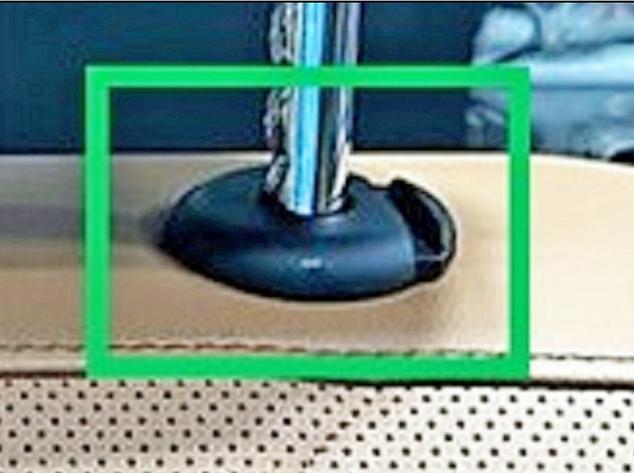
<p>Close up view, headrest guide sleeve OK (with lock).</p>
