RECALL 23V254 REMEDY INSTRUCTIONS

Make(s): STARCRAFT BUS
Model(s): PRODIGY
Model Year(s): 2019 - 2021

Concern:
A non-compliance to "FMVSS 221 Joint Strength" was found on two interior panel pieces removed from the ceiling of the bus.

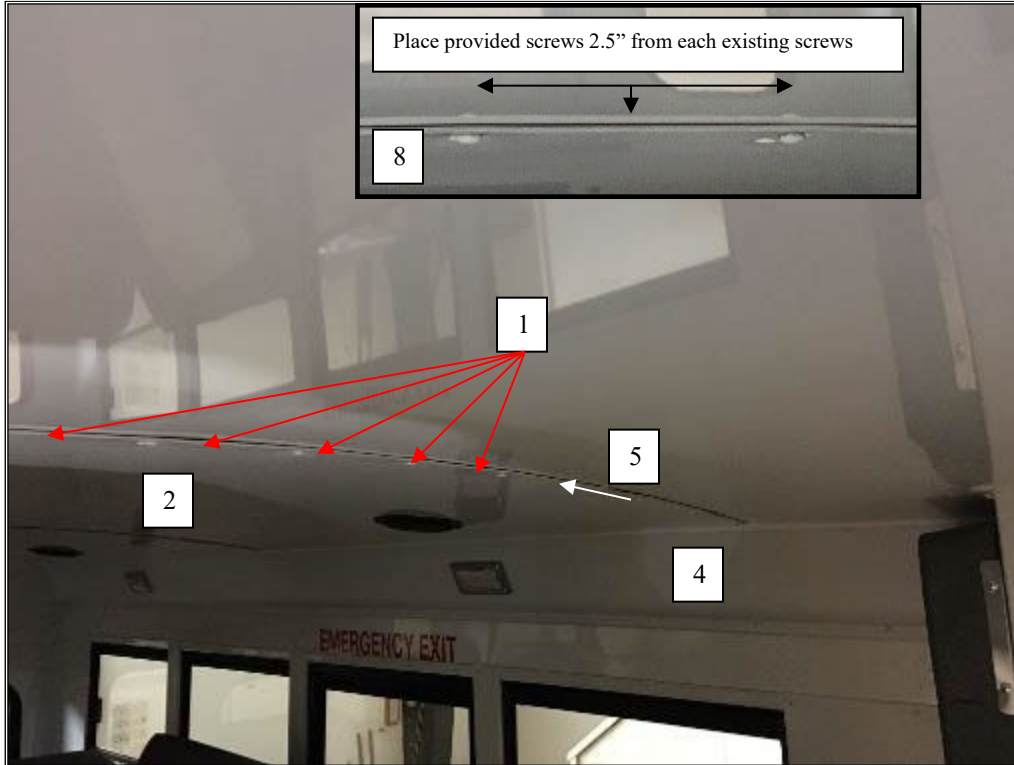
INSPECTION/REMEDY:

Concern:
A non-compliance to "FMVSS 221 Joint Strength" was found on two interior panel pieces removed from the ceiling of the bus.
