SAFETY RECALL

Volvo Trucks North America

**Volvo Active Drive Assist
VNR**

Updated Repair Instructions and Labor Codes

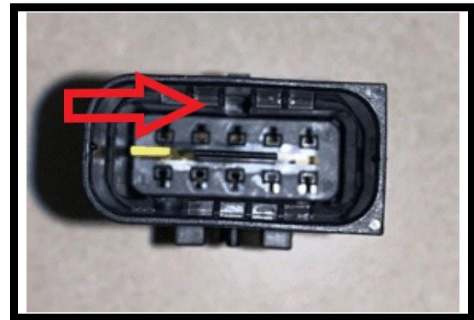
21. Install connector seals into connector cap and slide yellow locking tab to the locked position.

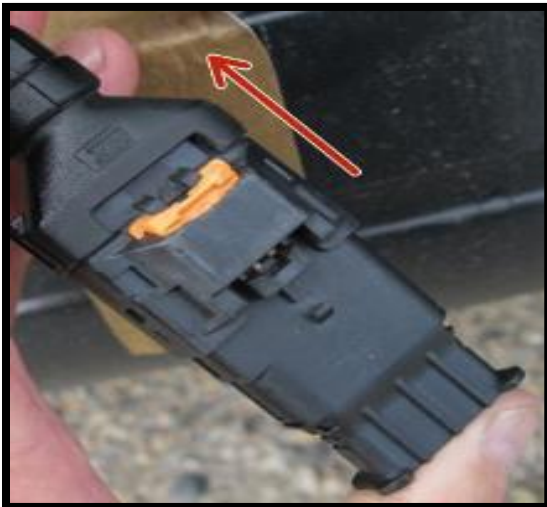
22. Install connector cap onto harness.

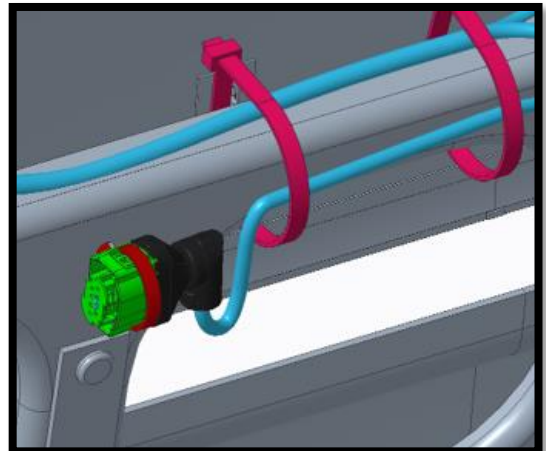
24. Tie back harness as pictured below.

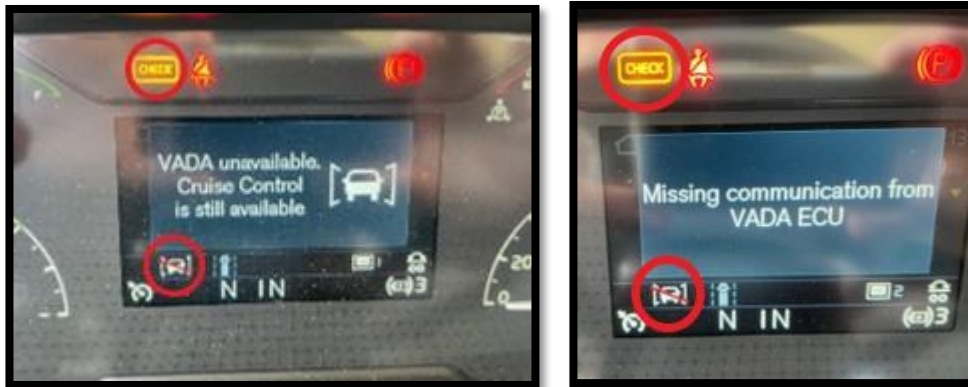
38. After programming, please ensure the following pop-ups and warning lights appear on dash.

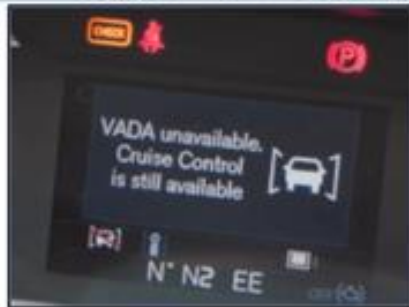
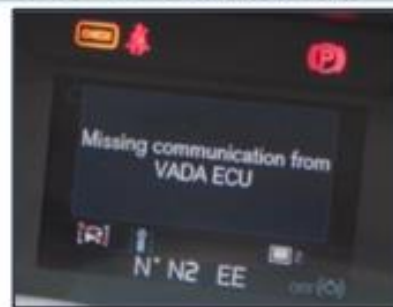
The below pop-up messages will appear when ignition is turned on. Press "ok" on toggle switch in steering wheel to acknowledge pop-ups
