# SAFETY RECALL

Volvo Trucks North America

Date	Number	Release	Page
05.2023	RVXX2303	05	1(4)

## Volvo Active Drive Assist VNR

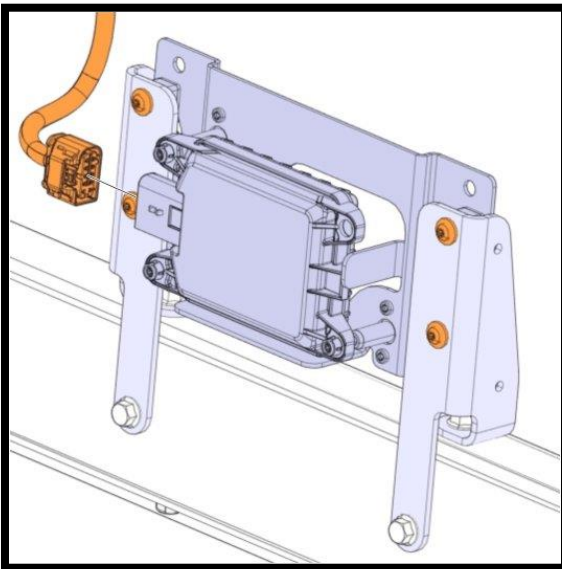
18. Disconnect the forward-facing radar.

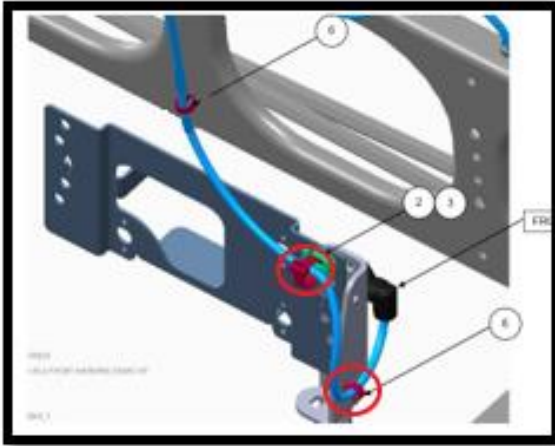
19. Remove the tie straps circled below.

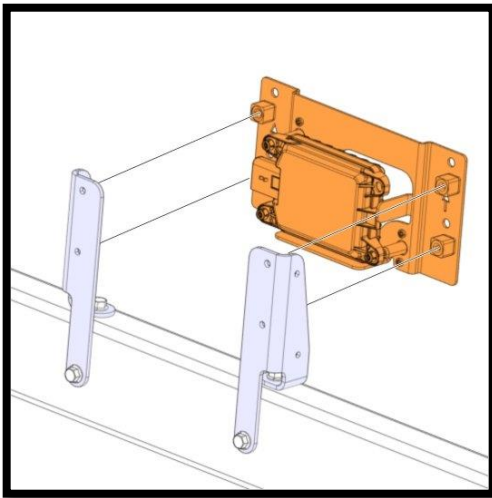
20. Remove forward-facing radar and bracket as an assembly.

**Important Note**  
If only the bracket is installed it will need to be removed in the same manner.

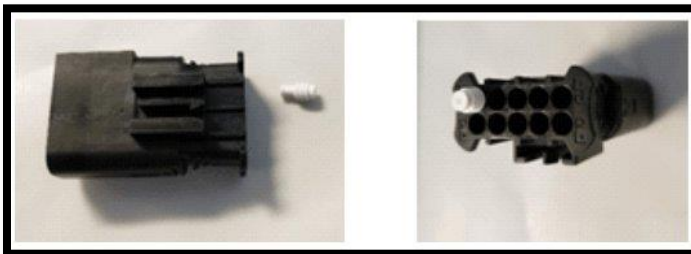
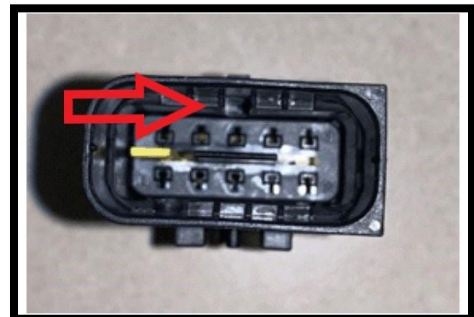
21. Install connector seals into connector cap and slide yellow locking tab to the locked position.

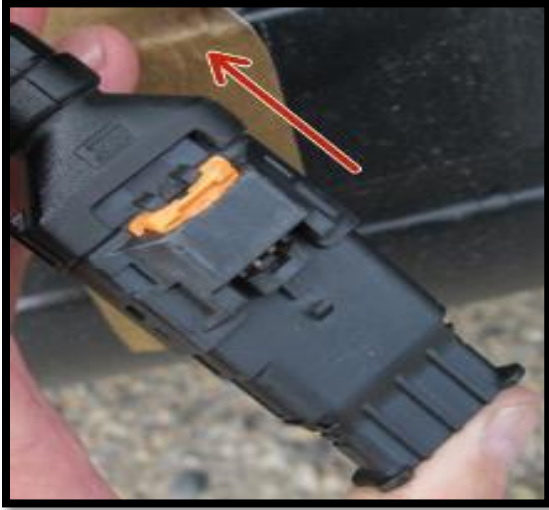
22. Install connector cap onto harness.

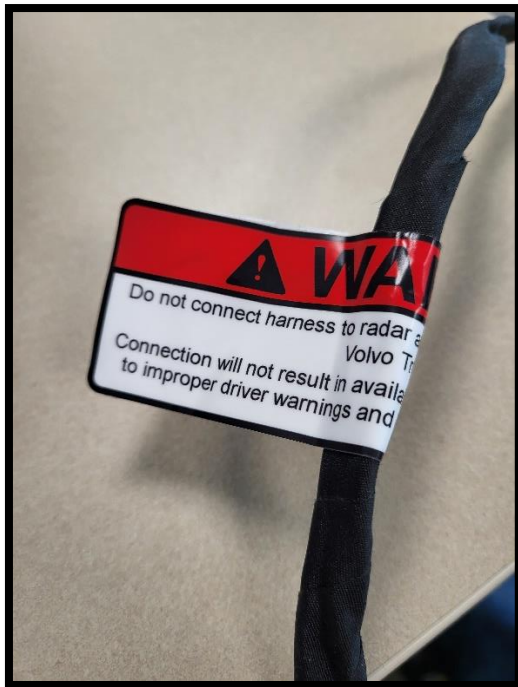
23. Wrap warning label (P/N-24585120) around radar harness within an inch of the radar connector.

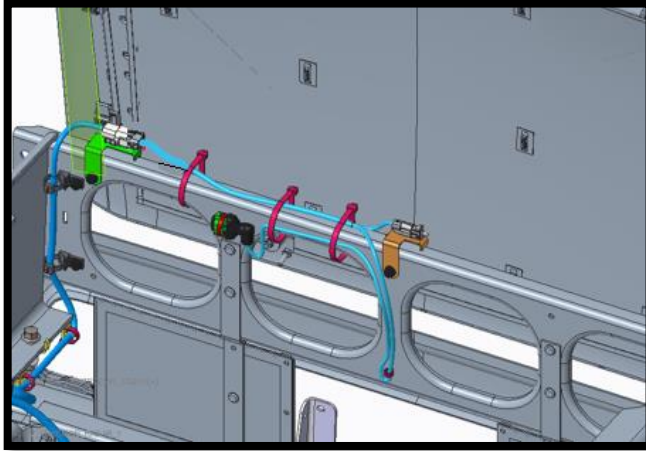
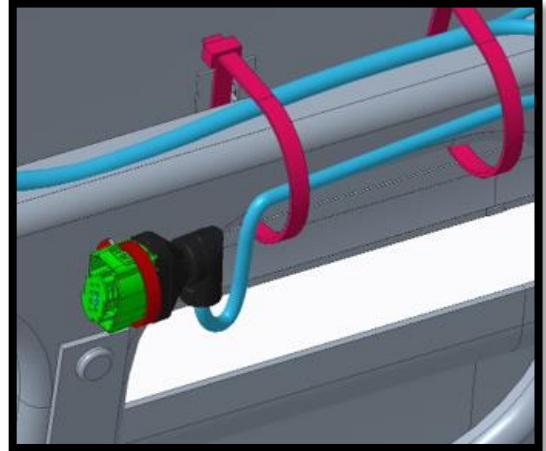
24. Tie back harness as pictured below.

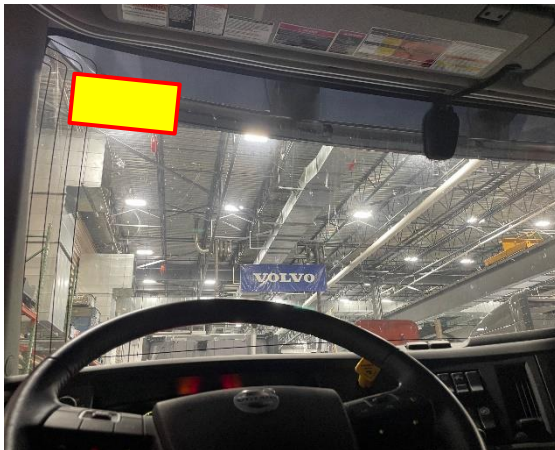
25. Place warning label (P/N-24585112) in top left-hand corner of windshield. If there is a label already there that pertains to VADA place new label over top of it.

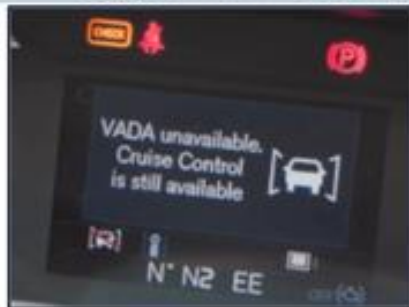
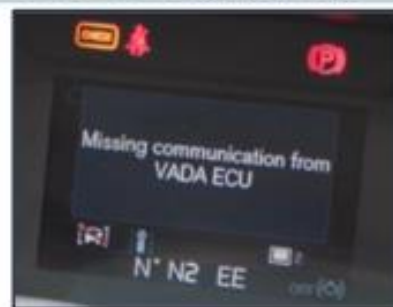
The below pop-up messages will appear when ignition is turned on. Press "ok" on toggle switch in steering wheel to acknowledge pop-ups

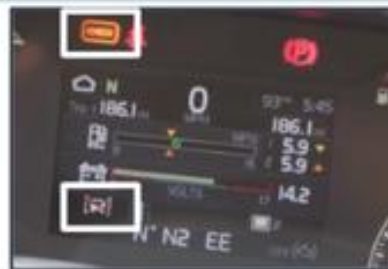
Yellow check light and Adaptive Cruise Control (ACC) icon with a red diagonal line will remain on
