SAFETY RECALL

Volvo Trucks North America

Date	Number	Release	Page
05.2023	RVXX2303	01	1(4)

**Volvo Active Drive Assist
VNR**

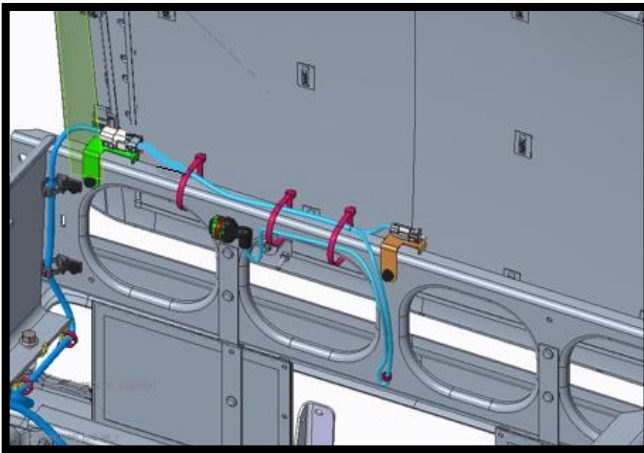
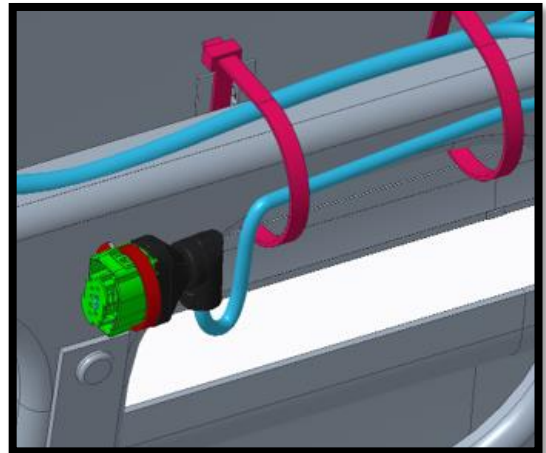
23. Tie back harness as pictured below.

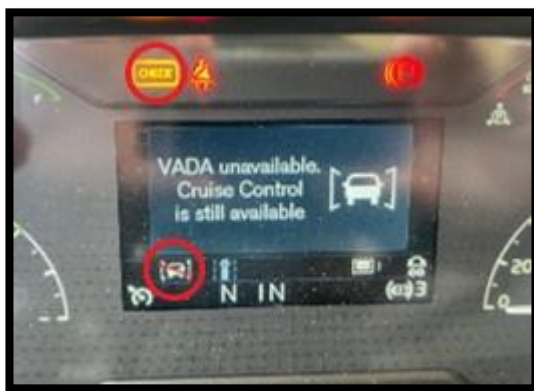
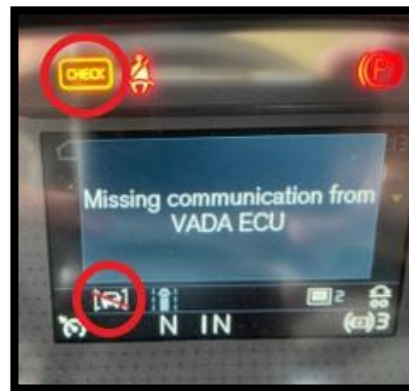
37. After programming, please ensure the following pop-ups and warning lights appear on dash.
