SAFETY RECALL

Date	Number	Release	Page
05.2023	RVXX2303	03	1(4)

**Volvo Active Drive Assist
VNR**

Updated Repair Instructions and Labor Codes

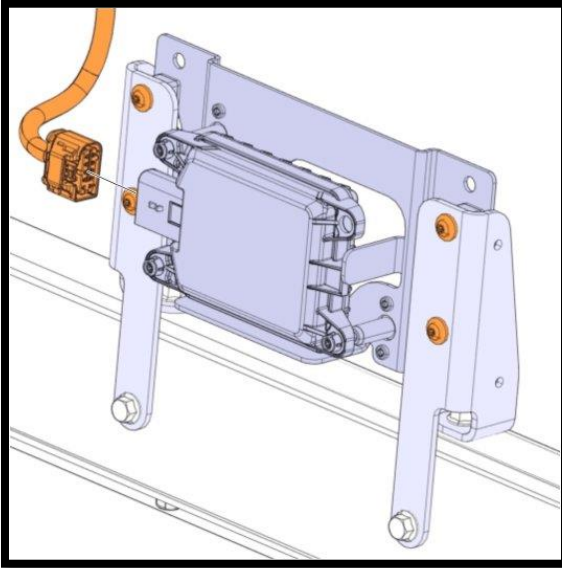
18. Disconnect the forward-facing radar.

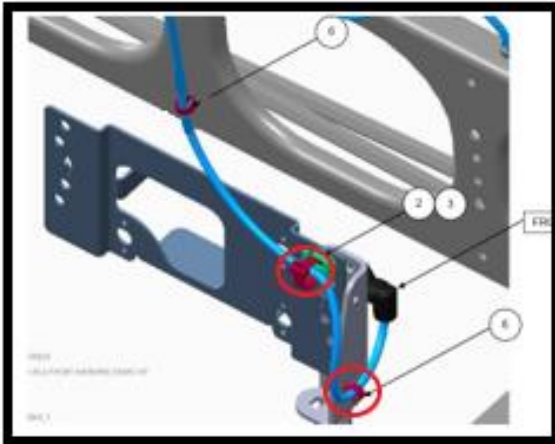
19. Remove the tie straps circled below.

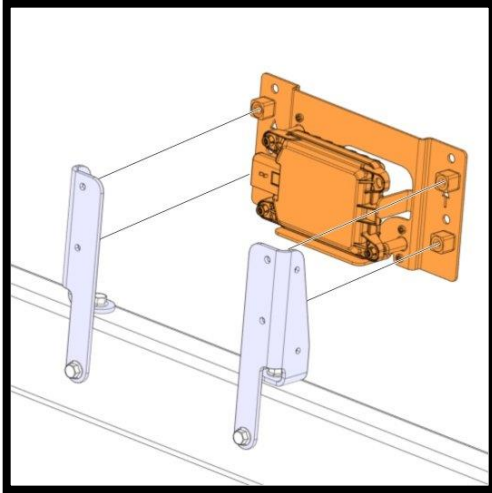
20. Remove forward-facing radar and bracket as an assembly.

Important Note
If only the bracket is installed it will need to be removed in the same manner.

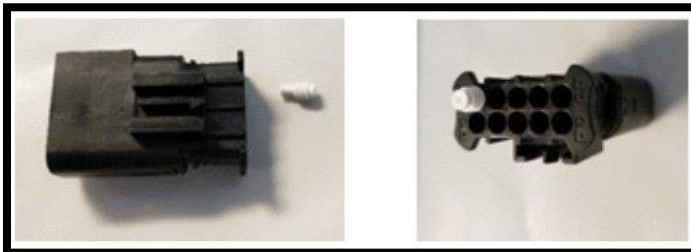
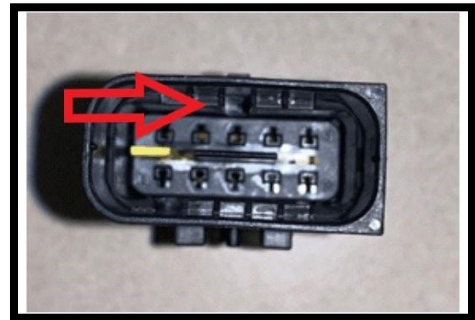
21. Install connector seals into connector cap and slide yellow locking tab to the locked position.

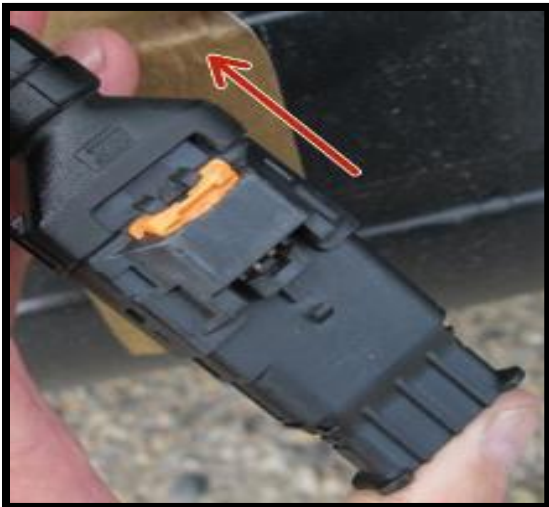
22. Install connector cap onto harness.

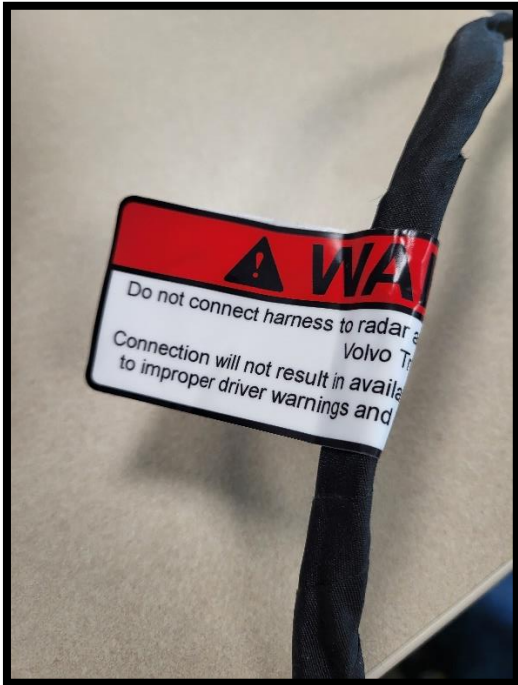
23. Wrap warning label (P/N-24585120) around radar harness within an inch of the radar connector.

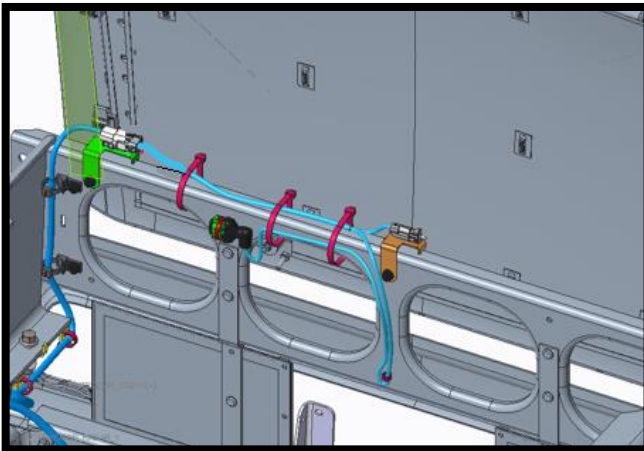
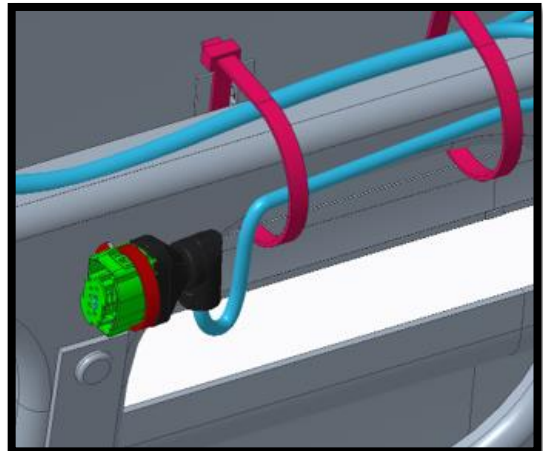
24. Tie back harness as pictured below.

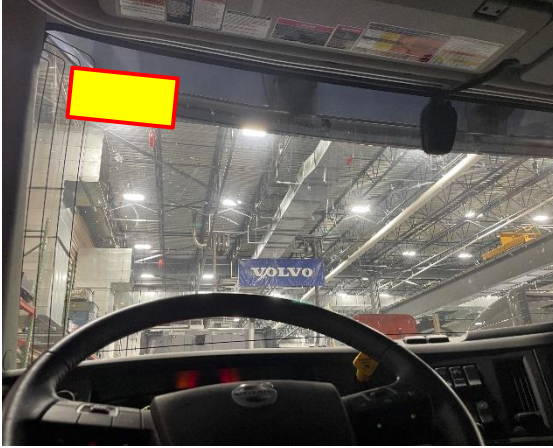
25. Place warning label (P/N-24585112) in top left-hand corner of windshield. If there is a label already there that pertains to VADA place new label over top of it.

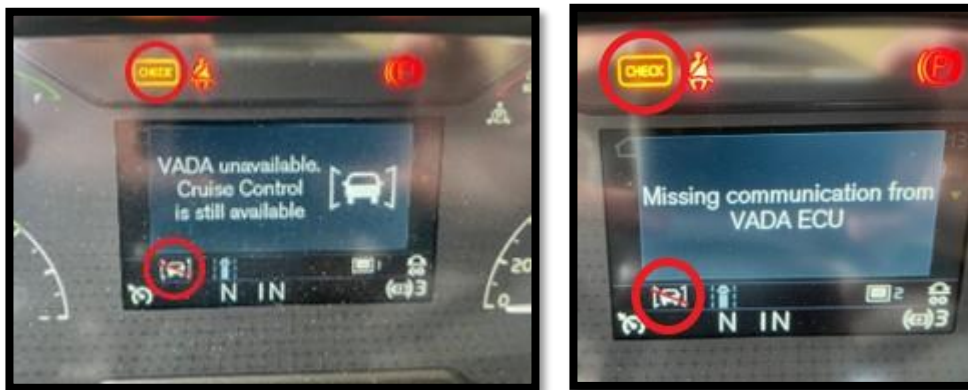
Important Note
Please ensure ABS .par file is updated even if the truck arrived for service with all parts removed and labels installed. Please also ensure dash look like pictures below.

39. After programming, please ensure the following pop-ups and warning lights appear on dash.

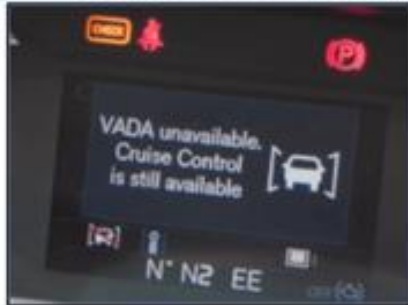
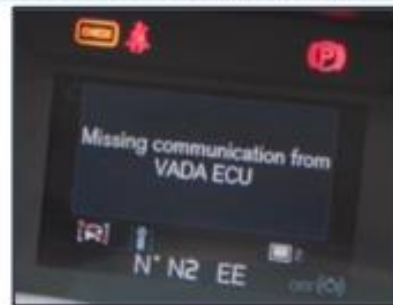
The below pop-up messages will appear when ignition is turned on. Press "ok" on toggle switch in steering wheel to acknowledge pop-ups

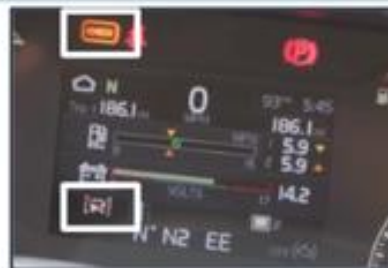
Yellow check light and Adaptive Cruise Control (ACC) icon with a red diagonal line will remain on
