SAFETY RECALL

Volvo Trucks North America

**Volvo Active Drive Assist
VNR**

Updated Repair Instructions and Labor Codes

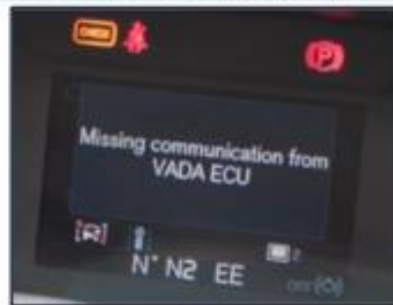
The below pop-up messages will appear when ignition is turned on. Press "ok" on toggle switch in steering wheel to acknowledge pop-ups

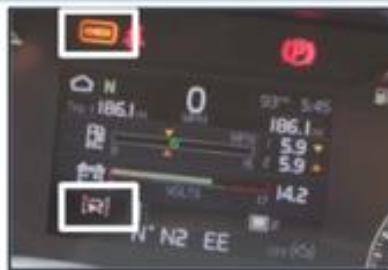
Yellow check light and Adaptive Cruise Control (ACC) icon with a red diagonal line will remain on
