SIB 72 02 23

RECALL 23V-260: SAFETY BELT REAR SEAT (LEFT AND RIGHT)

This Service Information Bulletin (Revision 3) replaces SI B72 02 23 **dated July 2023**.**What's New:**

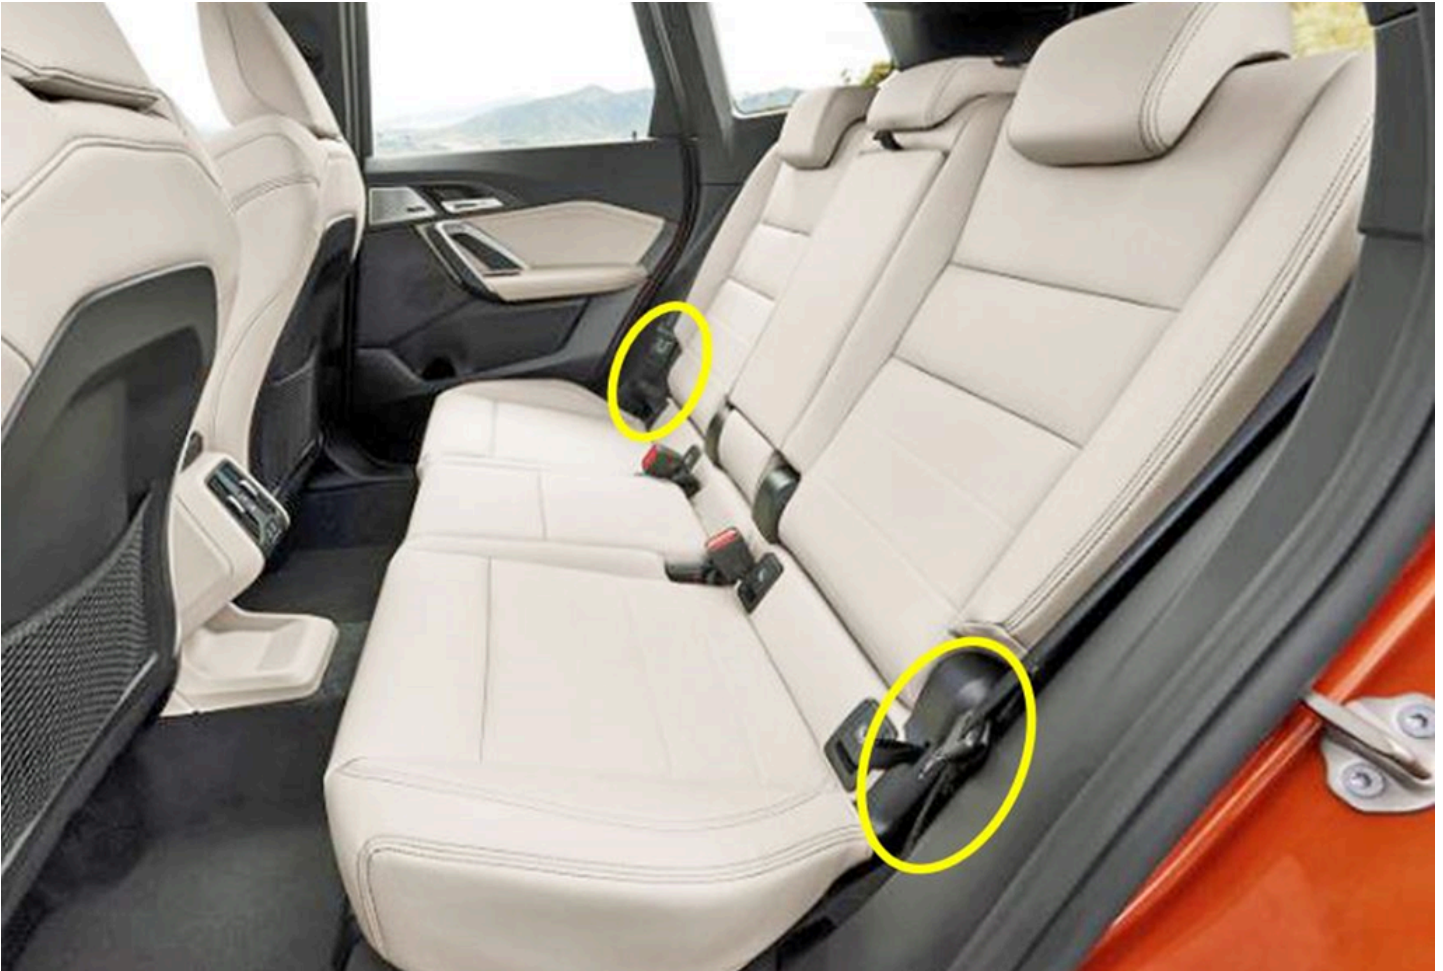
In the rear seating row, the safety belt on the left and/or right side may have been pinched against an interior C-pillar trim panel, at the bottom, during vehicle production.

Check the outer rear safety belts (left and right, per areas circled) and rework them if necessary.

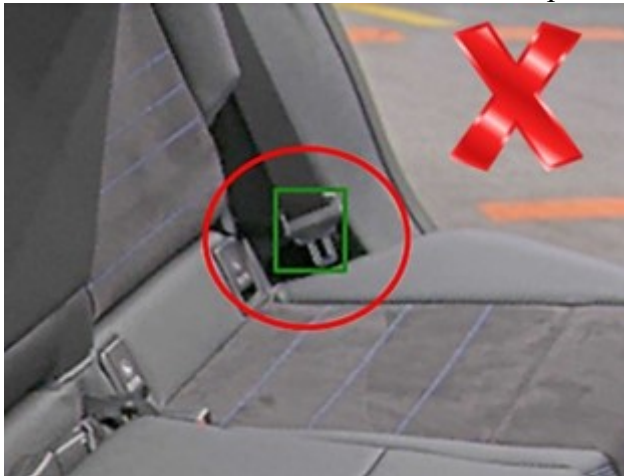
The safety belt webbing is slightly clamped by the C-pillar trim at the bottom. The latch is held in a low position. NOT OK

If the belts are not mounted correctly, grasp the lower part of the belt webbing (red arrow) below the latch and pull the belt firmly in the direction of the green arrow (toward center of vehicle) to release the pinched belt (the right rear passenger seat is shown).

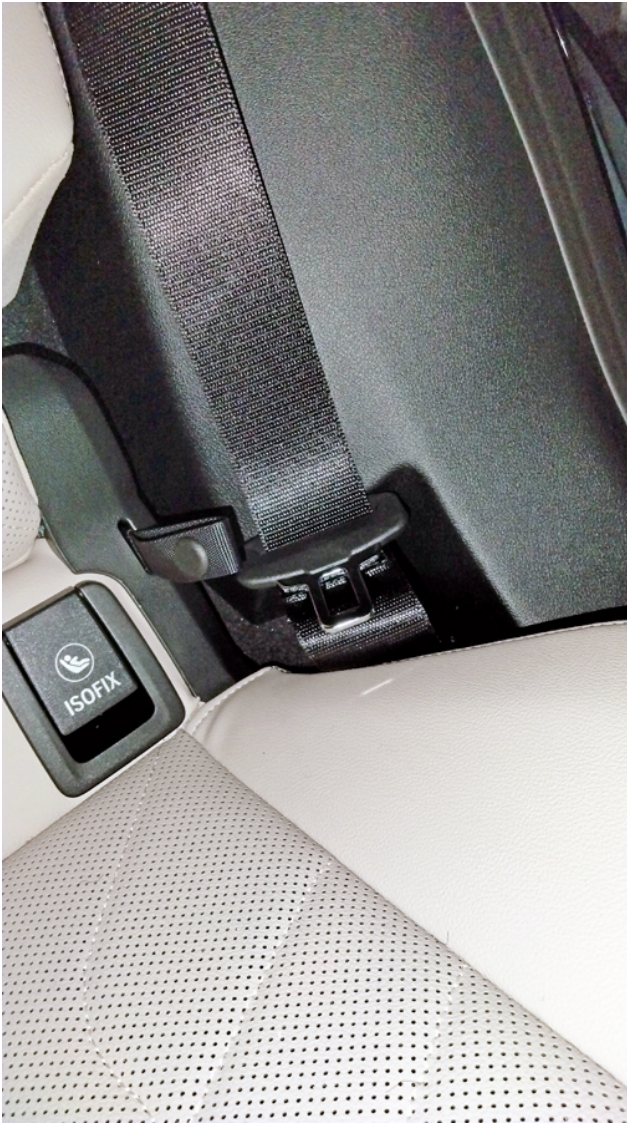
The safety belt webbing is slightly clamped by/pinched under the C-pillar trim at the bottom. The latch is held in a low position. NOT OK

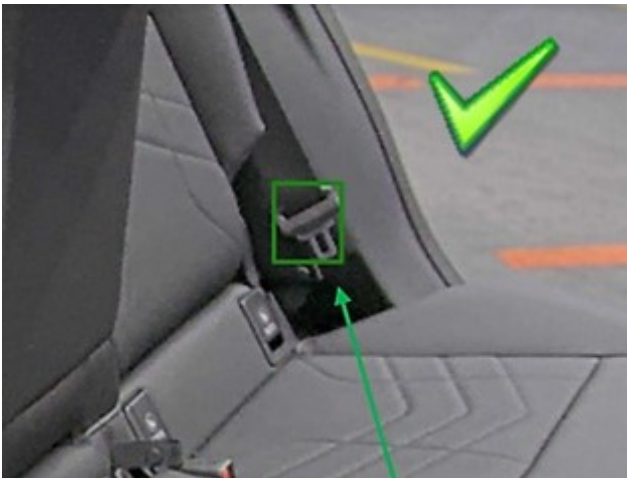
Safety belt installed correctly. OK

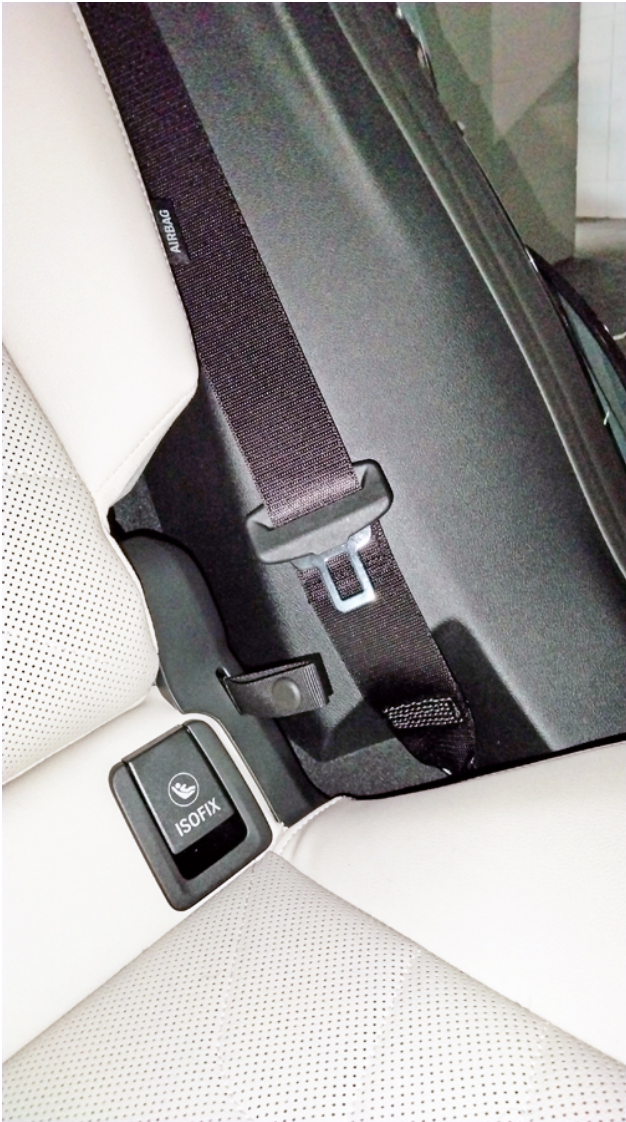
Safety belt installed correctly. OK
