SAFETY RECALL – NORTH AMERICA

B-Pillar Impact Sensor

Reference: 33A / NHTSA 23V-264

Remedy available for
2022 (DT) Ram 1500 Pickup

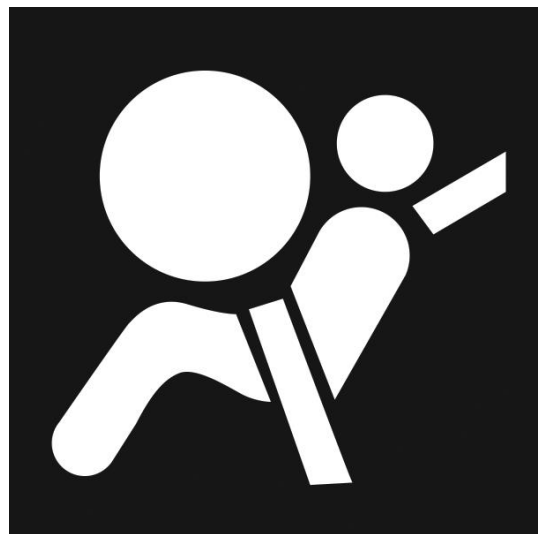
Figure 1 – Air Bag Warning Light

1. With the Ignition ON, check for an Air Bag Warning Light (Figure 1).
2. Connect the scan tool, and check for codes that would indicate a missing B-pillar Impact Sensor.
3. Impact Sensor missing?
 - a. YES: Proceed to Step 4.
 - b. NO: The system is complete and working properly. Return the vehicle to the owner, and close the recall.
