Safety Recall

N222375270 Brake Pressure Switch Connector Fire

Release Date: June 2023

Condition	General Motors has decided that a defect which relates to motor vehicle safety may exist in certain 2019-2023 model year Chevrolet Silverado Medium Duty 4500HD/5500HD/6500HD vehicles. These vehicles may have a brake pressure sensor assembly that allows brake fluid to leak beyond the diaphragm seal into the pressure switch. The brake fluid may seep into the sensor's electrical components and short the brake pressure switch and the associated fuse. If brake fluid shorts the brake pressure switch and the associated fuse, the circuit can generate excessive heat that could result in a fire, increasing the risk of injury. An underhood fire may occur when the vehicle is off and possibly unattended.
Correction	Dealers will replace the master cylinder pressure sensor. Dealers will also inspect the associated wire harness and replace if necessary.

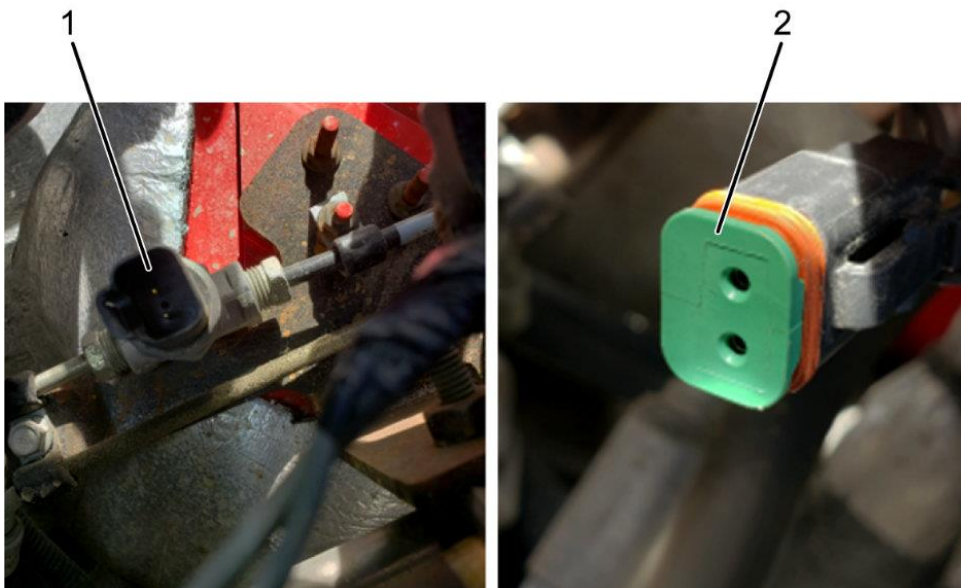
6361847

Note: Some vehicles may have dielectric grease in the switch/connector, this should not be confused with brake fluid.

9. Inspect for presence of brake fluid at both the Brake Pressure Switch Terminals (1) and Harness Connector (2).
 - If there is NO brake fluid in the switch terminals or harness connector, proceed to step 10.
 - If there is brake fluid present in the switch terminals or harness connector, proceed to step 13.

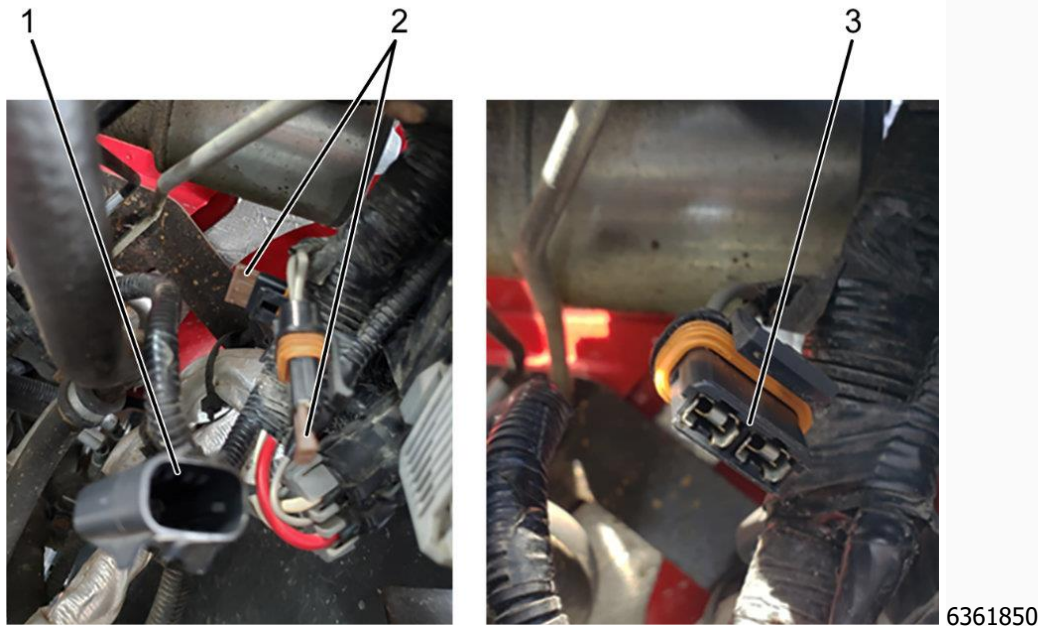
12. Inspect for presence of brake fluid in both fuse connections (3).

- If brake fluid is NOT present in the fuse connectors, reinstall fuses and protective covers. Proceed to step 13.
- If brake fluid is present in either fuse connectors, it is NOT necessary to reinstall fuses and protective covers, proceed to step 13.
