**Safety Recall 5823D – 2022-2023 CX-30 and 2023 CX-50 Brake Pedal Travel May Increase**

**Repair Procedure – Brake Pedal Travel May Increase  
Safety Recall 5823D**

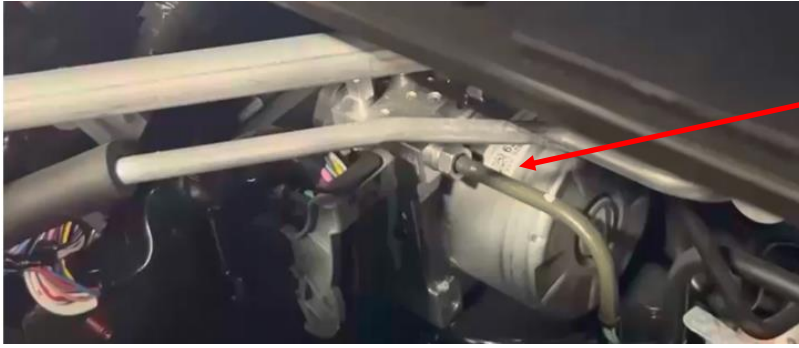
3. With the hood raised, place the Laptop on the Engine Cover with the USB Scan Tool Connected. Locate the ABS Unit (DSC HCU) under the rear LH side engine bay. You will need to scan the QR Code on the ABS Unit.
