Safety Recall 5823D – 2022-2023 CX-30 and 2023 CX-50 Brake Pedal Travel May Increase

A. VEHICLE INSPECTION PROCEDURE – AND PREPERATION FOR REPAIR

Repair Procedure – Brake Pedal Travel May Increase Safety Recall 5823D

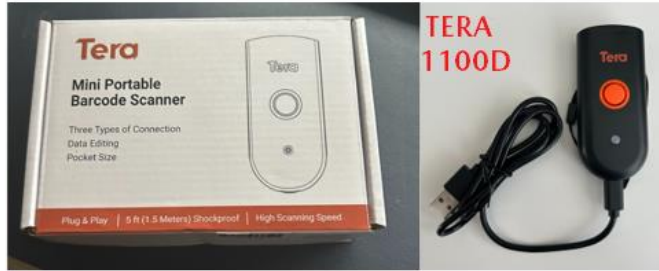
Use the Scan Tool with the black cable only, please do not use the “Bluetooth” dongle in the SST Scan Tool box as it does not work (red X in the box photo).

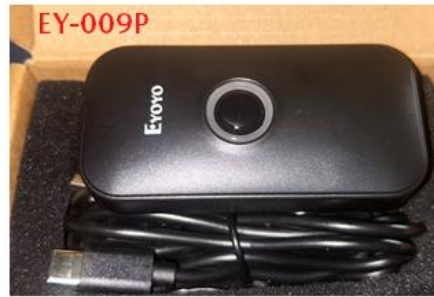
EY-015P. ONLY USE THE USB CABLE. DO NOT USE THE USB DONGLE TO SCAN

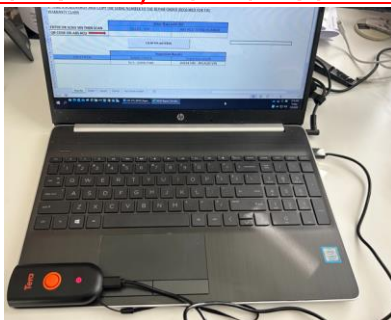
ONLY USE THE BLACK USB CABLE, DO NOT USE THE USB WIRELESS DONGLE

4. Connect the black USB cable to the USB Scan Tool and the Windows Laptop.

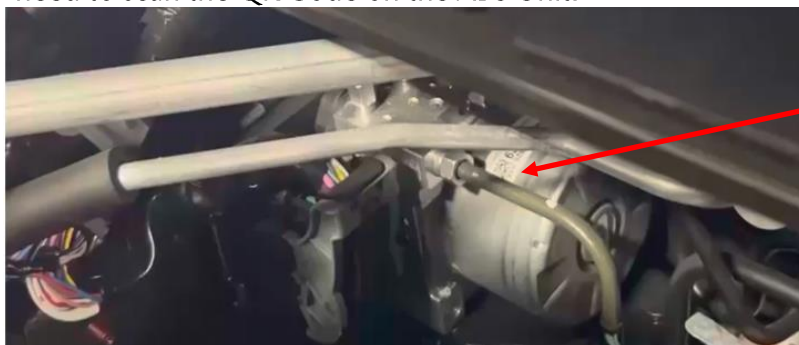
3. With the hood raised, place the Laptop on the Engine Cover with the USB Scan Tool Connected. Locate the ABS Unit (DSC HCU) under the rear LH side engine bay. You will need to scan the QR Code on the ABS Unit.

4. Place the cursor in the “ABS HCU SERIAL NUMBER” Field. Using the Barcode Scanner, Press and Hold the Orange button and scan the QR Code on the ABS Unit (DSC HCU). [Click Here to see a VIDEO on how to scan the QR Code “Video to Scan QR Code. This VIDEO is also available in MGSS under the 5823D Documents.](#)
