Safety Recall 5823D – 2022-2023 CX-30 and 2023 CX-50 Brake Pedal Travel May Increase

A. VEHICLE INSPECTION PROCEDURE – AND PREPERATION FOR REPAIR

**Repair Procedure – Brake Pedal Travel May Increase
Safety Recall 5823D**

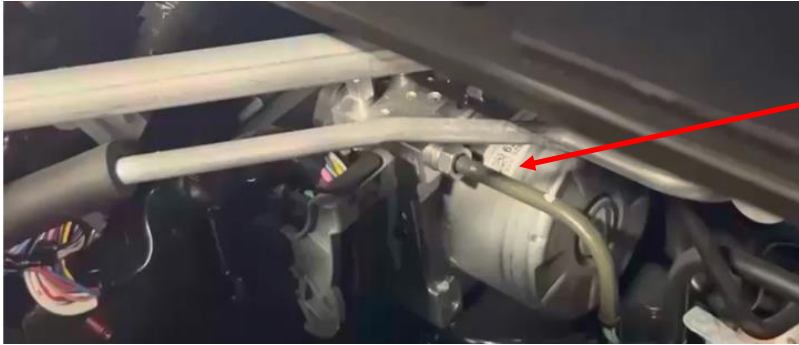
3. With the hood raised, place the Laptop on the Engine Cover with the USB Scan Tool Connected. Locate the ABS Unit (DSC HCU) under the rear LH side engine bay. You will need to scan the QR Code on the ABS Unit.

4. Place the cursor in the “ABS HCU SERIAL NUMBER” Field. Using the Barcode Scanner, Press and Hold the Orange button and scan the QR Code on the ABS Unit (DSC HCU). [Click here to watch a video on how to scan the QR code.](#)
