## PRODUCT CAMPAIGN BULLETIN

**APPLICABILITY:** 2023 MY Impreza

**NUMBER:** WRI-23

**SUBJECT:** Safety Recall/STOP SALE – Stop Lamp Switch Adjustment

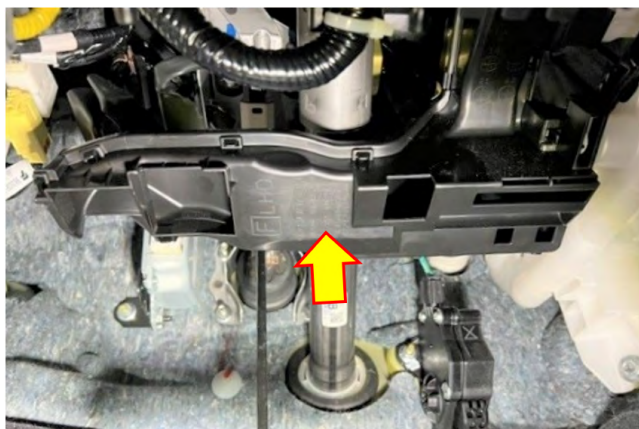
**STEP 1:** Remove the left front footwell air duct.

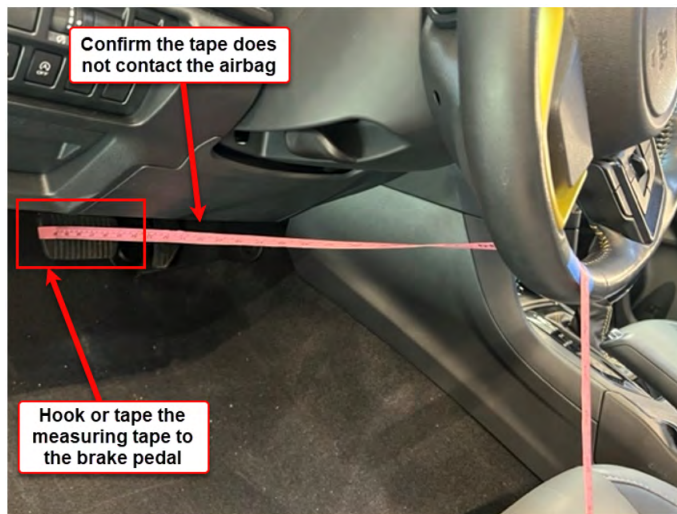
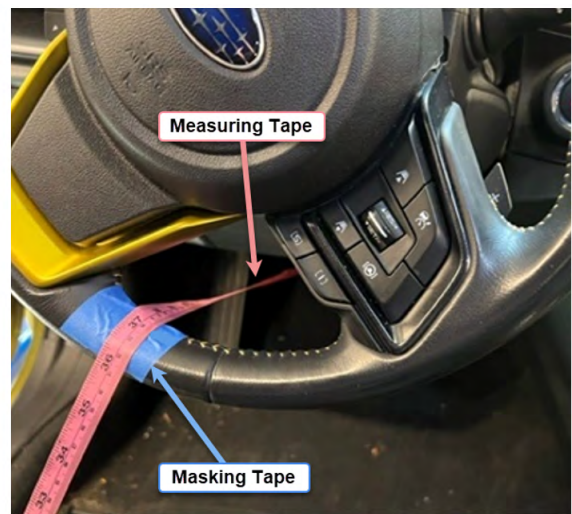
**NOTE:** If needed and to maintain consistency, apply a piece of tape to the brake pedal to be used as a reference mark when making measurements. The end of the measuring tape can also be taped to the pedal itself.

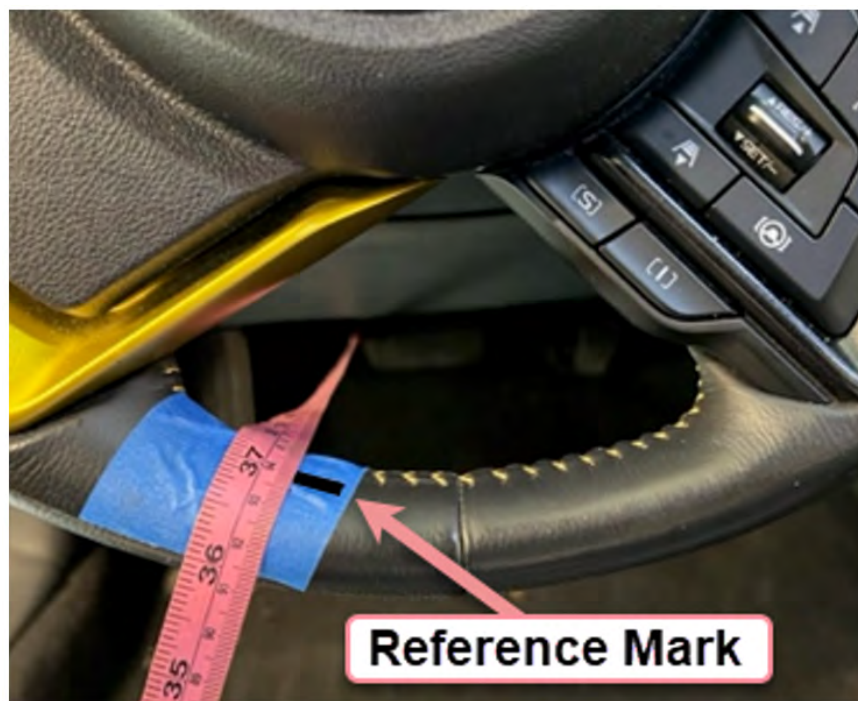
**STEP 4:** Write a reference mark on the taped section of the steering wheel. Make a measurement to the brake pedal in its current position and record it.
