## Recall Inspection and Repair Instructions

**NHTSA Recall #:** 23V-297

**Tiffin Motorhomes Recall #:** TIF-129

**Models Involved:** 2021 & 2022 Cahaba, all floorplans.

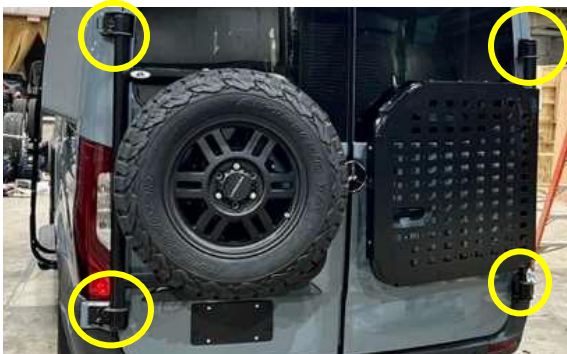
Figure 1

1. Verify the upper & lower door hinge brackets in Figure 1a have a rubber ring installed around the bar opening and that the door brackets are attached with a reinforcing plate as shown in figure 1b. If the reinforcing plate is missing install one from the hardware kit.

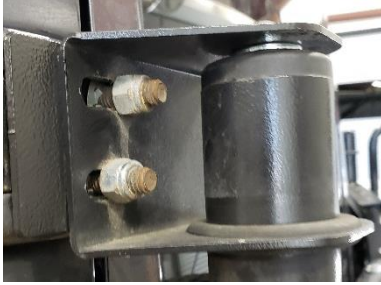
Figure 2a

2. Verify the assembly bars are secured to the door hinge bracket with a 3/8 button head bolt and lock washer (Figure 2a). Remove any rusted bolts and replace them with the stainless-steel bolts from the repair kit. If needed, extra washers can be installed to level the Molle rack or spare tire assembly bar (Figure 2b).

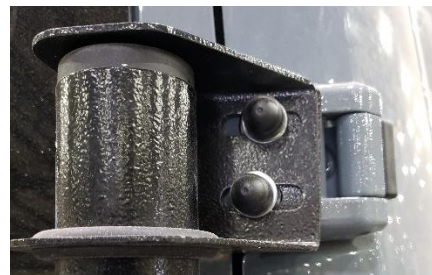
Figure 3c

3. Verify the inner reinforcing plates are correctly installed on the inner door hinge upper (Figure 3a) and lower (Figure 3b). Remove any rusted bolts and replace them with the stainless-steel bolts from the repair kit. When replacing rusted bolts, add a serrated lock washer to each bolt to replace the existing washer. Install the nut covers over the lock nuts and bolt heads on the outer side of the hinge (Figure 3c).

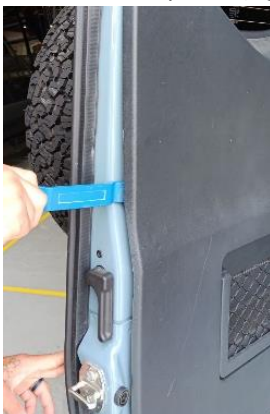
Figure 3a

4. Using the plastic fastener remover (figure 3a), remove the inner door panels from the rear doors. After the panel is removed, remove the orange snaps from inside the door frame and install them into the door panel (figure 3b) so it can be reinstalled when the repairs are complete.

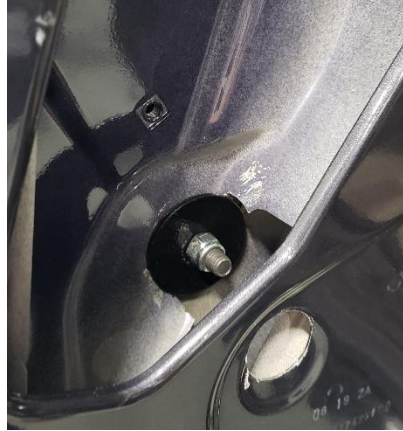
Figure 7a

5. Smooth any sharp metal edges and touch up any exposed metal that was cut during the original installation with paint to seal.
6. Verify the reinforcing plate is installed on the inner side of the door along with the VHB backer from the repair kit. The VHB backer should be against the metal of the rear door. Correct as needed using the parts from the repair kit to add the reinforcing plate and VHB backer (figure 6a).

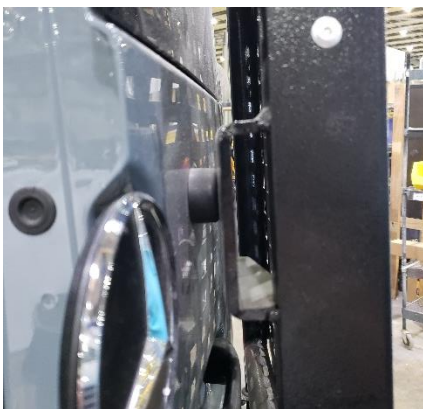
Figure 8a

7. Verify the rubber grommet is installed on the outside of the rear door. If the rubber grommet is damaged from over compression, replace it with a new one from the repair kit.
8. Verify the attachment of the tire carrier assembly and Molle rack assembly to the rear doors is as follows: The carriage bolt is installed through the attachment point on the Molle rack or tire carrier, then through the rubber grommet, the door, the VHB backer and the reinforcing plate. The carriage bolt should be secured with a lock nut (figure 8a). The bolt should be tight but not so tight that the rubber grommet is compressed. Proper installation of the grommet is shown in Figures 8a & 8b.
