RAM

Remedy available for
 2019-2021 (VF) Ram ProMaster

Park Engagement

Reference: 61A / NHTSA 23V-301

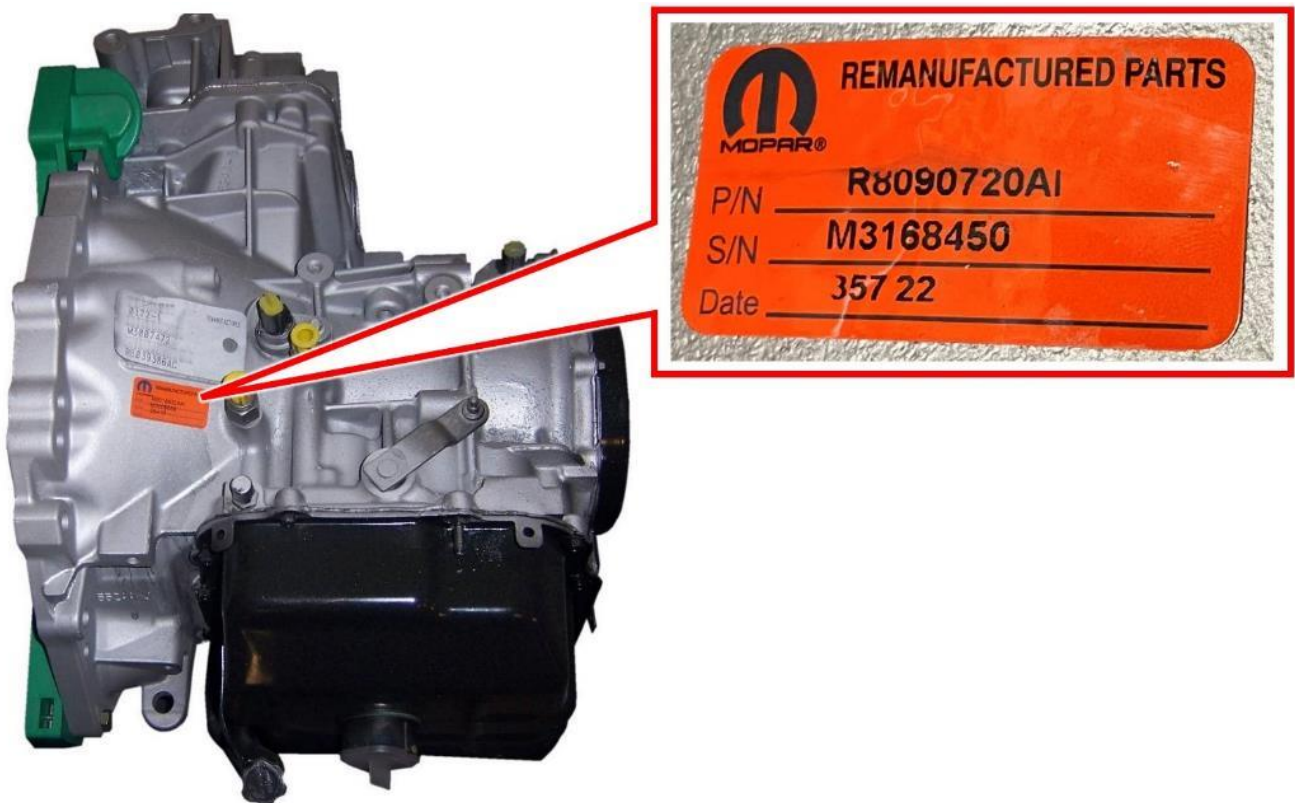
Figure 2 – Remanufactured Transmission – Inspect Serial Number

1. Inspect the transmission for an orange sticker indicating that it has been remanufactured (Figure 2).
 - **YES:** There is an orange sticker. Continue to the next step to read the Serial Number.
 - **YES – but sticker not readable:** Proceed to Section D. Compounder Replacement.
 - **NO:** Orange sticker not found. Proceed to Section D. Compounder Replacement.

2. If an orange remanufactured sticker was located on the transmission, read the sticker Serial Number (Figure 2).
 - **S/N M3164017 or above:** Close the vehicle hood and mark this campaign as completed. Return the vehicle to the customer.
 - **S/N M3164016 or below:** Proceed to Section D. Compounder Replacement.

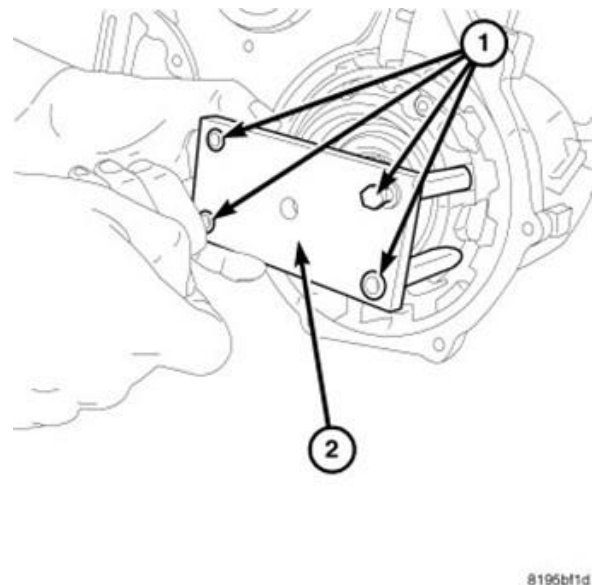
Figure 26 – Bearing Retainer Bolts

NOTE: The compounder bearing retainer bolts may be very tight so it is important to have a good fitting new driver tool (2) for removal of these bolts (1) or the bolts heads may become damaged during removal (Figure 26).
