# SAFETY RECALL

## Park Engagement

Reference: 61A / NHTSA 23V-301

2019-2021 (VF) Ram ProMaster

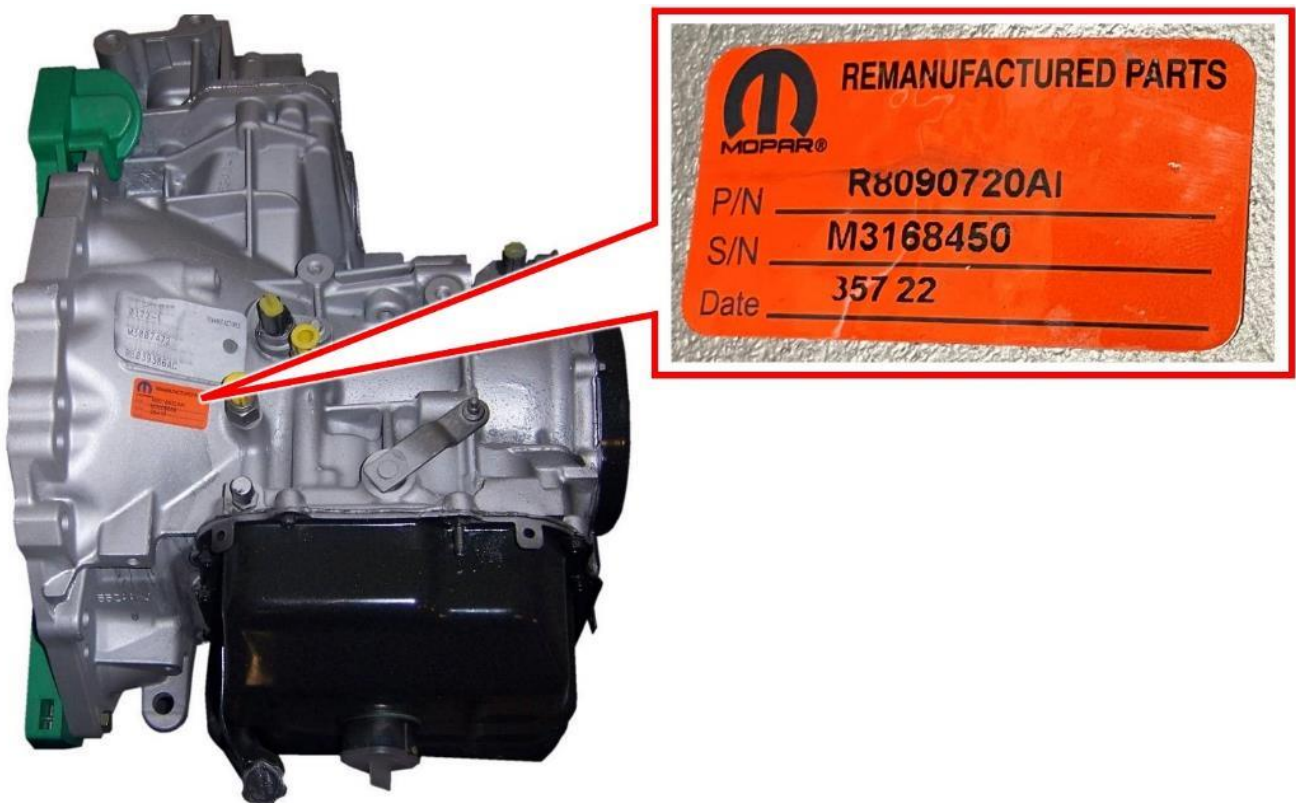
**Figure 2 – Remanufactured Transmission – Inspect Serial Number**

1. Inspect the transmission for a sticker indicating that it has been remanufactured (Figure 2).

2. If a remanufactured sticker was located on the transmission, read the sticker Serial Number (Figure 2).

- **S/N M3164017 or above:** Close the vehicle hood and mark this campaign as completed. Return the vehicle to the customer.
- **S/N M3164016 or below:** Proceed to Section D. Compounder Replacement.

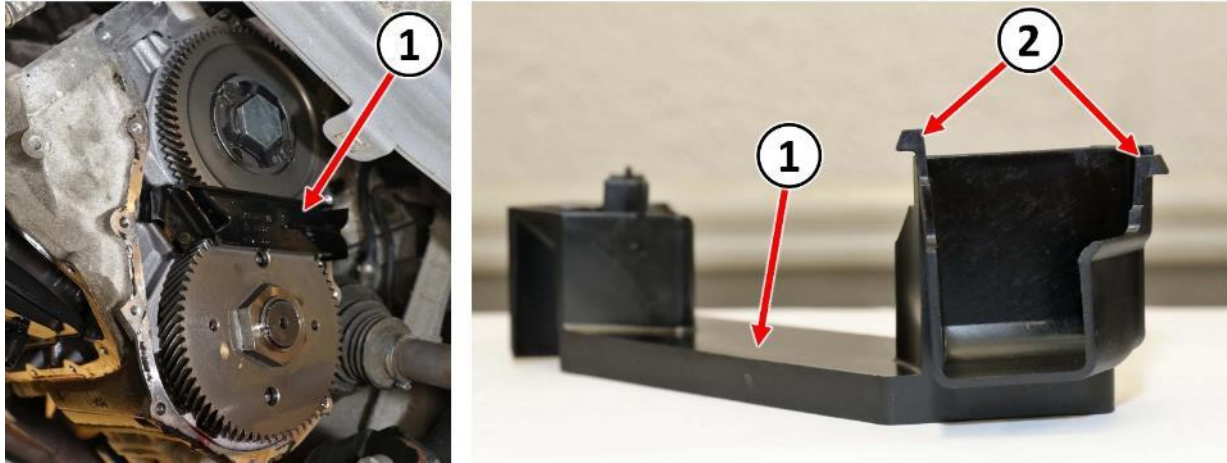
Figure 19 – Oil Scavenger

**NOTE:** Broken retaining tabs (2) on the oil scavenger (1) are acceptable because the scavenger is held in place by the transfer gear cover. However, if the scavenger is broken in such a way as to compromise its functionality, then it must be replaced (Figure 19).
