RAM

Remedy available for
 2019-2021 (VF) Ram ProMaster

Park Engagement

Reference: 44A / NHTSA 23V-301

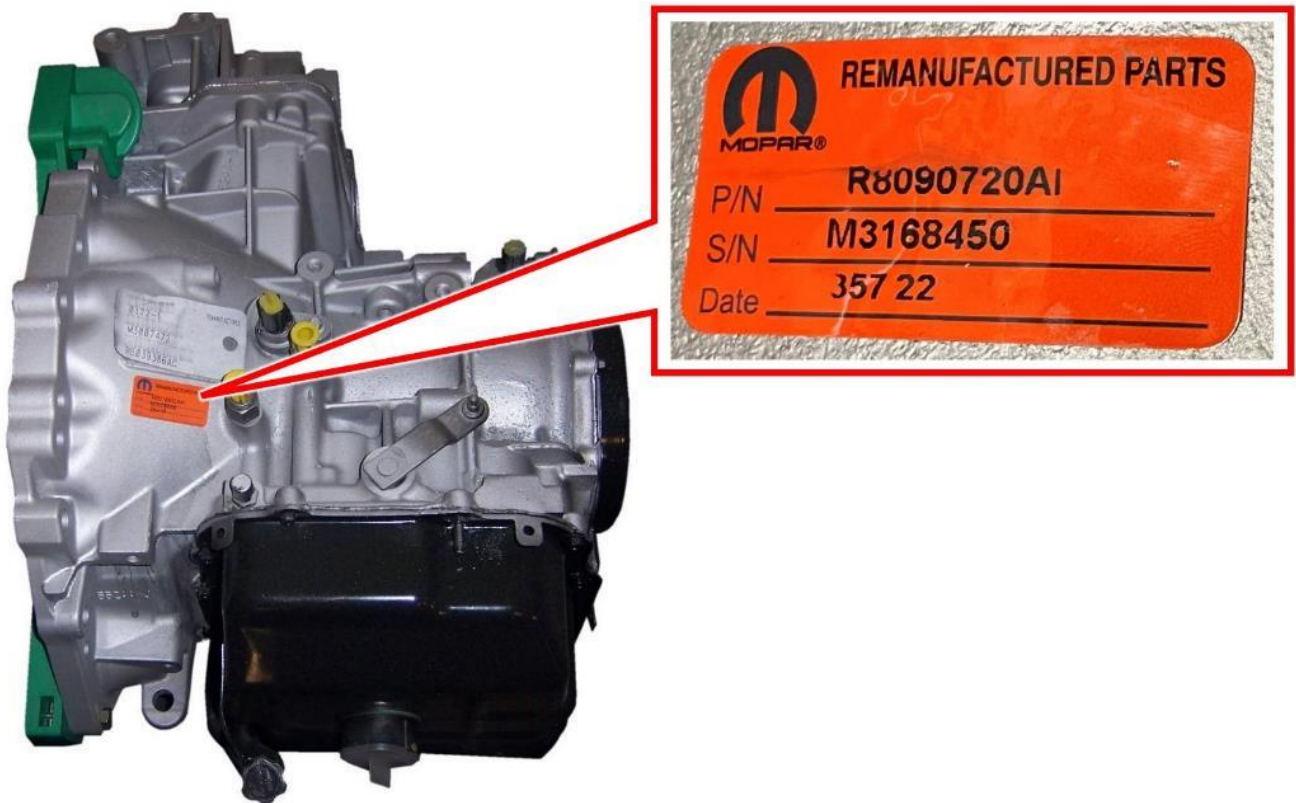
Figure 2 – Remanufactured Transmission – Inspect Serial Number

1. Inspect the transmission for an orange sticker indicating that it has been remanufactured (Figure 2).
 - **YES:** There is an orange sticker. Continue to the next step to read the Serial Number.
 - **NO:** Orange sticker not found or not readable. Proceed to Section D. Compounder Replacement.

2. If an orange remanufactured sticker was located on the transmission, read the sticker Serial Number (Figure 2).
 - **S/N M3164017 or above:** Close the vehicle hood and mark this campaign as completed. Return the vehicle to the customer.
 - **S/N M3164016 or below:** Proceed to Section D. Compounder Replacement.
