Reference: 61A / NHTSA 23V-301 FCA US LLC

2019-2021 (VF) Ram ProMaster

# **SAFETY RECALL**

# **Park Engagement**

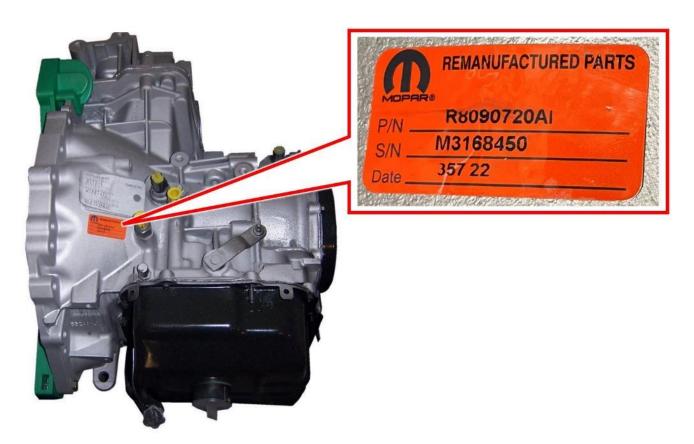
Figure 2 - Remanufactured Transmission - Inspect Serial Number

- 2. If a remanufactured sticker was located on the transmission, read the sticker Serial Number (Figure 2).
  - S/N M3164017 or above: Close the vehicle hood and mark this campaign as completed. Return the vehicle to the customer.
  - S/N M3164016 or below: Proceed to Section D. Compounder Replacement.

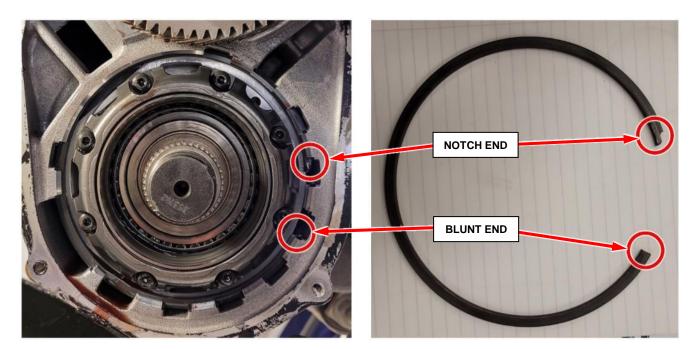
Figure 42 – Snap Ring Installation Orientation

CAUTION: Snap ring is bevelled and MUST be installed in the proper orientation. When looking directly at the snap ring, the notch end and blunt ends must be oriented as shown regardless of clock position of snap ring when installed in the transmission. The snap ring ends should be oriented so that the ends are in an open space rather than in the snap ring groove (Figure 42).

73. Obtain a **NEW** snap ring, then install that **NEW** snap ring to retain the underdrive compounder assembly. Ensure the snap ring is fully seated in the snap ring groove (Figure 42).
