**RAM** Remedy available for  
 2019-2021 (VF) Ram ProMaster

# SAFETY RECALL

## Park Engagement

Reference: 44A / NHTSA 23V-301

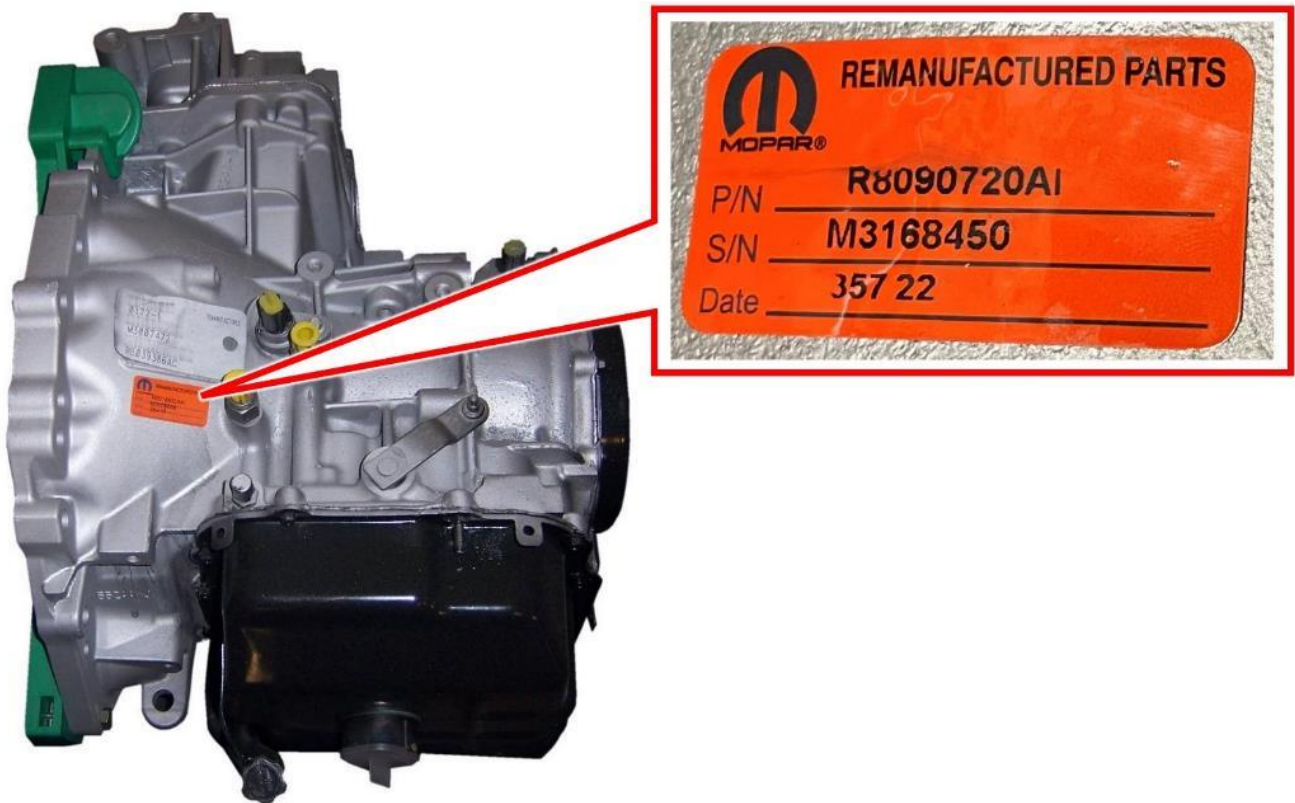
Figure 2 – Remanufactured Transmission – Inspect Serial Number

1. Inspect the transmission for an orange sticker indicating that it has been remanufactured (Figure 2).
  - **YES:** There is an orange sticker. Continue to the next step to read the Serial Number.
  - **NO:** Orange sticker not found or not readable. Proceed to Section D. Compounder Replacement.

2. If an orange remanufactured sticker was located on the transmission, read the sticker Serial Number (Figure 2).
  - **S/N M3164017 or above:** Close the vehicle hood and mark this campaign as completed. Return the vehicle to the customer.
  - **S/N M3164016 or below:** Proceed to Section D. Compounder Replacement.

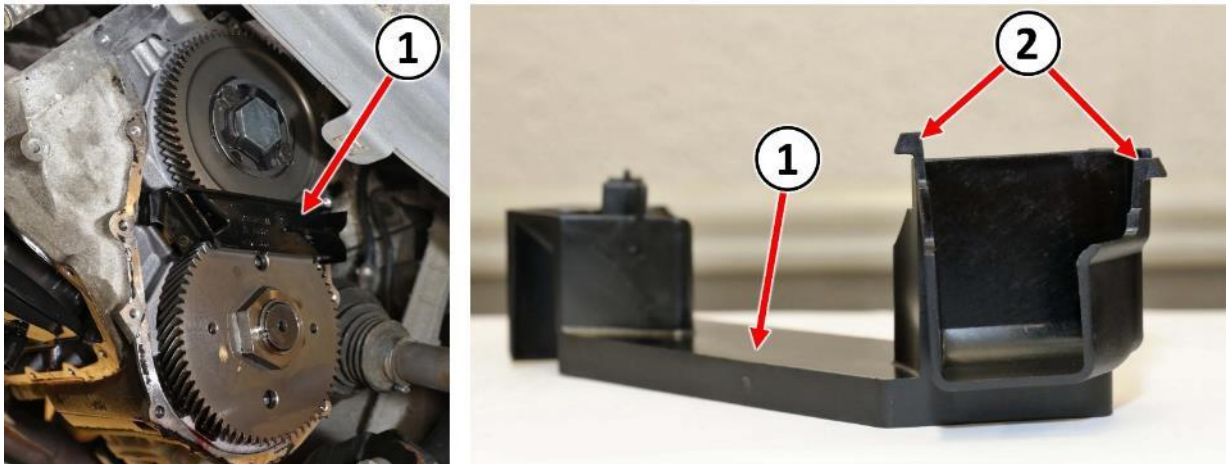
Figure 19 – Oil Scavenger

**NOTE:** Broken retaining tabs (2) on the oil scavenger (1) are acceptable because the scavenger is held in place by the transfer gear cover. However, if the scavenger is broken in such a way as to compromise its functionality, then it must be replaced (Figure 19).
