# SAFETY RECALL

## Park Engagement

Reference: 44A / NHTSA 23V-301

2019-2021 (VF) Ram ProMaster

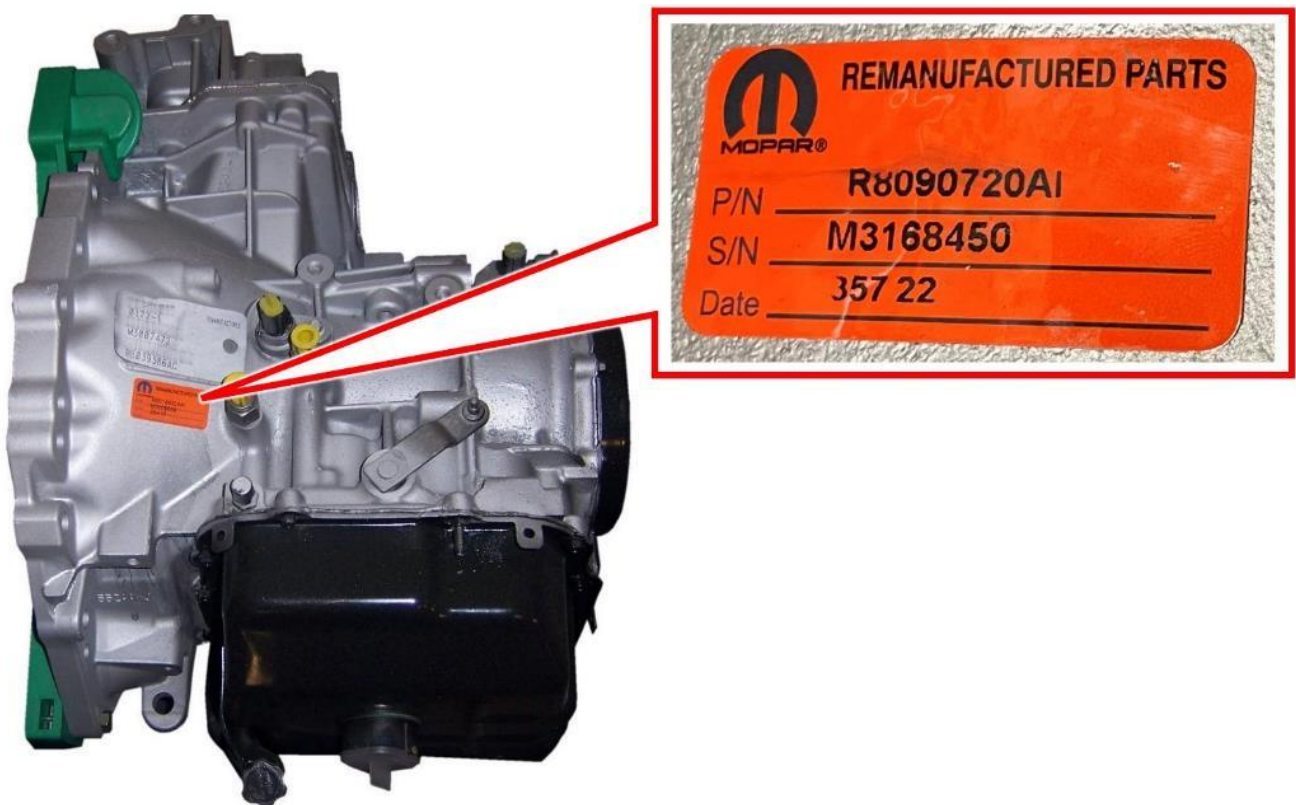
**Figure 2 – Remanufactured Transmission – Inspect Serial Number**

1. Inspect the transmission for a sticker indicating that it has been remanufactured (Figure 2).
  - **YES:** There is a sticker. Continue to the next step to read the Serial Number.
  - **NO:** Sticker not found or not readable. Proceed to Section D. Compounder Replacement.

2. If a remanufactured sticker was located on the transmission, read the sticker Serial Number (Figure 2).
  - **S/N M3164017 or above:** Close the vehicle hood and mark this campaign as completed. Return the vehicle to the customer.
  - **S/N M3164016 or below:** Proceed to Section D. Compounder Replacement.

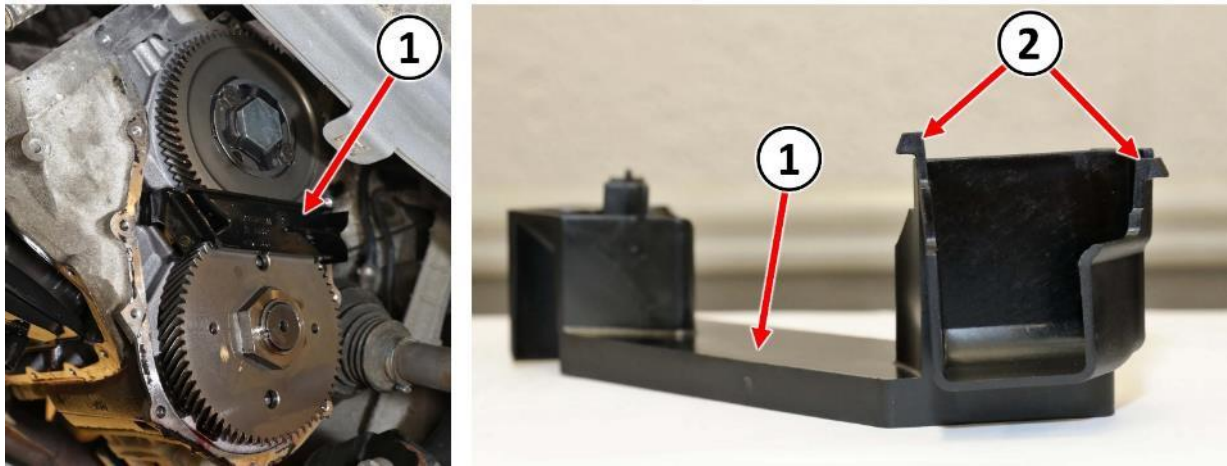
Figure 19 – Oil Scavenger

**NOTE:** Broken retaining tabs (2) on the oil scavenger (1) are acceptable because the scavenger is held in place by the transfer gear cover. However, if the scavenger is broken in such a way as to compromise its functionality, then it must be replaced (Figure 19).
