**RAM**

2019-2021 (VF) Ram ProMaster

## Park Engagement

Reference: 44A / NHTSA 23V-301

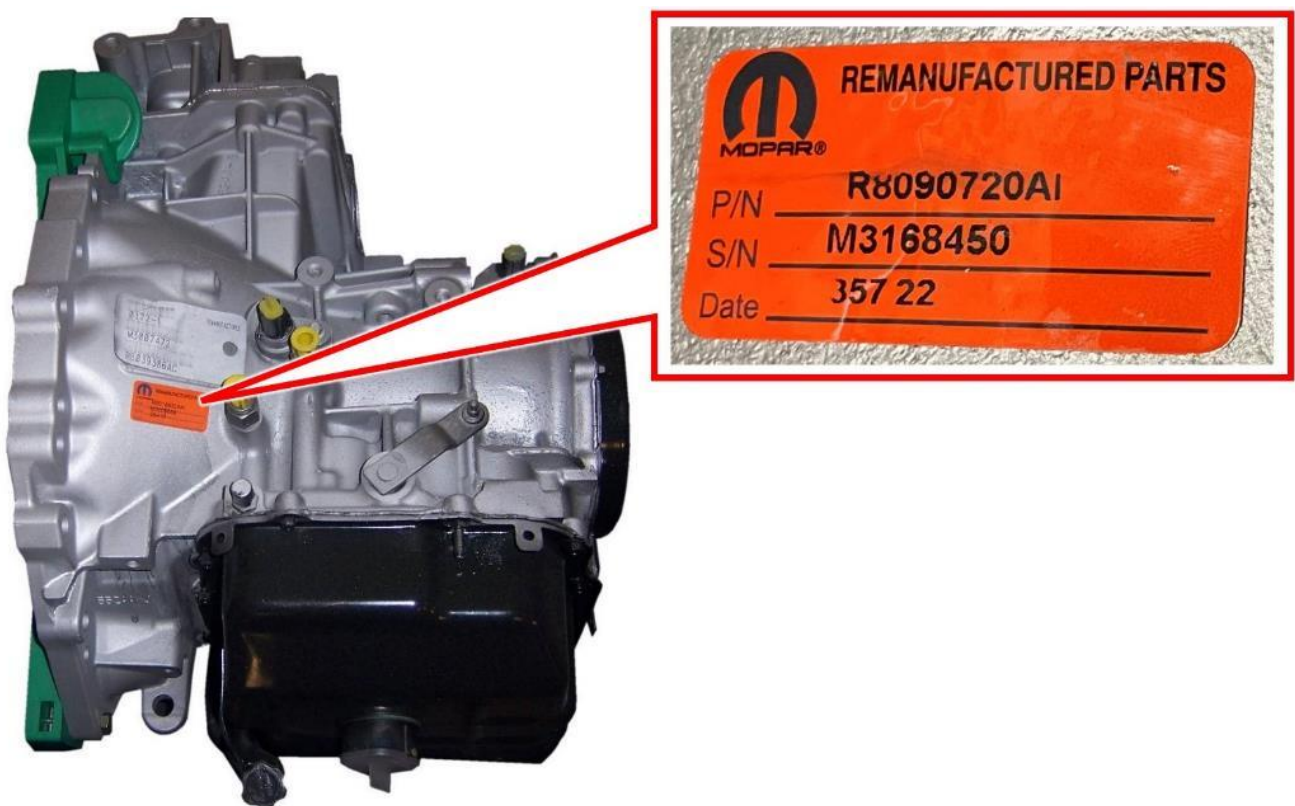
**Figure 2 – Remanufactured Transmission – Inspect Serial Number**

1. Inspect the transmission for a sticker indicating that it has been remanufactured (Figure 2).
  - **YES:** There is a sticker. Continue to the next step to read the Serial Number.
  - **NO:** Sticker not found or not readable. Proceed to Section D. Compounder Replacement.

2. If a remanufactured sticker was located on the transmission, read the sticker Serial Number (Figure 2).
  - **S/N M3164017 or above:** Close the vehicle hood and mark this campaign as completed. Return the vehicle to the customer.
  - **S/N M3164016 or below:** Proceed to Section D. Compounder Replacement.

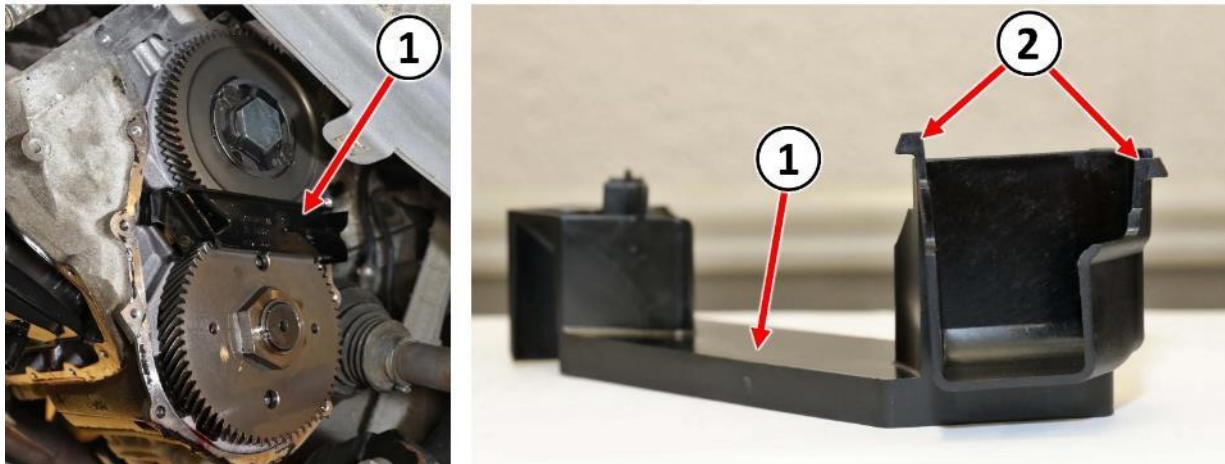
**Figure 19 – Oil Scavenger**

**NOTE:** Broken retaining tabs (2) on the oil scavenger (1) are acceptable because the scavenger is held in place by the transfer gear cover. However, if the scavenger is broken in such a way as to compromise its functionality, then it must be replaced (Figure 19).
