RAM Remedy available for
 2019-2021 (VF) Ram ProMaster

SAFETY RECALL

Park Engagement

Reference: 61A / NHTSA 23V-301

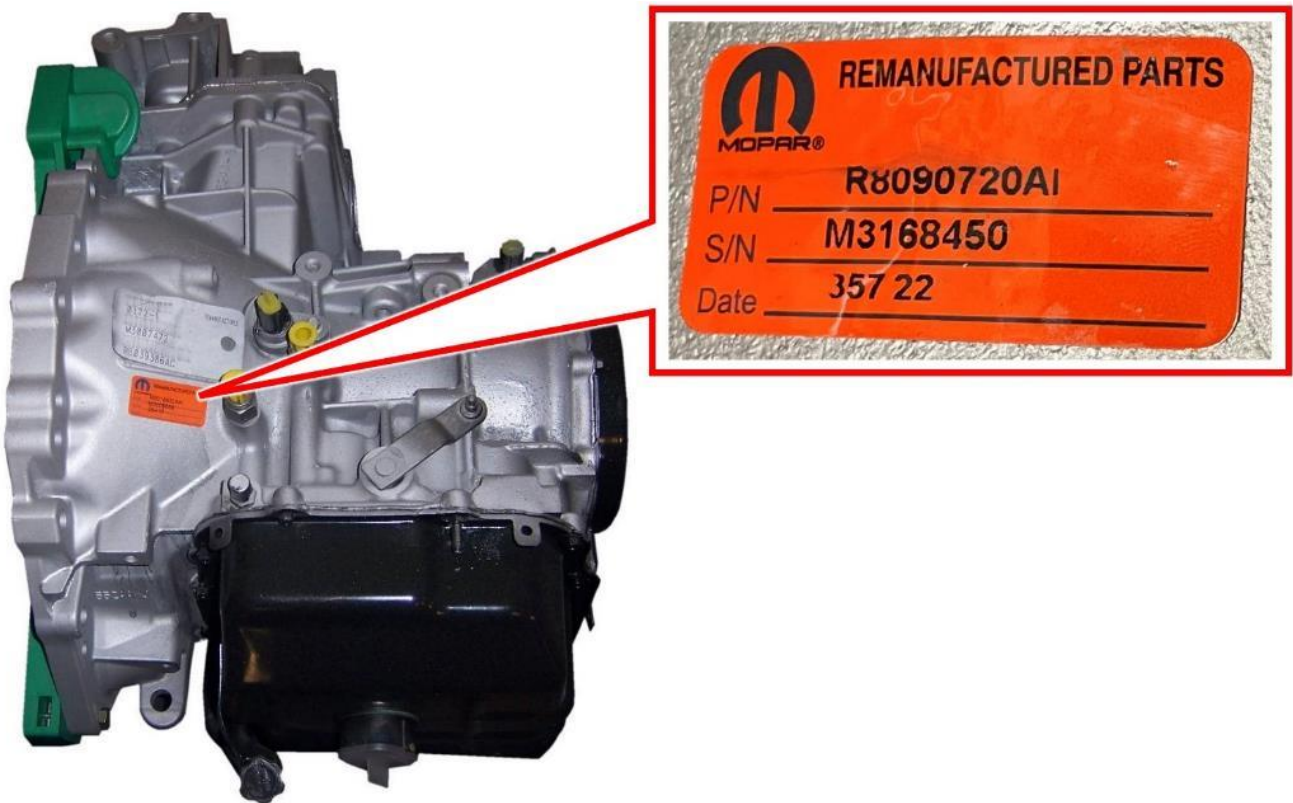
Figure 2 – Remanufactured Transmission – Inspect Serial Number

2. If an orange remanufactured sticker was located on the transmission, read the sticker Serial Number (Figure 2).

- **S/N M3164017 or above:** Close the vehicle hood and mark this campaign as completed. Return the vehicle to the customer.
- **S/N M3164016 or below:** Proceed to Section D. Compounder Replacement.

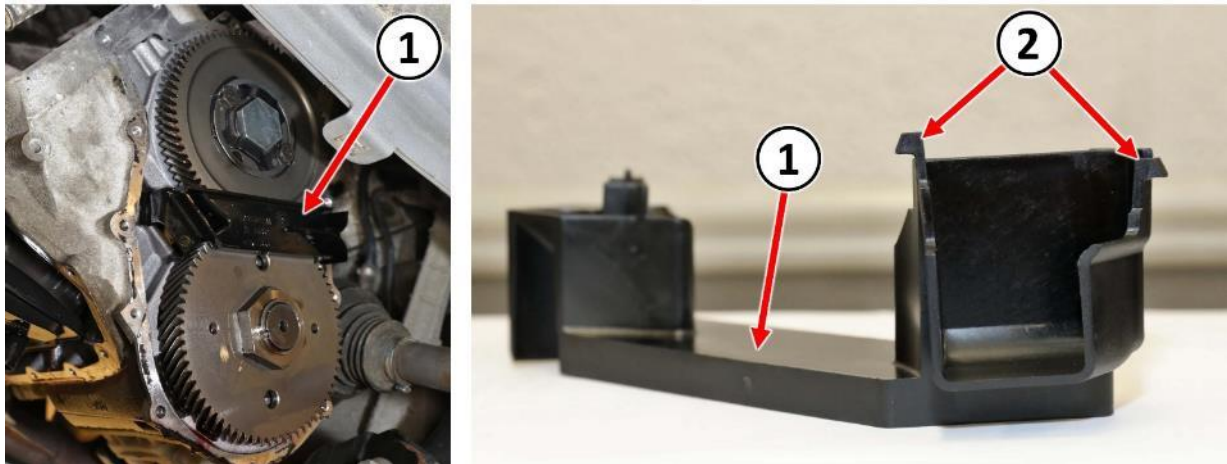
Figure 19 – Oil Scavenger

NOTE: Broken retaining tabs (2) on the oil scavenger (1) are acceptable because the scavenger is held in place by the transfer gear cover. However, if the scavenger is broken in such a way as to compromise its functionality, then it must be replaced (Figure 19).
