RAM Remedy available for
 2019-2021 (VF) Ram ProMaster

Revision	Edition	Detail
2	July 2023	Section B Step 15 revised.

Park Engagement

Reference: 44A / NHTSA 23V-301

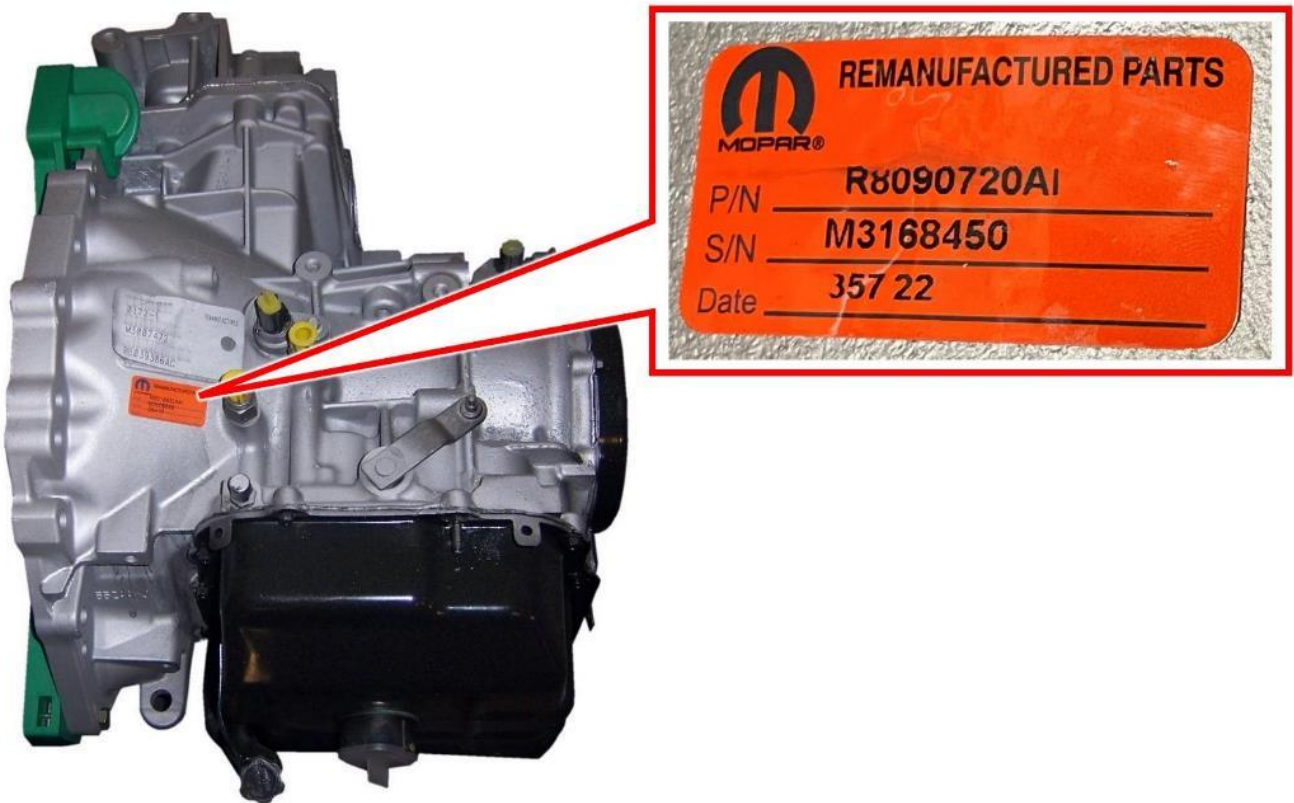
Figure 2 – Remanufactured Transmission – Inspect Serial Number

1. Inspect the transmission for an orange sticker indicating that it has been remanufactured (Figure 2).
 - **YES:** There is an orange sticker. Continue to the next step to read the Serial Number.
 - **NO:** Orange sticker not found or not readable. Proceed to Section D. Compounder Replacement.

2. If an orange remanufactured sticker was located on the transmission, read the sticker Serial Number (Figure 2).
 - **S/N M3164017 or above:** Close the vehicle hood and mark this campaign as completed. Return the vehicle to the customer.
 - **S/N M3164016 or below:** Proceed to Section D. Compounder Replacement.
