Recall Inspection and Repair Instructions

NHTSA Recall #: 23V-308

Tiffin Motorhomes Recall #: TIF-130

Models Involved: 2020, 2021, 2022 and 2023 Allegro Breeze Motorhomes

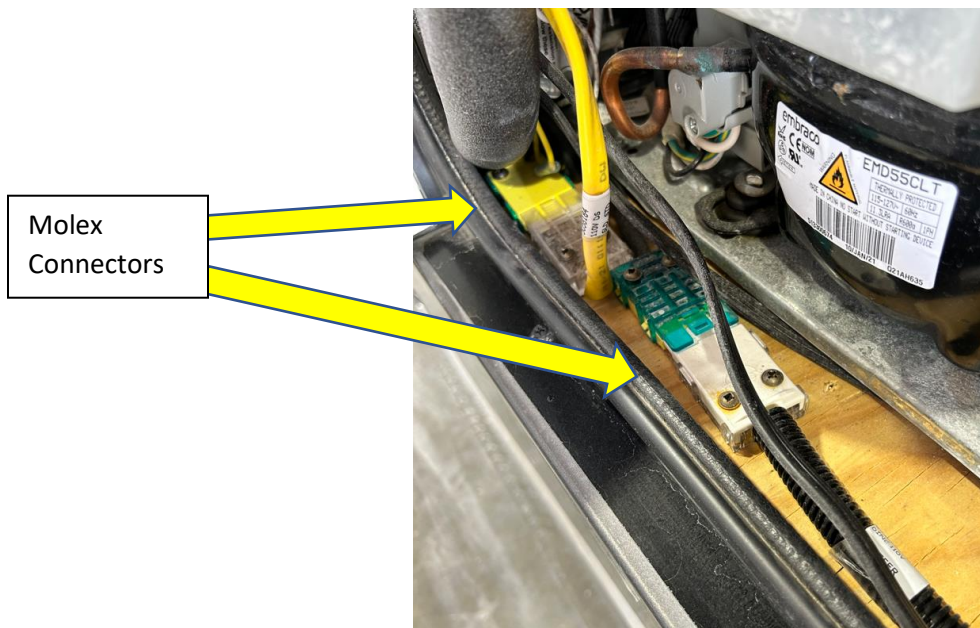
1. Disconnect the batteries. The main feed to the house and chassis batteries needs to be disconnected.
 - i. House batteries are in the front passenger compartment.
 - ii. Chassis batteries are in the rear passenger compartment.
2. Locate the two Molex connectors mounted to the floor directly behind the refrigerator. Verify there is no power to connector with a multimeter, then remove the 8 mounting screws.
