# SAFETY RECALL

Date	Number	Release	Page
06.2023	SC0443	02	1(15)

**Mack LR DSNY Horn Inoperative**  
**LR**

## RECALL INFORMATION

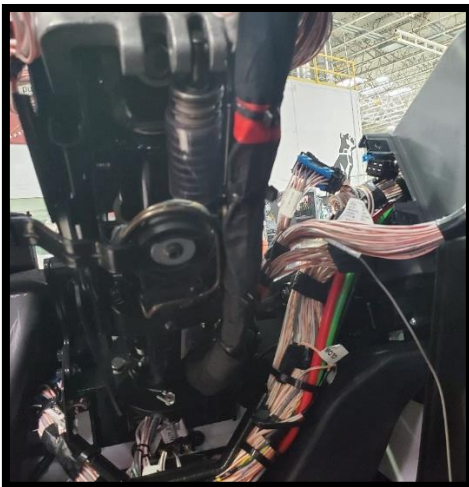
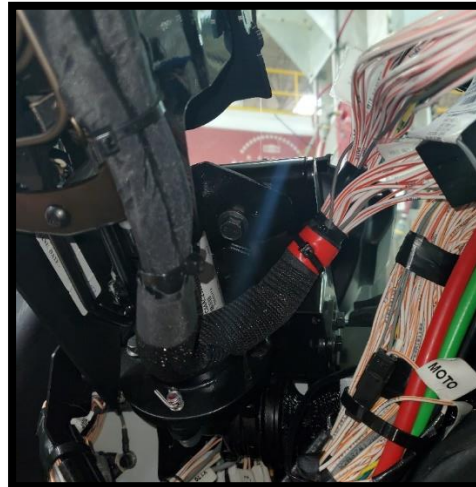
20. Disconnect all connectors for the column harness, take note how the harness is routed.

21. Remove the left side column harness.

22. Install the new column wiring harness **24078162** following the original routing.

23. The new harness has several areas with red tape marks, use these marks when securing the new harness with tie straps.
