Safety Recall

Code: 57J5

Subject	Door Handles															
Document History	<table border="1"><thead><tr><th>Date</th><th>Summary</th></tr></thead><tbody><tr><td>03/22/2024</td><td>Updated claiming and work instructions</td></tr><tr><td>08/25/2023</td><td>Updated instructions for door handles without a port Corrected parts table Additional customer letter examples added</td></tr><tr><td>08/08/2023</td><td>Original publication</td></tr></tbody></table>	Date	Summary	03/22/2024	Updated claiming and work instructions	08/25/2023	Updated instructions for door handles without a port Corrected parts table Additional customer letter examples added	08/08/2023	Original publication							
Date	Summary															
03/22/2024	Updated claiming and work instructions															
08/25/2023	Updated instructions for door handles without a port Corrected parts table Additional customer letter examples added															
08/08/2023	Original publication

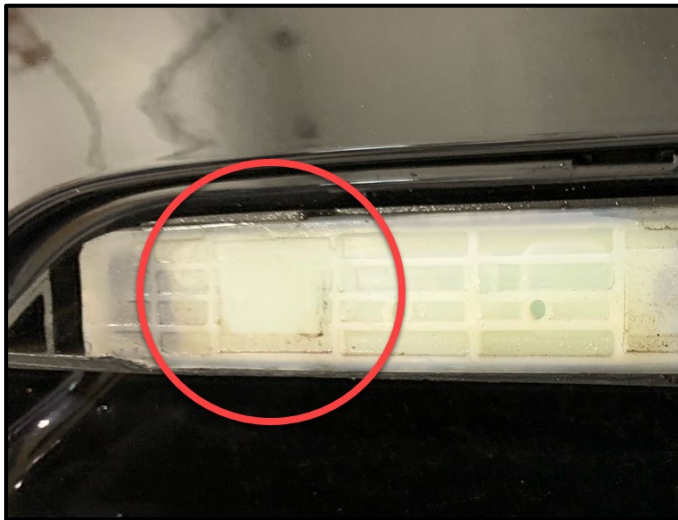
- Locate the membrane <1> on the door handle.

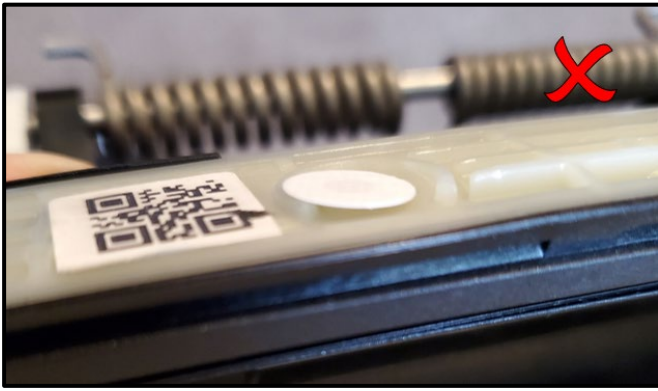
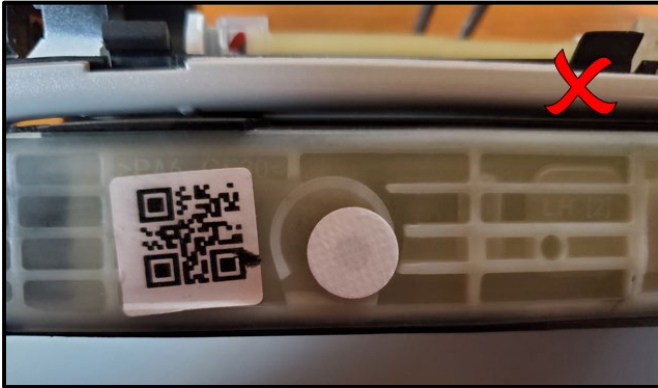
- Some door handles may not have a pressure equalization port, and will not have a recessed area for the membrane.
- **These door handles will not be replaced during the 57J5 repair. They will instead be replaced during the 57J8 repair.**
- **The door control module update must still be carried out during the 57J5 repair.**
- See Step 3 for door handle cover reassembly.

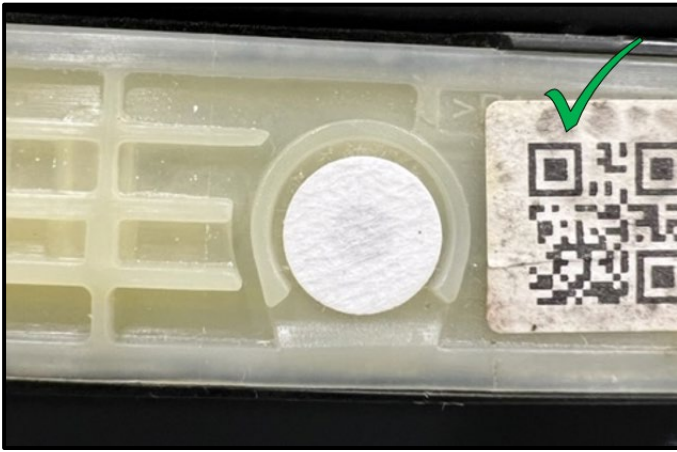
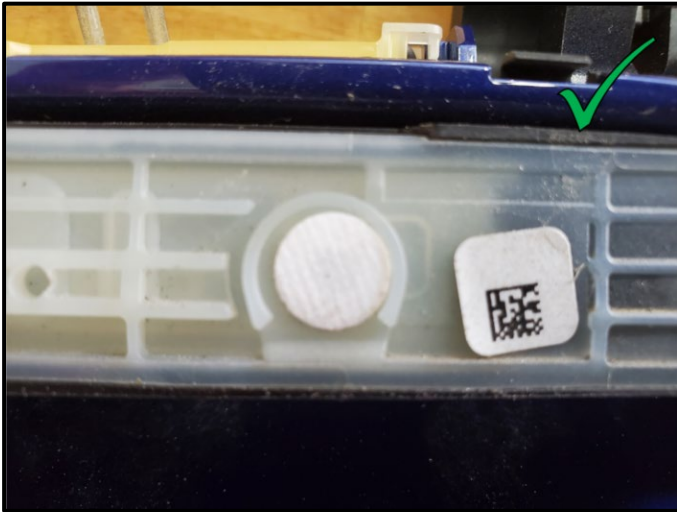
- Check the current installation of the membrane.
- If the membrane is not adhered properly (membrane is missing, edge is lifted or partially applied on the circular boss, for example):
 - The door handle must be replaced.
 - Front doors - Proceed to Section C for front door handle assembly removal.
 - Rear doors – Proceed to Section D for rear door handle assembly removal.

- If the membrane appears to be adhered properly, see Step 3 for door handle cover reassembly.
- Once all door handles are reassembled, Proceed to Section F to update the door control module software.
