APA4 - Check Connection Points on the Body and Rework if Necessary (Recall Campaign)

Vehicle Type: **Taycan 4S (Y1A) / Taycan GTS (Y1A) / Taycan Turbo (Y1A)**

Model Year: **As of 2020 up to 2023**

Concerns: **Connecting points on the body**

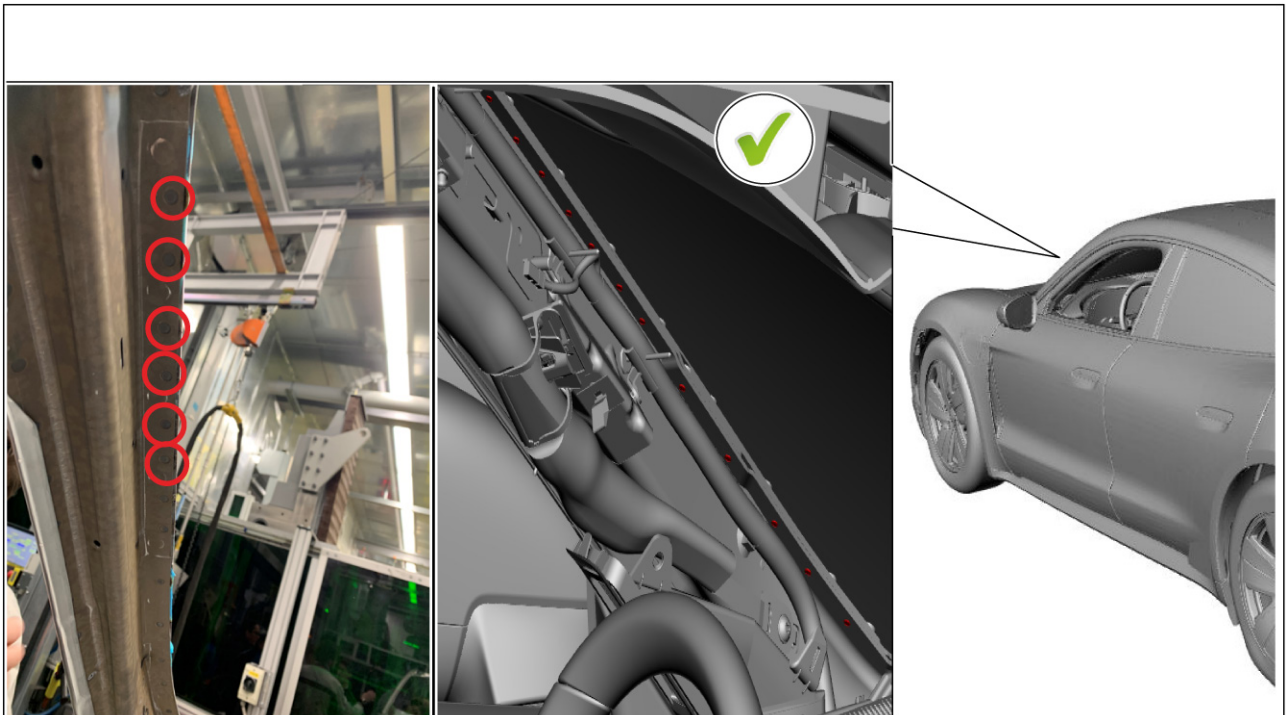
2 **Visually inspect resistance points** in the marked area of the left A-pillar.

Visual inspection of resistance points on A-pillar

Assessment	Action
The A-pillar has resistance points .	All connection points are set according to specifications and do not have to be reworked. End of remedial action. ⇒ Continue with Step 3 [Scope 1]
No resistance points present on the A-pillar.	Connecting points are not set according to specifications. The A-B-C pillars and rear side sections must be reworked . ¹ ⇒ Continue with repair instructions from APA4 PPN document [Scope 2]

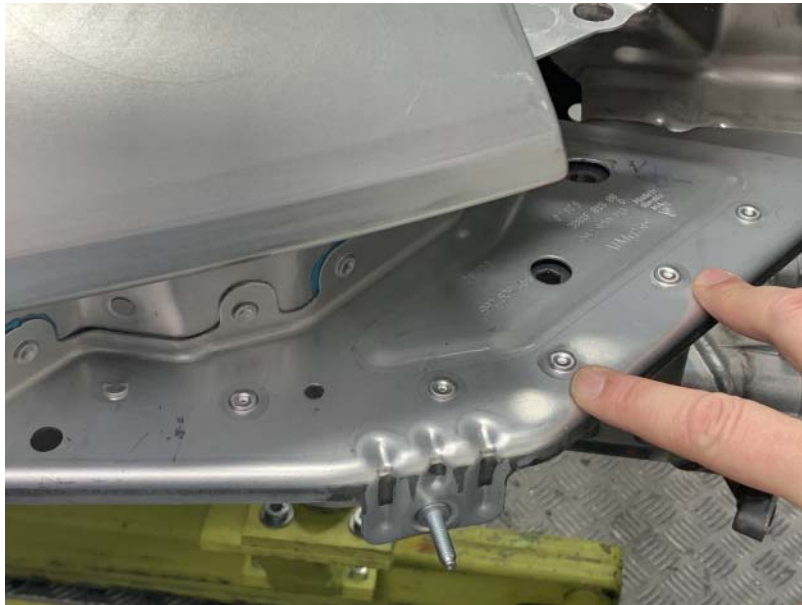
Example 1

Examples
of correctly
performed
welds
