SIM 61 05 23

RECALL 23V-337: FOOTWELL MODULE (FRM) MOISTURE/WATER INTRUSION

This Service Information Bulletin (Revision 6) replaces SI B61 05 23 **dated October 2024**.

BMW AG is conducting a Voluntary Safety Recall (effective May 11, 2023) on certain Model Year 2007 - 2014 MINI vehicles that were produced between November 16, 2006, and June 27, 2014.

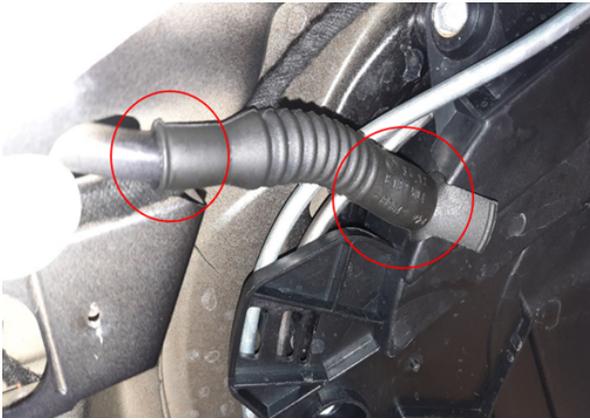
Due to several factors, over time, the FRM (Footwell Module) could become susceptible to corrosion due to moisture/water intrusion into the vehicle, specifically from the sunroof assembly's water drain hose(s). Eventually, the corrosion could potentially result in a short circuit.

3. Replace the sunroof drain tube water outlet hoses on both sides (driver and passenger side).

Note: Prior to installing the new sunroof drain water outlet hoses, using compressed air, blowout both front sunroof drain tubes until they are clear from any debris.

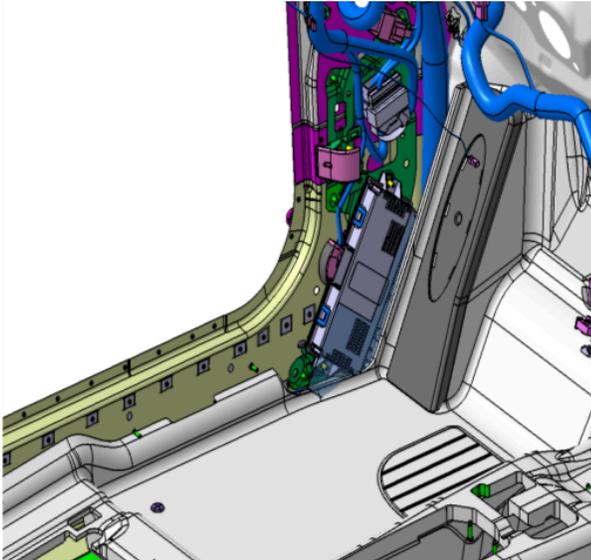
9. Inspect the driver and passenger side floorboard for any corrosion/oxidation.

- If the floorboard on either side has any corrosion/oxidation on it, it will need to be removed using a wire brush and then primed using 2K epoxy primer to protect it against corrosion.
- If the floorboard on either side is too thin to repair, contains holes and/or cracks due to standing water-related corrosion, review and follow the attached document (R55 and R56 Floorboard Repair Procedure).

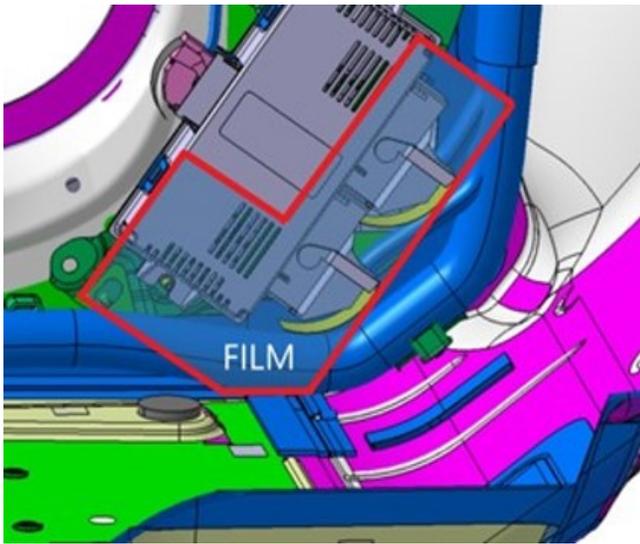
10. The FRM will need to be removed following the repair instructions listed in ISTA/AIR 61 35 115 (included in 00 75 806/00 75 232). Inspect the FRM and its connectors (**X14259, X14260, and X14261**) for corrosion/oxidation. Removing the connector sleeves is required to get a better visual of the condition of the pins and wires.

If there is any corrosion/oxidation on any of the male pins on the FRM (Footwell Module) control module or any of the female pins on the FRM connectors, the FRM control module and the damaged pins, wiring, and connectors will need to be replaced. Review and follow the notes listed in ISTA/AIR on how to handle wiring harnesses and cables 61 00.

Note: Replacement of the FRM (Footwell Module) control module requires programming via ISTA-P. Review and follow repair instructions listed in ISTA/AIR 61 00 730.

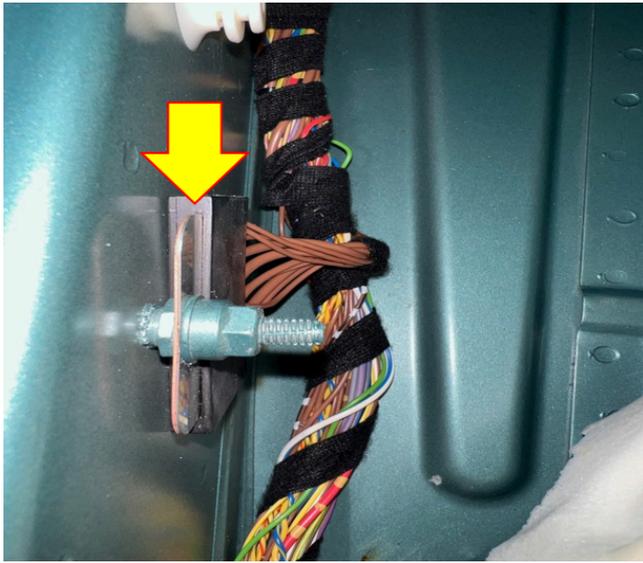
12. The Junction Box Electronics (JBE) control module will need to be removed following the repair instructions listed in ISTA/AIR 61 35 040. Inspect the JBE control module and its connectors (**X11001, X11002, X11003, X11005, X11006, X11007, X11008, X11009, X11010, X14272 and X34117**) for corrosion/oxidation. Removing the connector sleeves is required to get a better visual of the condition of the pins and wires.

If there is any corrosion/oxidation on any of the male pins on the JBE (Junction Box Electronics) control module or any of the female pins on the JBE connectors, the JBE control module and the damaged pins, wiring, and connectors will need to be replaced. Review and follow the notes listed in ISTA/AIR on how to handle wiring harnesses and cables 61 00.

Note: Replacement of the JBE (Junction Box Electronic) control module requires programming via ISTA-P. Review and follow repair instructions listed in ISTA/AIR 61 00 730.

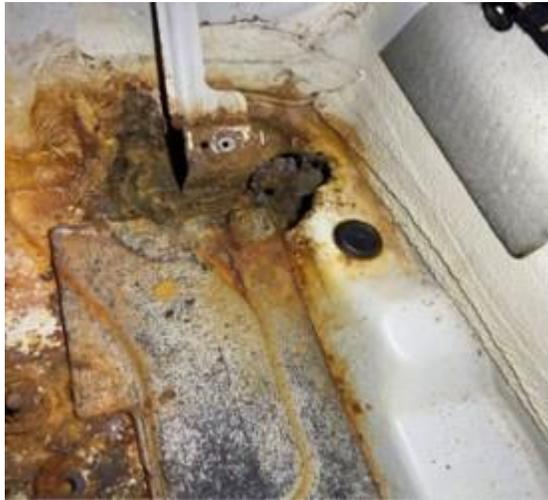
The floorboard/panel(s) are found to too thin to repair, corroded through, and/or are cracked.

- Cut out the corroded edges of the hole(s)
- Using part number **(41 21 7 275 563 – Reinforcement plate universal)**, cut the replacement plate to the size of the current hole with an overlap of 2-3cm
- Remove the screws from the reinforcement plate if it is necessary to use the entire plate
- If the size of the reinforcement plate is not sufficient, a standard steel sheet (0.8-1mm thick) must be used
- Shape the panel in accordance with the contour of the floorboard
- Weld the reinforcement plate to the floorboard.
Make sure to review and follow the welding notes on the next slide
- Prime the repaired area using 2K epoxy primer
- Apply D1/D2 sealant to the repaired area
