SIM 61 05 23

2024-04-26

RECALL 23V-337: FOOTWELL MODULE (FRM) MOISTURE/WATER INTRUSION

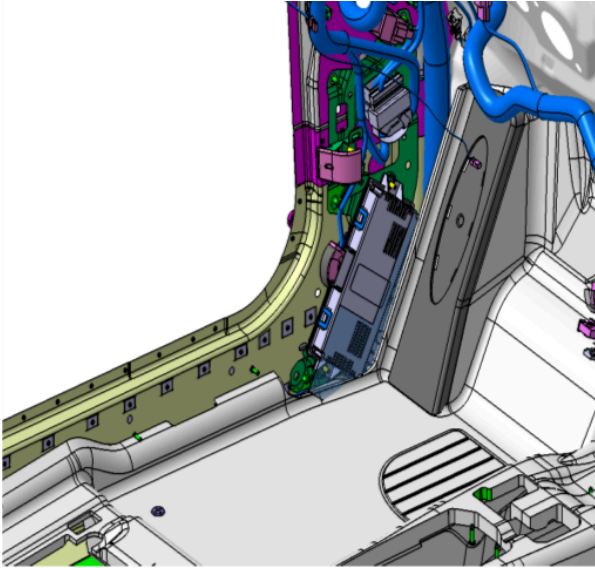
9. Inspect the driver and passenger side floorboard for any corrosion/oxidation.

If the floorboard on either side has any corrosion/oxidation on it, it will need to be removed using a wire brush and then primed using 2K epoxy primer to protect it against corrosion.

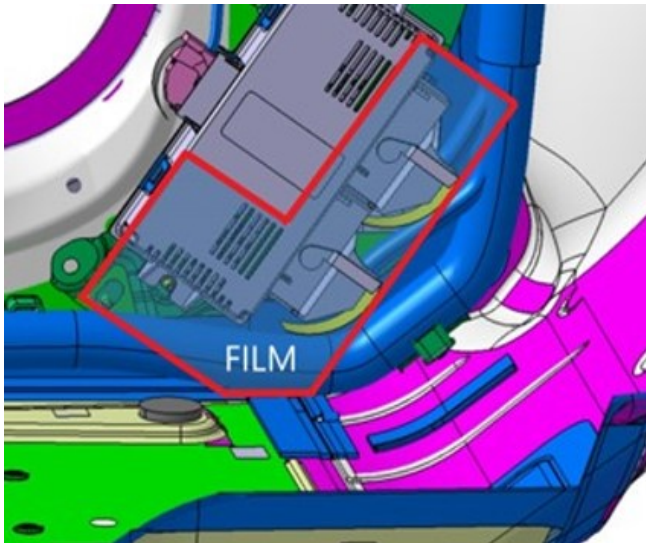
10. The FRM will need to be removed following the repair instructions listed in ISTA/AIR 61 35 115 (included in 00 75 806/00 75 232). Inspect the FRM and its connectors (**X14259, X14260, and X14261**) for corrosion/oxidation. Removing the connector sleeves is required to get a better visual of the condition of the pins and wires.

If there is any corrosion/oxidation on any of the male pins on the FRM (Footwell Module) control module or any of the female pins on the FRM connectors, the FRM control module and the damaged pins, wiring, and connectors will need to be replaced. Review and follow the notes listed in ISTA/AIR on how to handle wiring harnesses and cables 61 00.

Note: Replacement of the FRM (Footwell Module) control module requires programming via ISTA-P. Review and follow repair instructions listed in ISTA/AIR 61 00 730.
