RECALL 23V-337: FOOTWELL
MODULE (FRM)
MOISTURE/WATER INTRUSION

SIB 61 05 23

2024-10-16

BMW AG is conducting a Voluntary Safety Recall (effective May 11, 2023) on certain Model Year 2007 - 2014 MINI vehicles that were produced between November 16, 2006, and June 27, 2014.

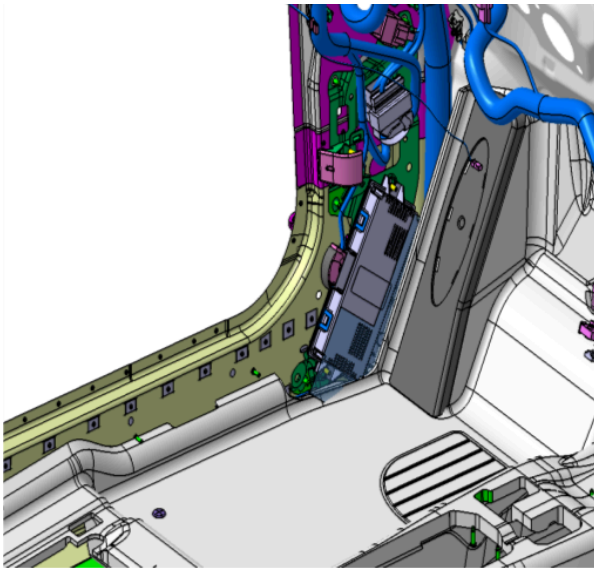
9. Inspect the driver and passenger side floorboard for any corrosion/oxidation.

If the floorboard on either side has any corrosion/oxidation on it, it will need to be removed using a wire brush and then primed using 2K epoxy primer to protect it against corrosion.

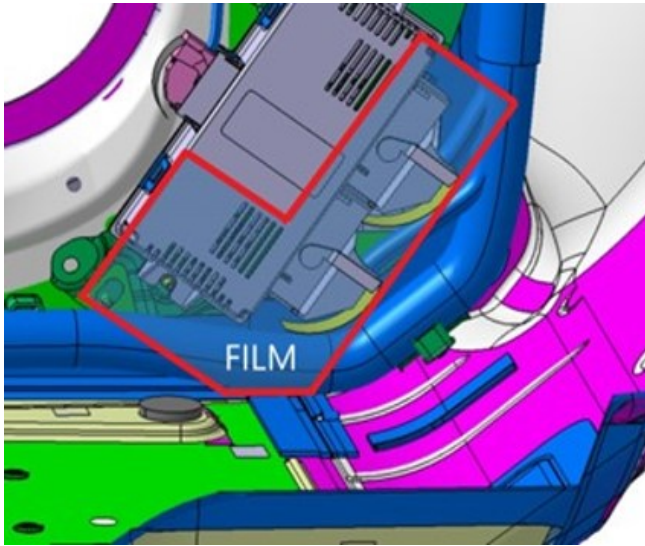
10. The FRM will need to be removed following the repair instructions listed in ISTA/AIR 61 35 115 (included in 00 75 806/00 75 232). Inspect the FRM and its connectors (**X14259, X14260, and X14261**) for corrosion/oxidation. Removing the connector sleeves is required to get a better visual of the condition of the pins and wires.

If there is any corrosion/oxidation on any of the male pins on the FRM (Footwell Module) control module or any of the female pins on the FRM connectors, the FRM control module and the damaged pins, wiring, and connectors will need to be replaced. Review and follow the notes listed in ISTA/AIR on how to handle wiring harnesses and cables 61 00.

Note: Replacement of the FRM (Footwell Module) control module requires programming via ISTA-P. Review and follow repair instructions listed in ISTA/AIR 61 00 730.
