SIM 61 05 23

## RECALL 23V-337: FOOTWELL MODULE (FRM) MOISTURE/WATER INTRUSION

This Service Information Bulletin (Revision 7) replaces SI M61 05 23 **dated February 2025**.

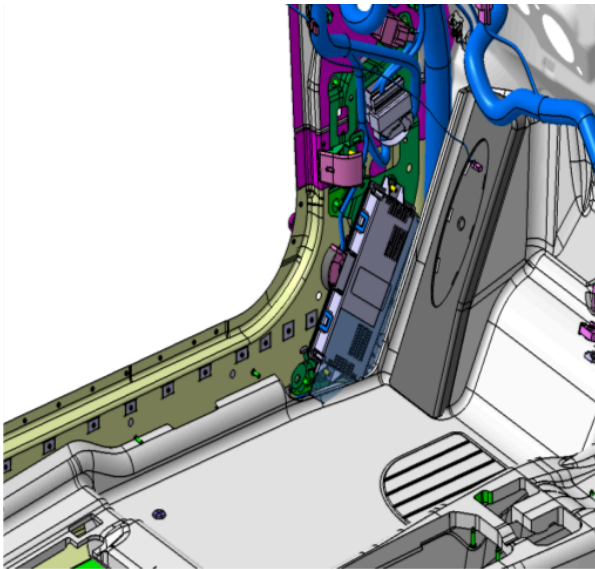
9. Inspect the driver and passenger side floorboard for any corrosion/oxidation.

- If the floorboard on either side has any corrosion/oxidation on it, it will need to be removed using a wire brush and then primed using 2K epoxy primer to protect it against corrosion.
- If the floorboard on either side is too thin to repair, contains holes and/or cracks due to standing water-related corrosion, review and follow the attached document (R55 and R56 Floorboard Repair Procedure).

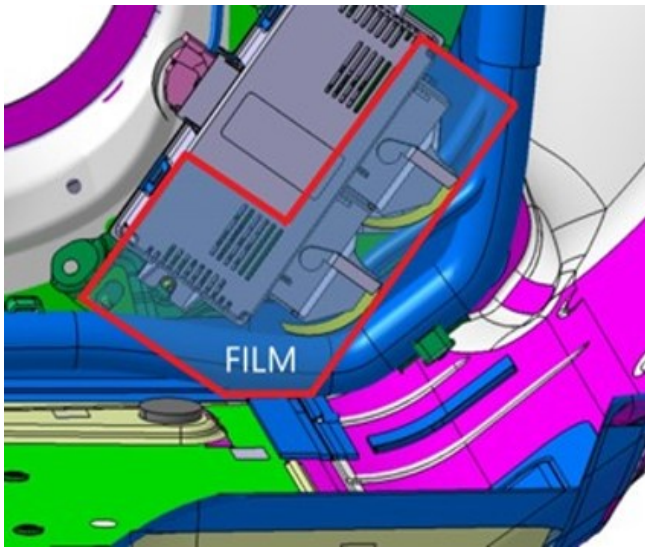
10. The FRM will need to be removed following the repair instructions listed in ISTA/AIR 61 35 115 (included in 00 75 806/00 75 232). Inspect the FRM and its connectors (**X14259, X14260, and X14261**) for corrosion/oxidation. Removing the connector sleeves is required to get a better visual of the condition of the pins and wires.

If there is any corrosion/oxidation on any of the male pins on the FRM (Footwell Module) control module or any of the female pins on the FRM connectors, the FRM control module and the damaged pins, wiring, and connectors will need to be replaced. Review and follow the notes listed in ISTA/AIR on how to handle wiring harnesses and cables 61 00.

**Note: Replacement of the FRM (Footwell Module) control module requires programming via ISTA-P. Review and follow repair instructions listed in ISTA/AIR 61 00 730.**
