SIM 61 05 23

RECALL 23V-337: FOOTWELL MODULE (FRM) MOISTURE/WATER INTRUSION

BMW AG is conducting a Voluntary Safety Recall (effective May 11, 2023) on certain Model Year 2007 - 2014 MINI vehicles that were produced between November 16, 2006, and June 27, 2014.

Due to several factors, over time, the FRM (Footwell Module) could become susceptible to corrosion due to moisture/water intrusion into the vehicle, specifically from the sunroof assembly's water drain hose(s). Eventually, the corrosion could potentially result in a short circuit.

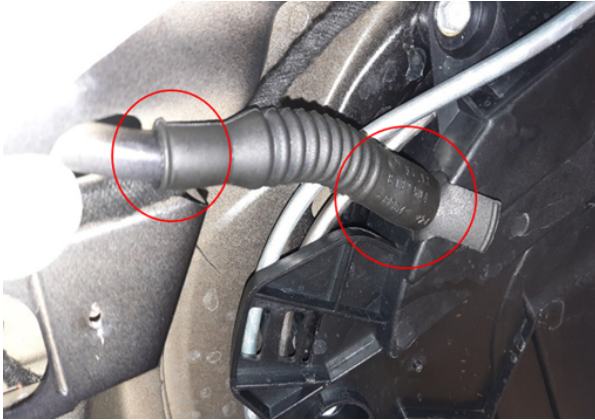
Note: Inspect the headliner for any signs of mold/mildew. If mold/mildew is present, the headliner will need to be replaced.

1. Disconnect the vehicles 12V battery following the repair instructions listed in ISTA/AIR 61 20 900.
2. Remove the headliner from the vehicle following the repair instructions listed in ISTA/AIR 51 44 011.

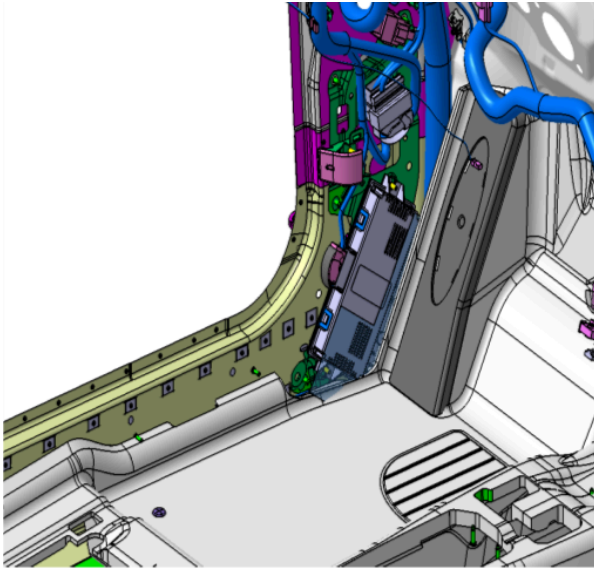
9. Inspect the driver and passenger side floorboard for any corrosion/oxidation.

If the floorboard on either side has any corrosion/oxidation on it, it will need to be removed using a wire brush and then primed using 2K epoxy primer to protect it against corrosion.

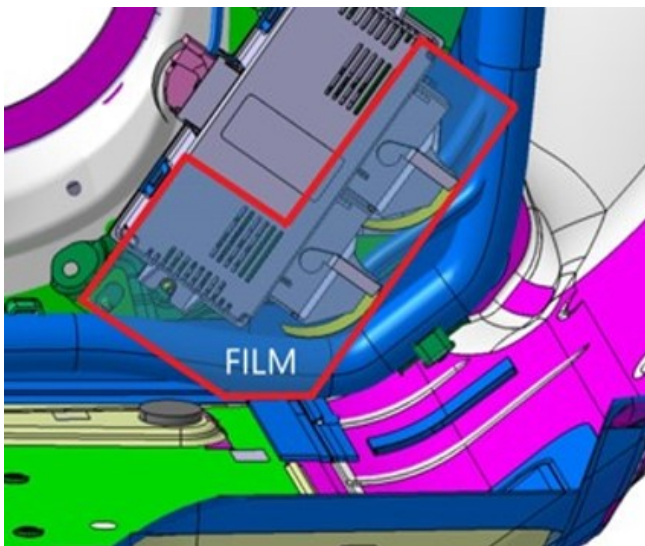
10. The FRM will need to be removed following the repair instructions listed in ISTA/AIR 61 35 115 (included in 00 75 806/00 75 232). Inspect the FRM and its connectors (**X14259, X14260, and X14261**) for corrosion/oxidation. Removing the connector sleeves is required to get a better visual of the condition of the pins and wires.

If there is any corrosion/oxidation on any of the male pins on the FRM (Footwell Module) control module or any of the female pins on the FRM connectors, the FRM control module and the damaged pins, wiring, and connectors will need to be replaced. Review and follow the notes listed in ISTA/AIR on how to handle wiring harnesses and cables 61 00.

Note: Replacement of the FRM (Footwell Module) control module requires programming via ISTA-P. Review and follow repair instructions listed in ISTA/AIR 61 00 730.

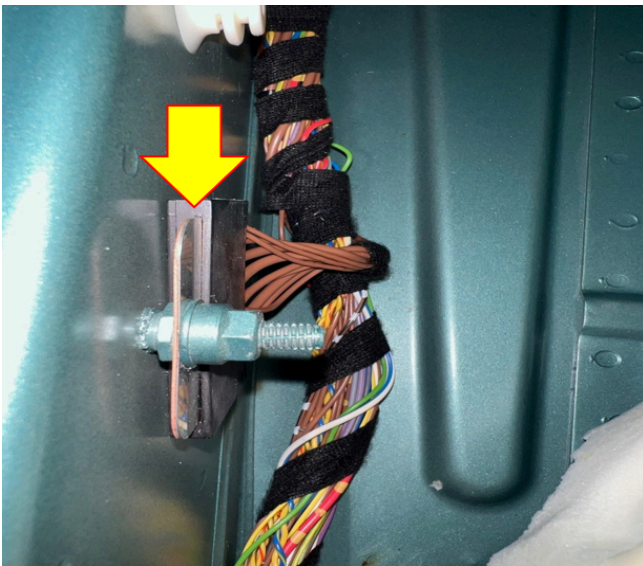
12. The Junction Box Electronics (JBE) control module will need to be removed following the repair instructions listed in ISTA/AIR 61 35 040. Inspect the JBE control module and its connectors (**X11001, X11002, X11003, X11005, X11006, X11007, X11008, X11009, X11010, and X14272**) for corrosion/oxidation. Removing the connector sleeves is required to get a better visual of the condition of the pins and wires.

If there is any corrosion/oxidation on any of the male pins on the JBE (Junction Box Electronics) control module or any of the female pins on the JBE connectors, the JBE control module and the damaged pins, wiring, and connectors will need to be replaced. Review and follow the notes listed in ISTA/AIR on how to handle wiring harnesses and cables 61 00.

Note: Replacement of the JBE (Junction Box Electronic) control module requires programming via ISTA-P. Review and follow repair instructions listed in ISTA/AIR 61 00 730.
