Remedy available for  
 2021 - 2023 (WL) Jeep Grand Cherokee L  
 2022 - 2023 (WL) Jeep Grand Cherokee

# SAFETY RECALL

## Intermediate Shaft

Reference: 58A / NHTSA 23V-352

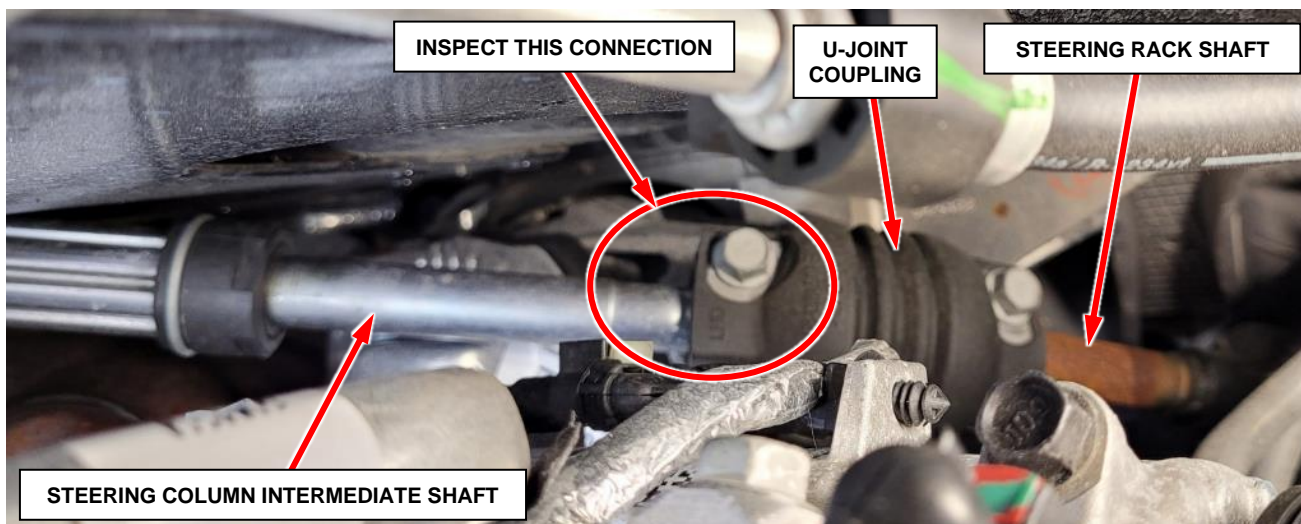
Figure 3 – Locate Suspect Steering Connection

4. Visually locate the steering column intermediate shaft to U-joint interface connection for inspection (Figure 3).

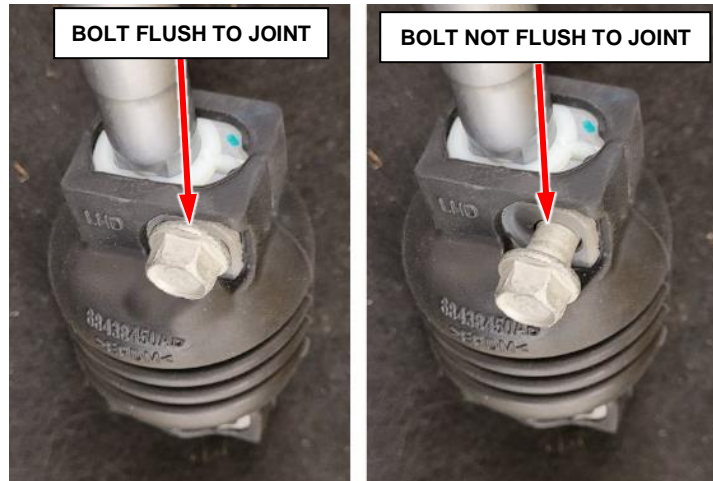
**Figure 4 – Inspect Bolt Flushness with U-Joint Connection**

- a) Does the U-joint coupling upper bolt appear to be fully tightened flush against the U-joint coupling or not fully tightened? (Figure 4).

**Bolt Fully Flush**    **Bolt NOT Fully Flush**

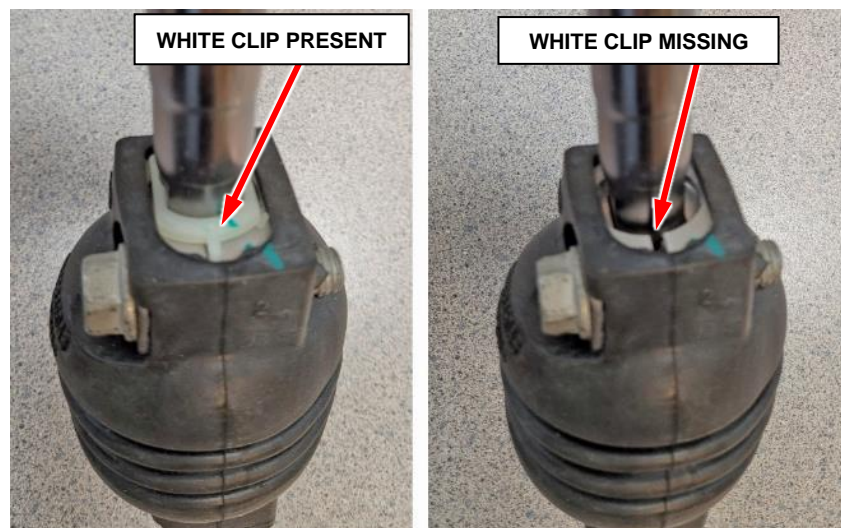
**Figure 5 – Inspect for White Clip at U-Joint Connection**

- b) Is the white spacer clip present or missing? (Figure 5).

**White Clip Present**    **White Clip MISSING**

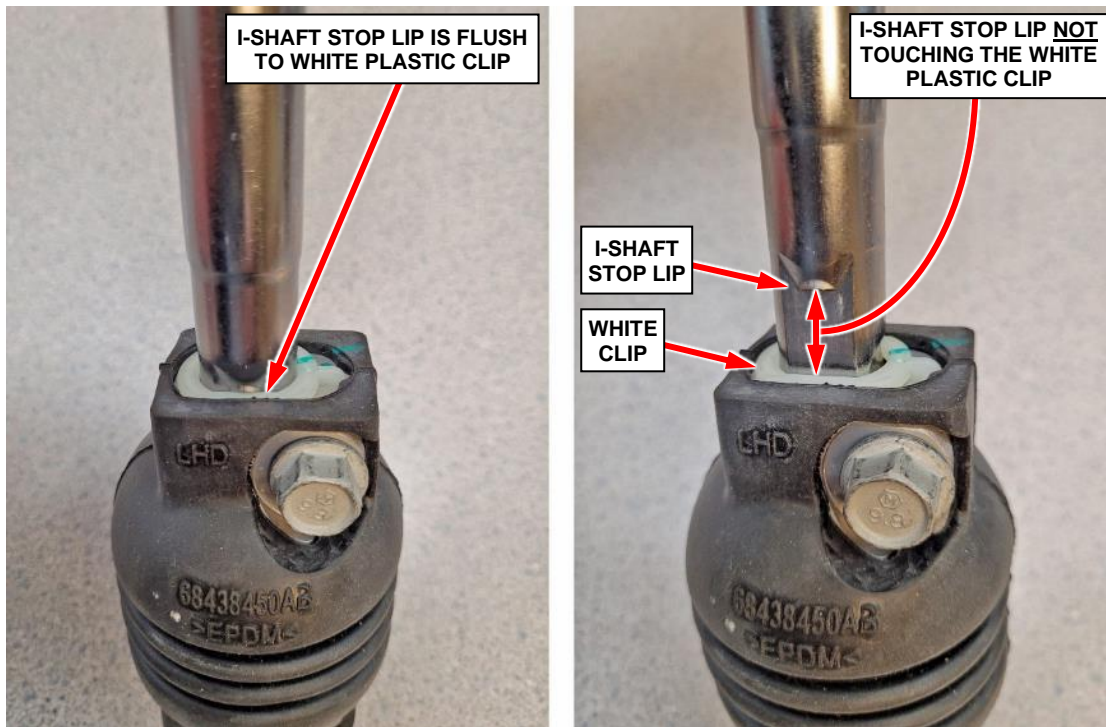
- c) Is the intermediate shaft fully inserted into the U-joint coupler with I-shaft stop lip touching the white plastic clip or not fully inserted? (Figure 6).

**Shaft Inserted to Clip**

**Shaft NOT Fully Inserted to Clip**

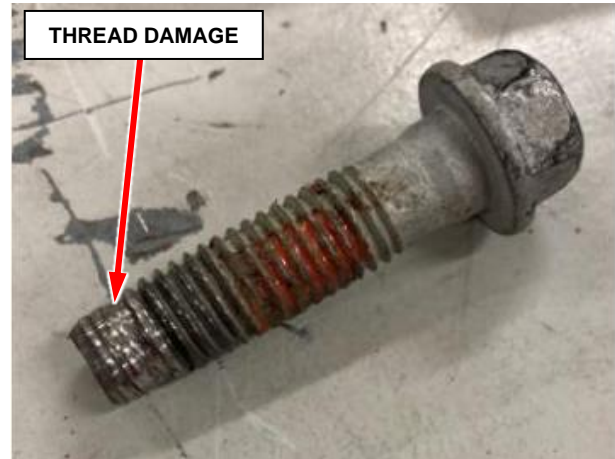
Figure 21 – Inspect Bolt Threads

5. Remove the upper steering column shaft U-joint coupling pinch bolt and examine the bolt threads for any damage then **DISCARD** the bolt (Figure 21).

- **Bolt Threads Damaged:** The U-Joint coupling will require replacement. Continue to **Step 6** of repair procedure.
- **Bolt Threads NOT Damaged:** U-Joint coupling may be reused. U-joint coupling replacement step may be skipped. Continue to **Step 7** of the repair procedure.

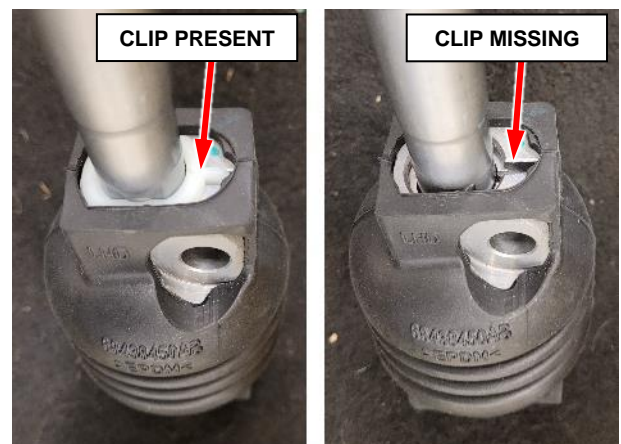
Figure 24 – White Plastic Clip

7. Is the white plastic clip present or missing from the U-joint coupling? (Figure 24)

- **White Plastic Clip Present:** Continue to next step of repair procedure.
- **White Plastic Clip Missing:** Obtain a **NEW** white plastic clip and follow these instructions.

Install the **NEW** white plastic clip to U-joint coupling:

- Grasp the I-shaft near the U-joint coupling then slide the I-shaft back into itself releasing it from the U-joint coupling (Figure 23).
- Install the white plastic clip to the U-joint coupling (Figure 24).
- Slide the I-shaft back into the U-joint coupling inserting the I-shaft fully into the U-joint coupling as far as it will go. The white plastic clip will act as a stop (Figure 23).
- Proceed to the next step of the repair procedure.

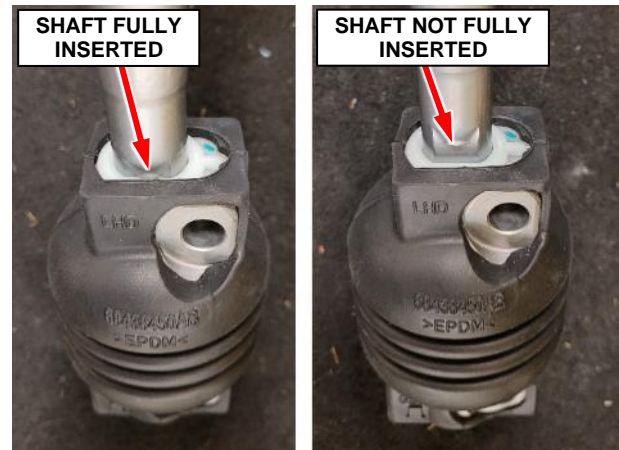
Figure 25 – Intermediate Shaft Insertion Into U-Joint Coupling

- **I-Shaft Stop Lip Contacts White Plastic Clip:**  
Continue to **Step 10** of repair procedure.
- **I-Shaft Stop Lip NOT Contacting White Plastic Clip and CANNOT Be Inserted Further:**  
Intermediate shaft is oversize. Obtain a **NEW** intermediate shaft then follow these instructions.

Fully Inserted

Not Fully Inserted
